MINERALS PROGRAM INSPECTION REPORT
PHONE: (303) 866-3567

MINE NAME: The Orr Pit	MINE/PROSPECTING ID#: M-2009-074	MINERAL: Sand and gravel	COUNTY: Pueblo
INSPECTION TYPE: Monitoring	WEATHER: Clear	INSP. DATE: February 28, 2023	INSP. TIME: 08:45
OPERATOR: Colorado Backhoe Service	OPERATOR REPRESENTATIVE: Thomas Joseph	TYPE OF OPERATION: 112c - Construction Regular Operation

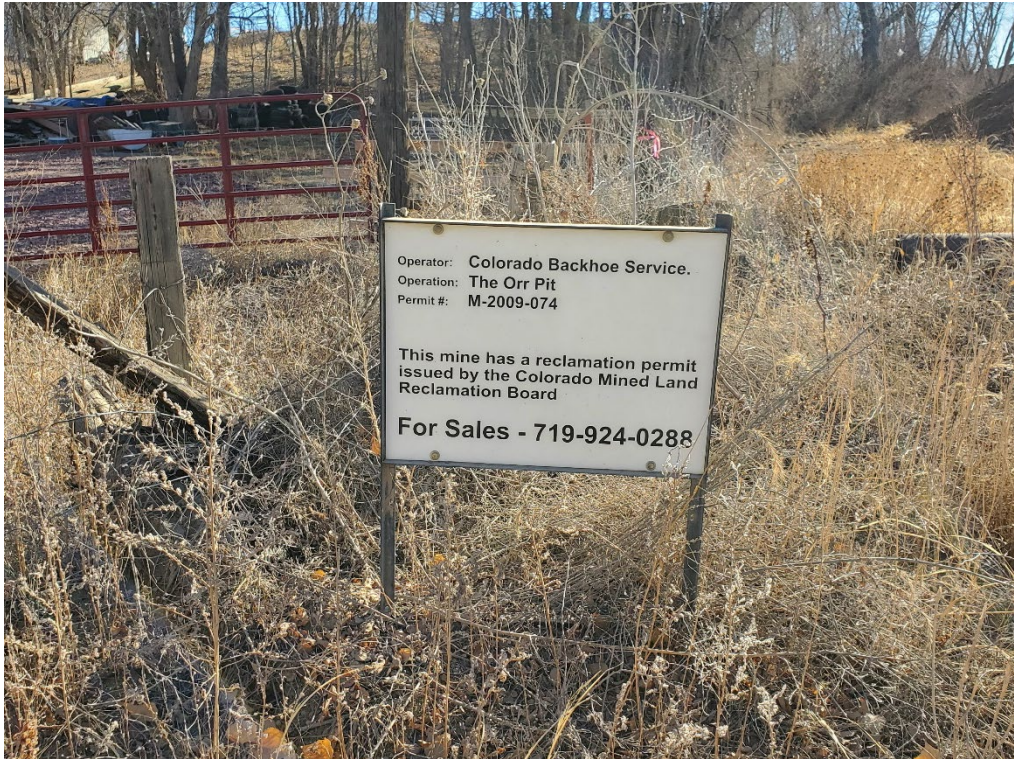
Photo 1: Mine sign at the entrance to the site.

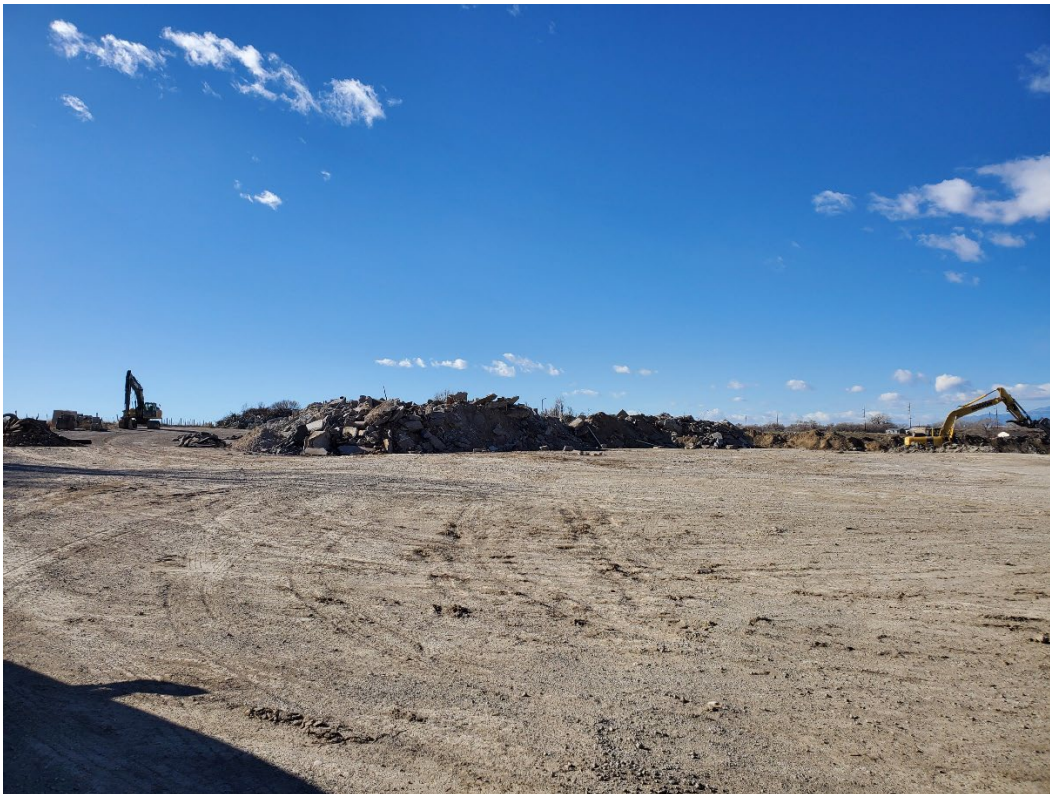
The Operator stated that much of their income from the operation comes from crushing, processing, and selling imported products. This is approved and the Operator stated that they do not use this as backfill. Various product stockpiles were observed on site.

Photo 10: Looking south across the site at imported material stockpiles.

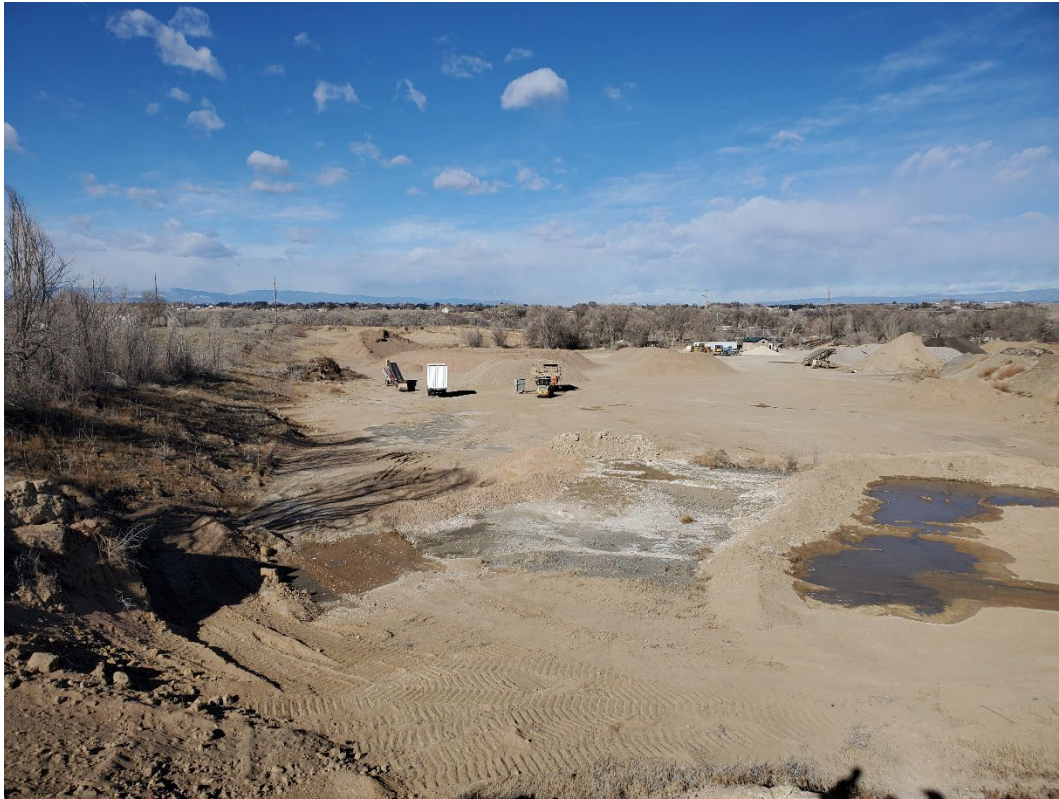
Photo 11: Looking west across the open pit.

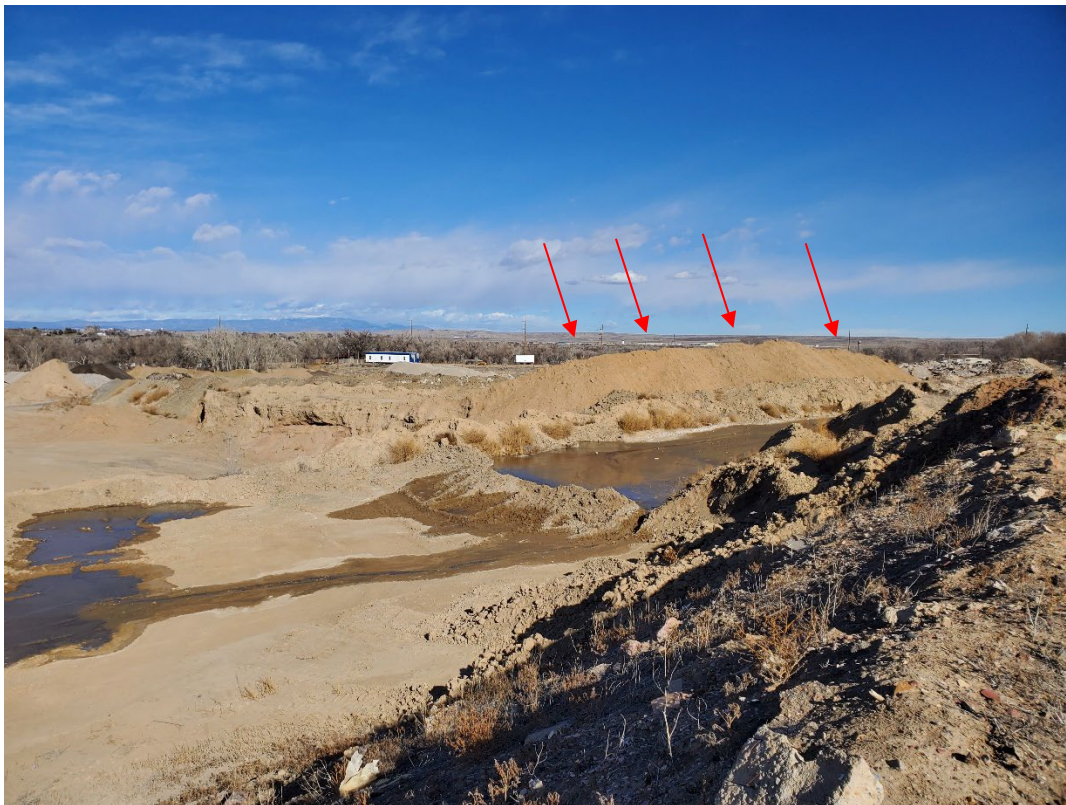
PROBLEM: The topsoil stockpiles do not have established vegetation on them and are therefore susceptible to erosion. Rule 3.1.9(1) states if topsoil is not replaced into the backfill area within a time short enough to avoid deterioration of the topsoil, vegetative cover or other means shall be employed so that the topsoil is protected from erosion.

A problem was cited above for improper topsoil storage. Currently, the topsoil is being stockpiled concurrently with mining, and is surrounding the active mining pit in the east-central portion of the permit. Pursuant to Rule 3.1.9(3) topsoil must be stockpiled in places and configurations to minimize erosion and located in areas where disturbance by ongoing mining operations will be minimized. The Operator shall submit evidence to the Division that the topsoil piles have been re-located and stabilized prior to the corrective actions date.

Photo 12: Looking north-west across the pit at the current topsoil pile (arrows) and shallow standing water.

CORRECTIVE ACTIONS: The operator shall relocate and seed the topsoil stockpiles with the seed mix that was submitted as part of the approved Reclamation Plan. The Operator shall demonstrate compliance by submitting seed tags, a bill of sale or photographs of seeding activities. The Operator may also request a follow up inspection.

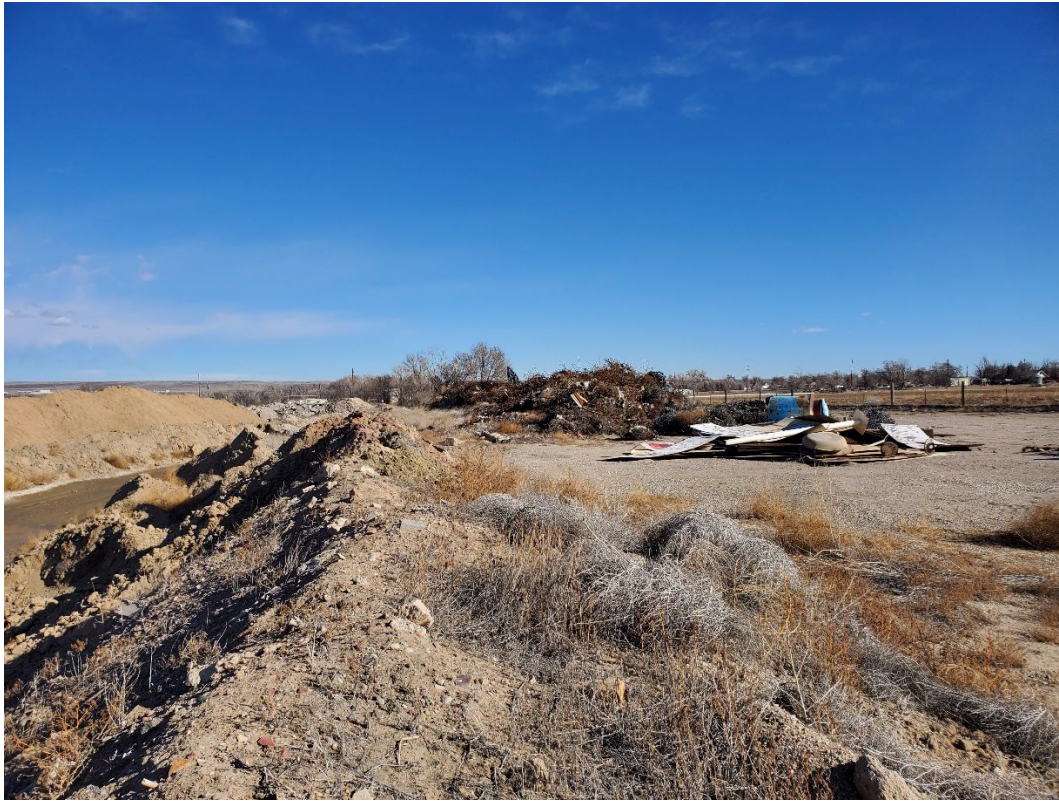
Photo 13: Looking north at imported waste product being temporarily stored onsite

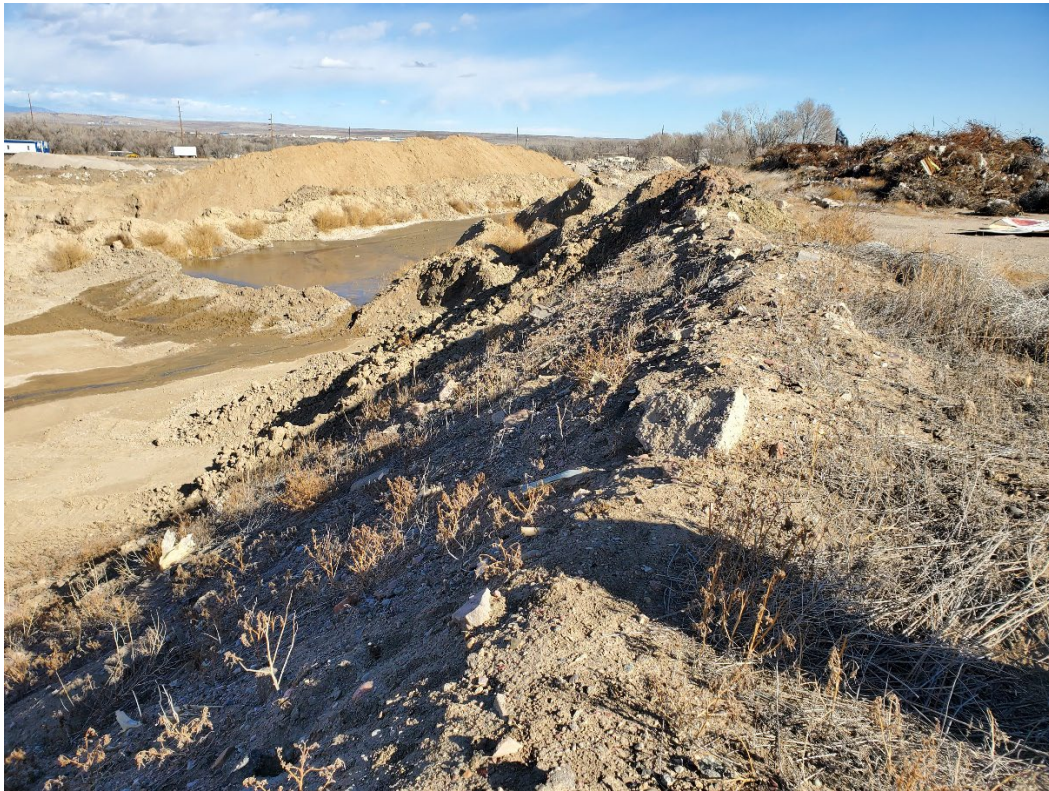
Currently toward the center of the operation, the working face is steeper than a 2H:1V slope and is approximately 15'-20' in height that faces west. The topsoil is located behind this working face.

Photo 15: Looking north across the working face. The working face is at about a 2H:1V slope and is approximately 15'-20' in height.

This site will require a combination of backfilling and grading. The working face will be cut and backfilled to create a 3H:1V slope. The Operator stated that they will soon begin mining towards the southern portion of the permit boundary from the north-east corner along the eastern border. The Operator was reminded that in doing so they will need to leave enough room along the permit boundary for the equipment to backfill and grade the slope so that they do not create off-site damage. The Operator committed to keeping a 5'-10' buffer between the fence and the working face. The mining floor will be graded and graveled in the area that pre-law mining took place.

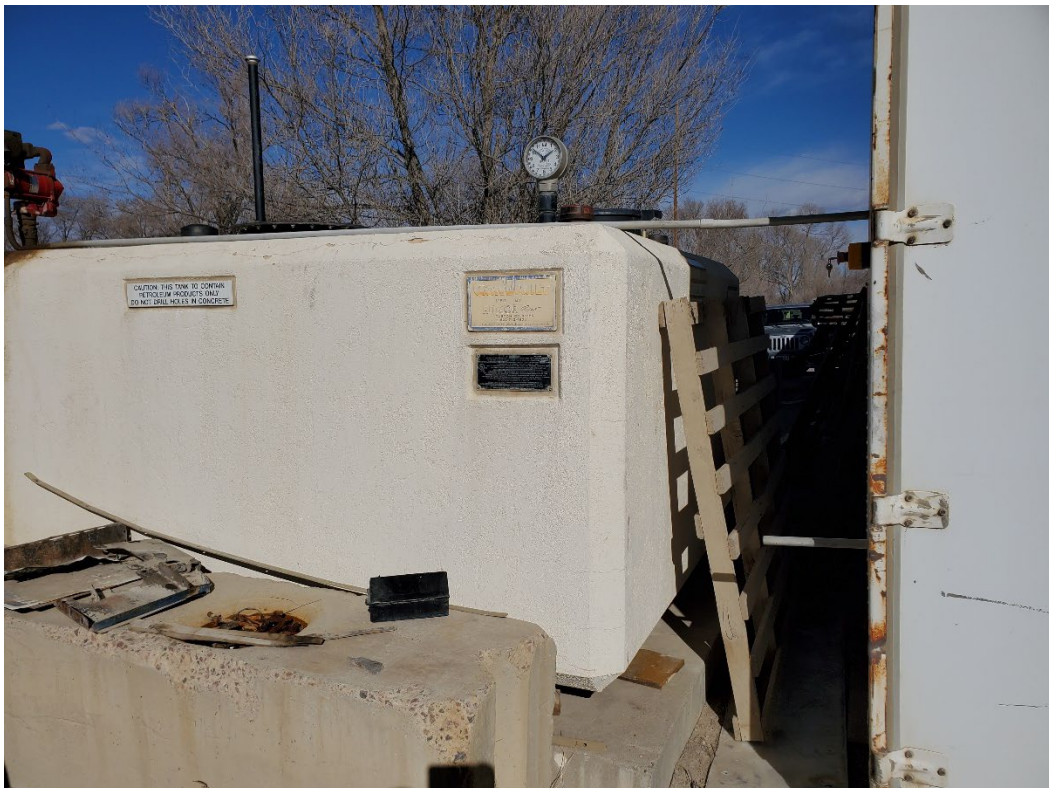
Fuel is stored onsite in a double-walled tank and is surrounded by concrete blocks. The storage tank appeared to be well insulated and no spills were observed.

Photo 16: Fuel storage double-walled container on concrete blocks.

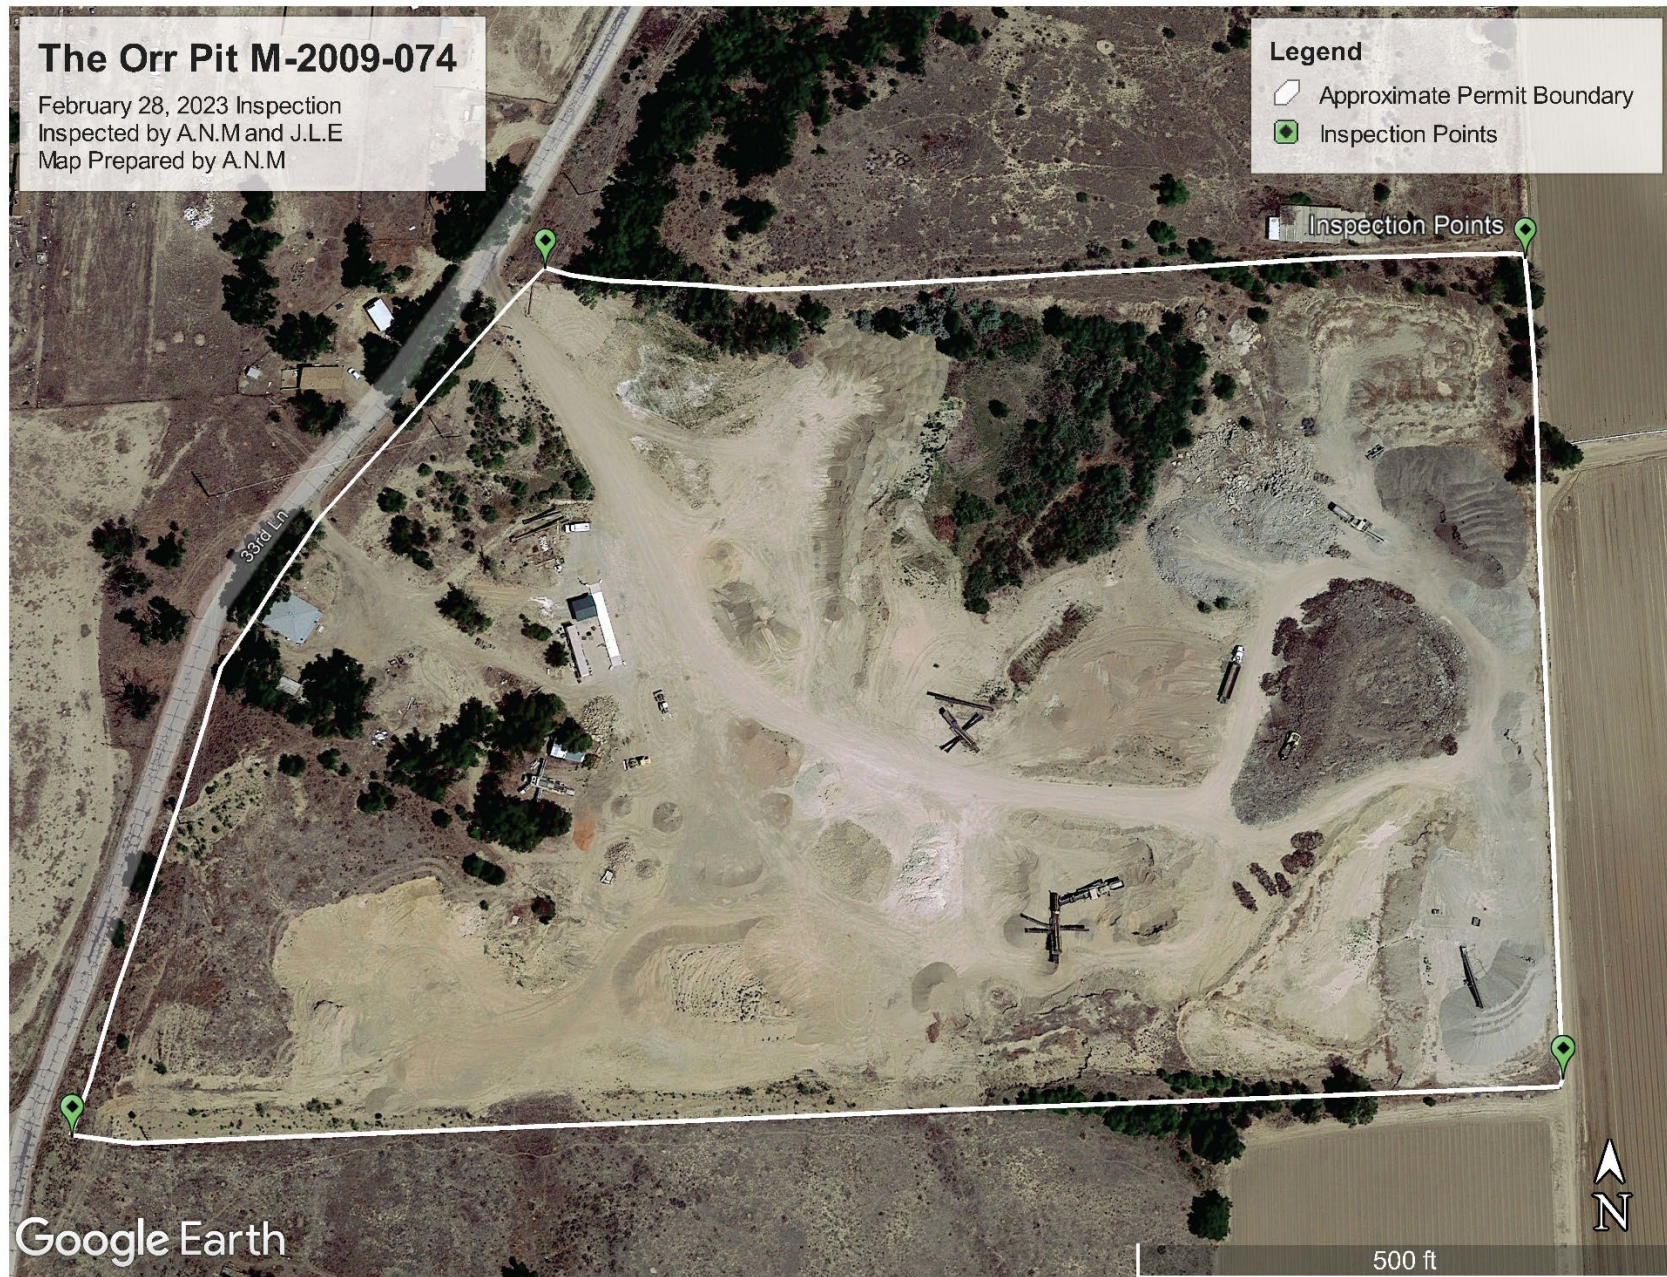
A permit sign was observed at the entrance to the site. The Operator also led the inspectors to each permit corner marker where GPS coordinates were then collected.

Map showing the GPS coordinates for the permit corner markers collected during the 2023 inspection and the approximate permit boundary
