HG Loadout Inspection Report

Permit Number: C-1992-081 Mine Name: Hayden Gulch Loadout Operator: Hayden Gulch Terminal, LLC Operator Address: Ms Miranda Kawcak 29515 Routt County Road 27 Oak Creek, CO 80467	County: Routt Operation Type: Loadout Permit Status: Active Ownership: Private Operator Representative Present:			
Operator Representative Signature: (Field Issuance Only)

This was a partial inspection of the Hayden Gulch Loadout; DRMS Permit No. C-1992-081, operated by Hayden Gulch Terminal, LLC. No activity was occurring on site at the time of inspection.

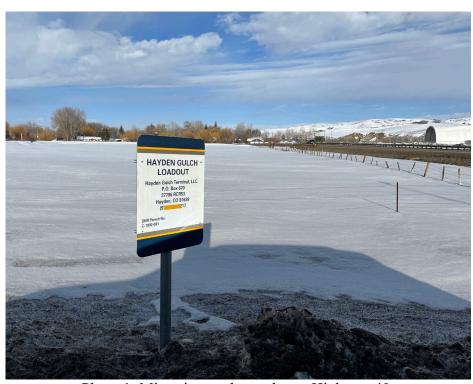
Mine identification markers were observed throughout the site. The required phone number information is currently blocked off from signage (Photos 1 and 2). This was discussed with TC representative Kevin Copeland at the Foidel Creek Mine inspection dated March 30, 2023. **Please update the division when signage has been appropriately amended.**

Photo 1: Mine signage located near Highway 40.

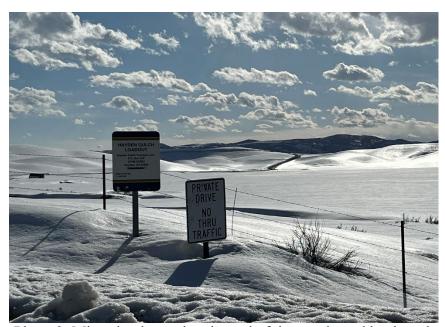
Photo 2: Mine sign located at the end of the unreleased haul road.

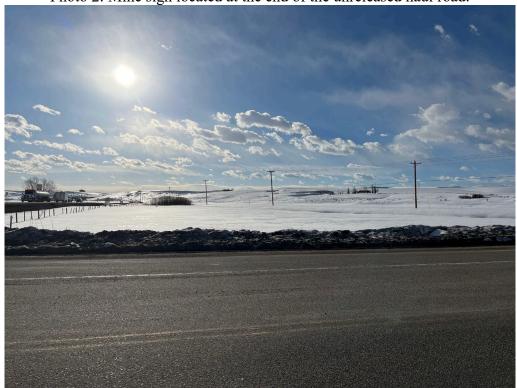
Areas not phase III bond released in the permit include the former haul road, maintained by Routt County (Photo 4). The haul road and associated areas includes 214.1 acres, of which 96.6 are disturbed. Technical Revision No. 12 (TR-12) was approved on February 24, 2023 and allows for permanent retention of this haul road. The other remaining, not yet bond released area is directly north and south of Hwy 40, to be reclaimed to agricultural use. This includes 6.8 acres of which 2.3 are disturbed (Photo 3).

RECLAMATION SUCCESS - Rule 4.15, Rule 3: The remaining permit area North of Hwy 40 was snow covered and unable to be fully inspected. This portion of the permit is planned to be incorporated into adjacent hay fields. Inspection contact stated previously that they are aiming to release this final area in the coming year.

Photo 3: Snow-covered hay fields North of Highway 40, yet to be released.

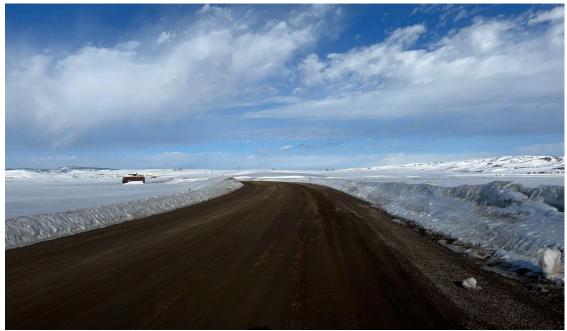
ROADS – Rule 4.03 Construction 4.03.1(3)/4.03.2(3), Drainage 4.03.1(4)/4.03.2(4), Surfacing and Maintenance4.03.1(5) and (6)/4.03.2(5) and (6), Reclamation 4.03.1(7)/4.03.2(7): The haul road was well maintained and no issues were noted (Photo 4). This area will be ready for release once the snow melts and its associated features are able to be fully inspected.

Photo 4: Haul road was plowed and well maintained.

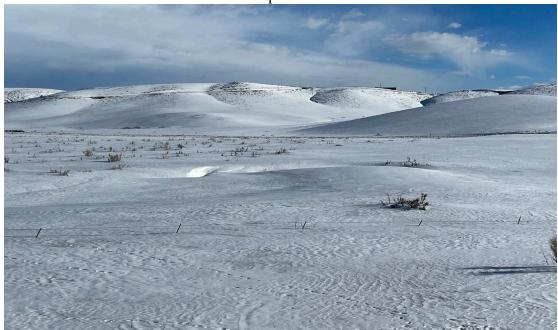
Permit Revision No. 2 (PR-2) and Bond Release No.2 (SL-2) were issued by the Division. PR-2 modified the approved reclamation plan and post-mining land use for the major portion of the Hayden Gulch Loadout, consistent with the transfer of former rail spur areas to the Town of Hayden (Hayden) for recreational use. The former rail spur area has been converted to a recreational trail for the use of residents and visitors to Hayden under a locally managed "Tracks-to-Trails" program (Photos 5 and 7) Two ponds are present within this released area (Photos 6 and 8).

Photo 5: View looking North across the Tracks-to-Trails area.

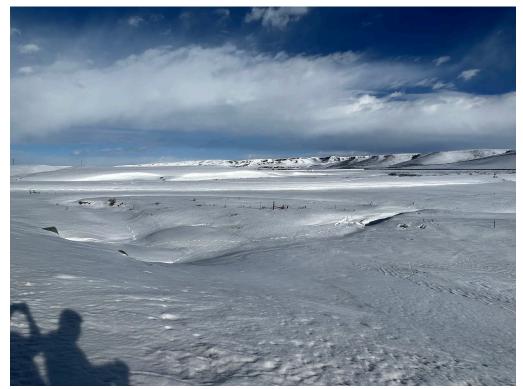
Photo 6: View looking Northwest across Tracks-to-Trails area. Large culverts are located to the west which drain the Rail Loop Pond 002 and Dry Creek which runs through the site.

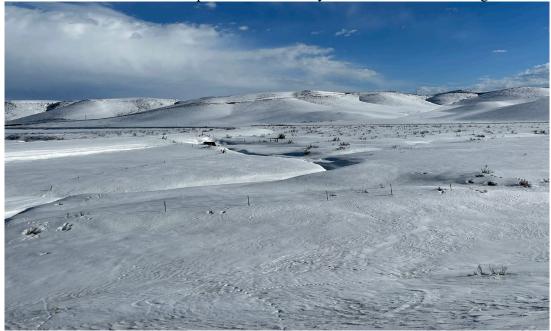
Photo 7: View North of Dry Creek which runs through the Tracks-to-Trails area.

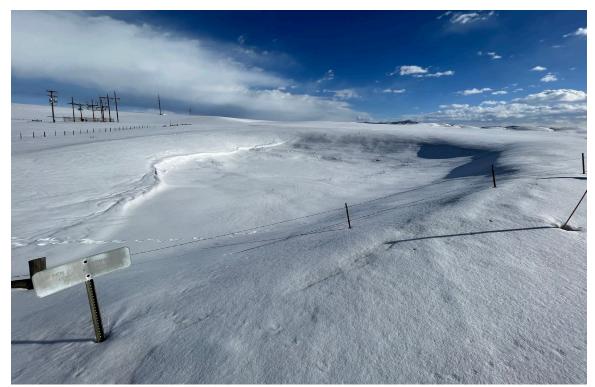
Photo 8: Truck Loop Pond 001 located in the previously released Tracks-to-Trails area. A faded mine identification sign is present.
