**MINERALS PROGRAM INSPECTION REPORT**  
**PHONE: (303) 866-3567**

<b>MINE NAME:</b> Phillips Stone Company	<b>MINE/PROSPECTING ID#:</b> M-1981-075	<b>MINERAL:</b> Sandstone	<b>COUNTY:</b> Boulder
<b>INSPECTION TYPE:</b> Preoperation Inspection	<b>WEATHER:</b> Cloudy	<b>INSP. DATE:</b> March 20, 2023	<b>INSP. TIME:</b> 09:00
<b>OPERATOR:</b> Blue Mountain Stone, Inc.	<b>OPERATOR REPRESENTATIVE:</b> Raul Vasquez	<b>TYPE OF OPERATION:</b> 110c - Construction Limited Impact	
<b>REASON FOR INSPECTION:</b> Preoperation Inspection	<b>BOND CALCULATION TYPE:</b> Partial Bond	<b>BOND AMOUNT:</b> \$17,180.00	
<b>DATE OF COMPLAINT:</b> NA	<b>POST INSP. CONTACTS:</b> None	<b>JOINT INSP. AGENCY:</b> None	
<b>INSPECTOR(S):</b> Patrick Lennberg	<b>INSPECTOR'S SIGNATURE:</b>

<b>SIGNATURE DATE:</b> April 17, 2023

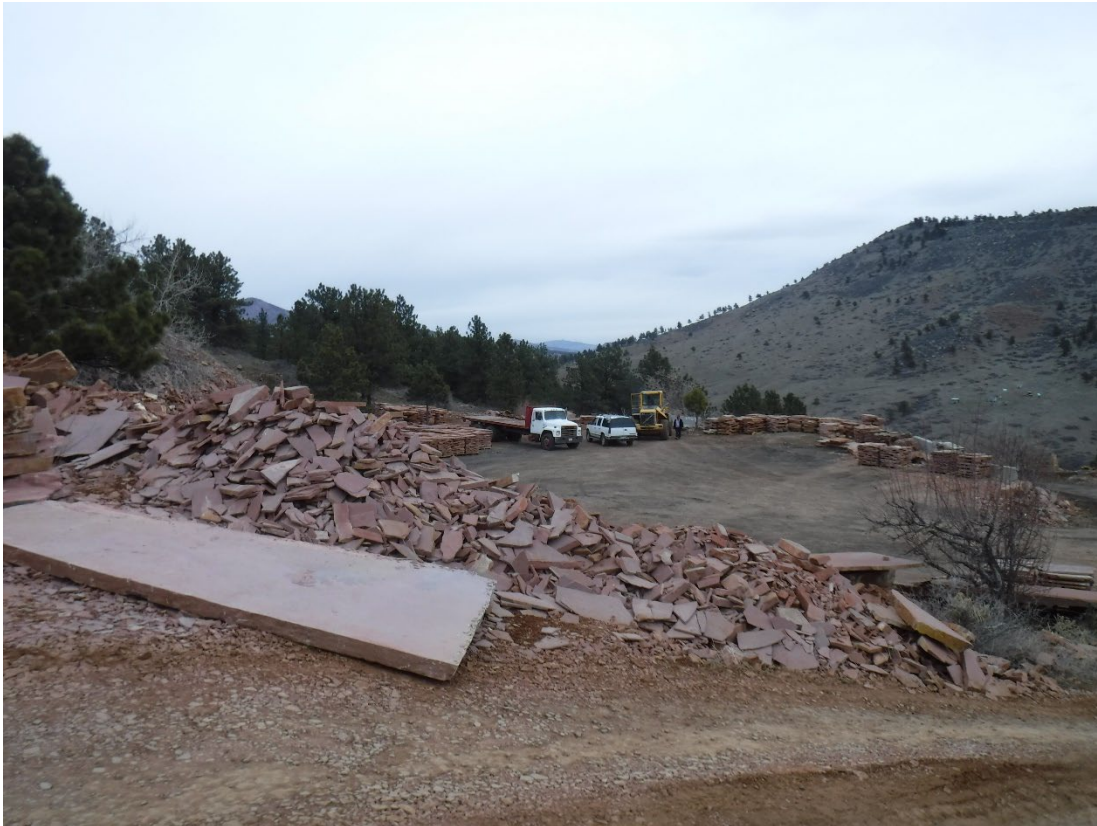
**Photo 3:** View from the road of the Storage Are, 1.4 acres

outside of the approved 9.9 acre permit boundary, Attachment 3. The land affected outside the permit boundary, approximately 2.1 acres, is being cited as a Possible Violation pursuant to C.R.S. 34-32.5-109(1) for failure to first obtain a reclamation permit before engaging in a mining operation. The area associated with the ranching operation is not included in the calculation of land affected outside the permit boundary.

**CORRECTIVE ACTIONS:** This possible violation will require a hearing before the Mined Land Reclamation Board. The schedule and other details for the MLRB hearing will be provided under a separate document to be sent via certified mail to the operator.

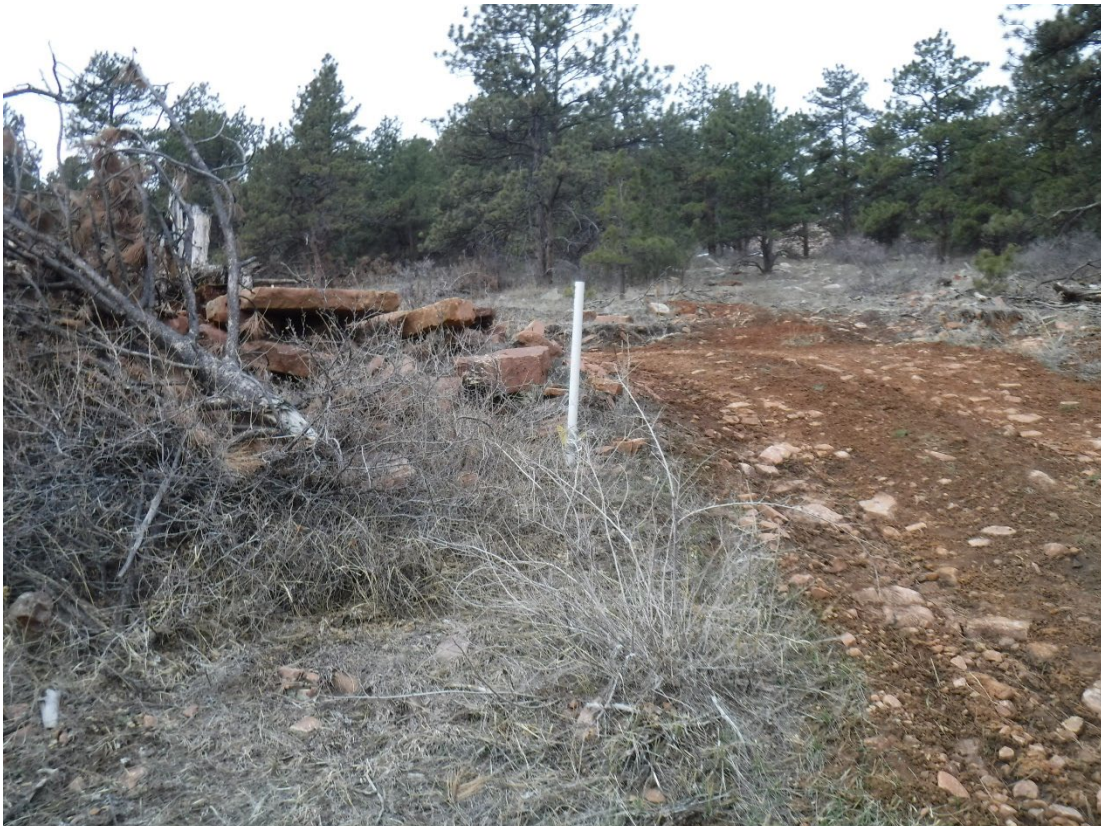
**Photo 18:** NW permit boundary marker, permit area to the left of post, road development to the right of post

During this inspection the Division was directed to the currently installed permit boundary markers and the Division marked those locations using a handheld GPS unit a Garmin 64st. The Division mapped the permit markers using Google Earth Pro and determined the markers are not correctly placed. Incorrectly placed markers around the affected area is being cited as a problem in this report pursuant to Rule 3.1.12(2). The markers currently installed at the site encompass approximately 8.5 acres, Attachment 2, whereas the approved permit area is 9.9 acres. In the May 2017 inspection report the Division provided an aerial image of the approved permit boundary that corresponded with the Mining Plan Map approved in AM-1 in 2005 along with another map that reflected mining disturbance as of October 9, 2015, the date the aerial image was collected. As the Division continued its review of aerial imagery, permit file documents, and observations made during the inspection it has determined the Operator has affected a total of 12 acres with 2.1 acres

**CORRECTIVE ACTIONS:** The operator shall conduct a survey and replace the boundary markers in the correct location(s). The operator shall provide proof to the Division that this has been done by the corrective action date.

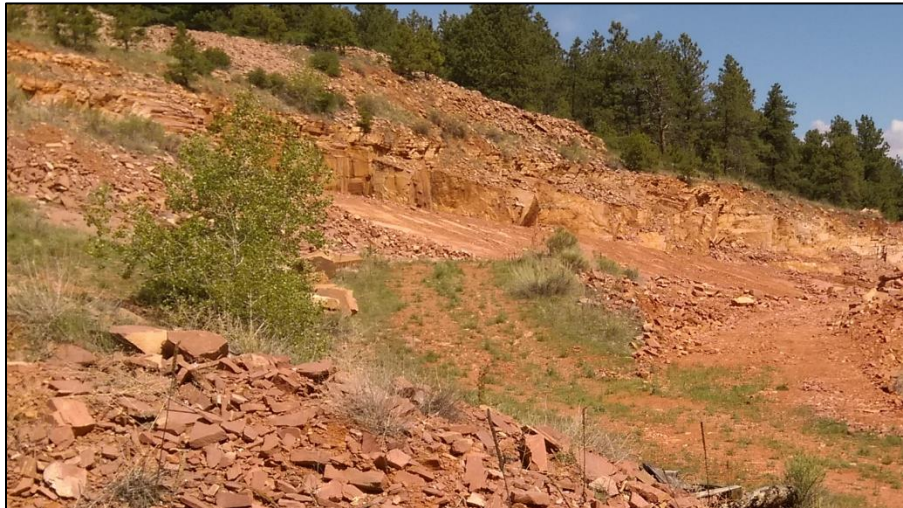
**Photo 5.** View of highwall along western edge of site in southern quarry area.

According to the approved reclamation plan, highwalls will be left at no more than 6 feet in height. All disturbed land will be reduced to a 2H:1V or flatter slope gradient, topsoil will be replaced, and the site revegetated. The reclamation vegetative cover will be established by planting a seed mix composed of native bunch grass species and transplanting seedlings of Skunkbrush sumac, Mountain mahogany, Ponderosa pine, and Rocky Mountain juniper. Haul roads located within the permit area will be reclaimed.

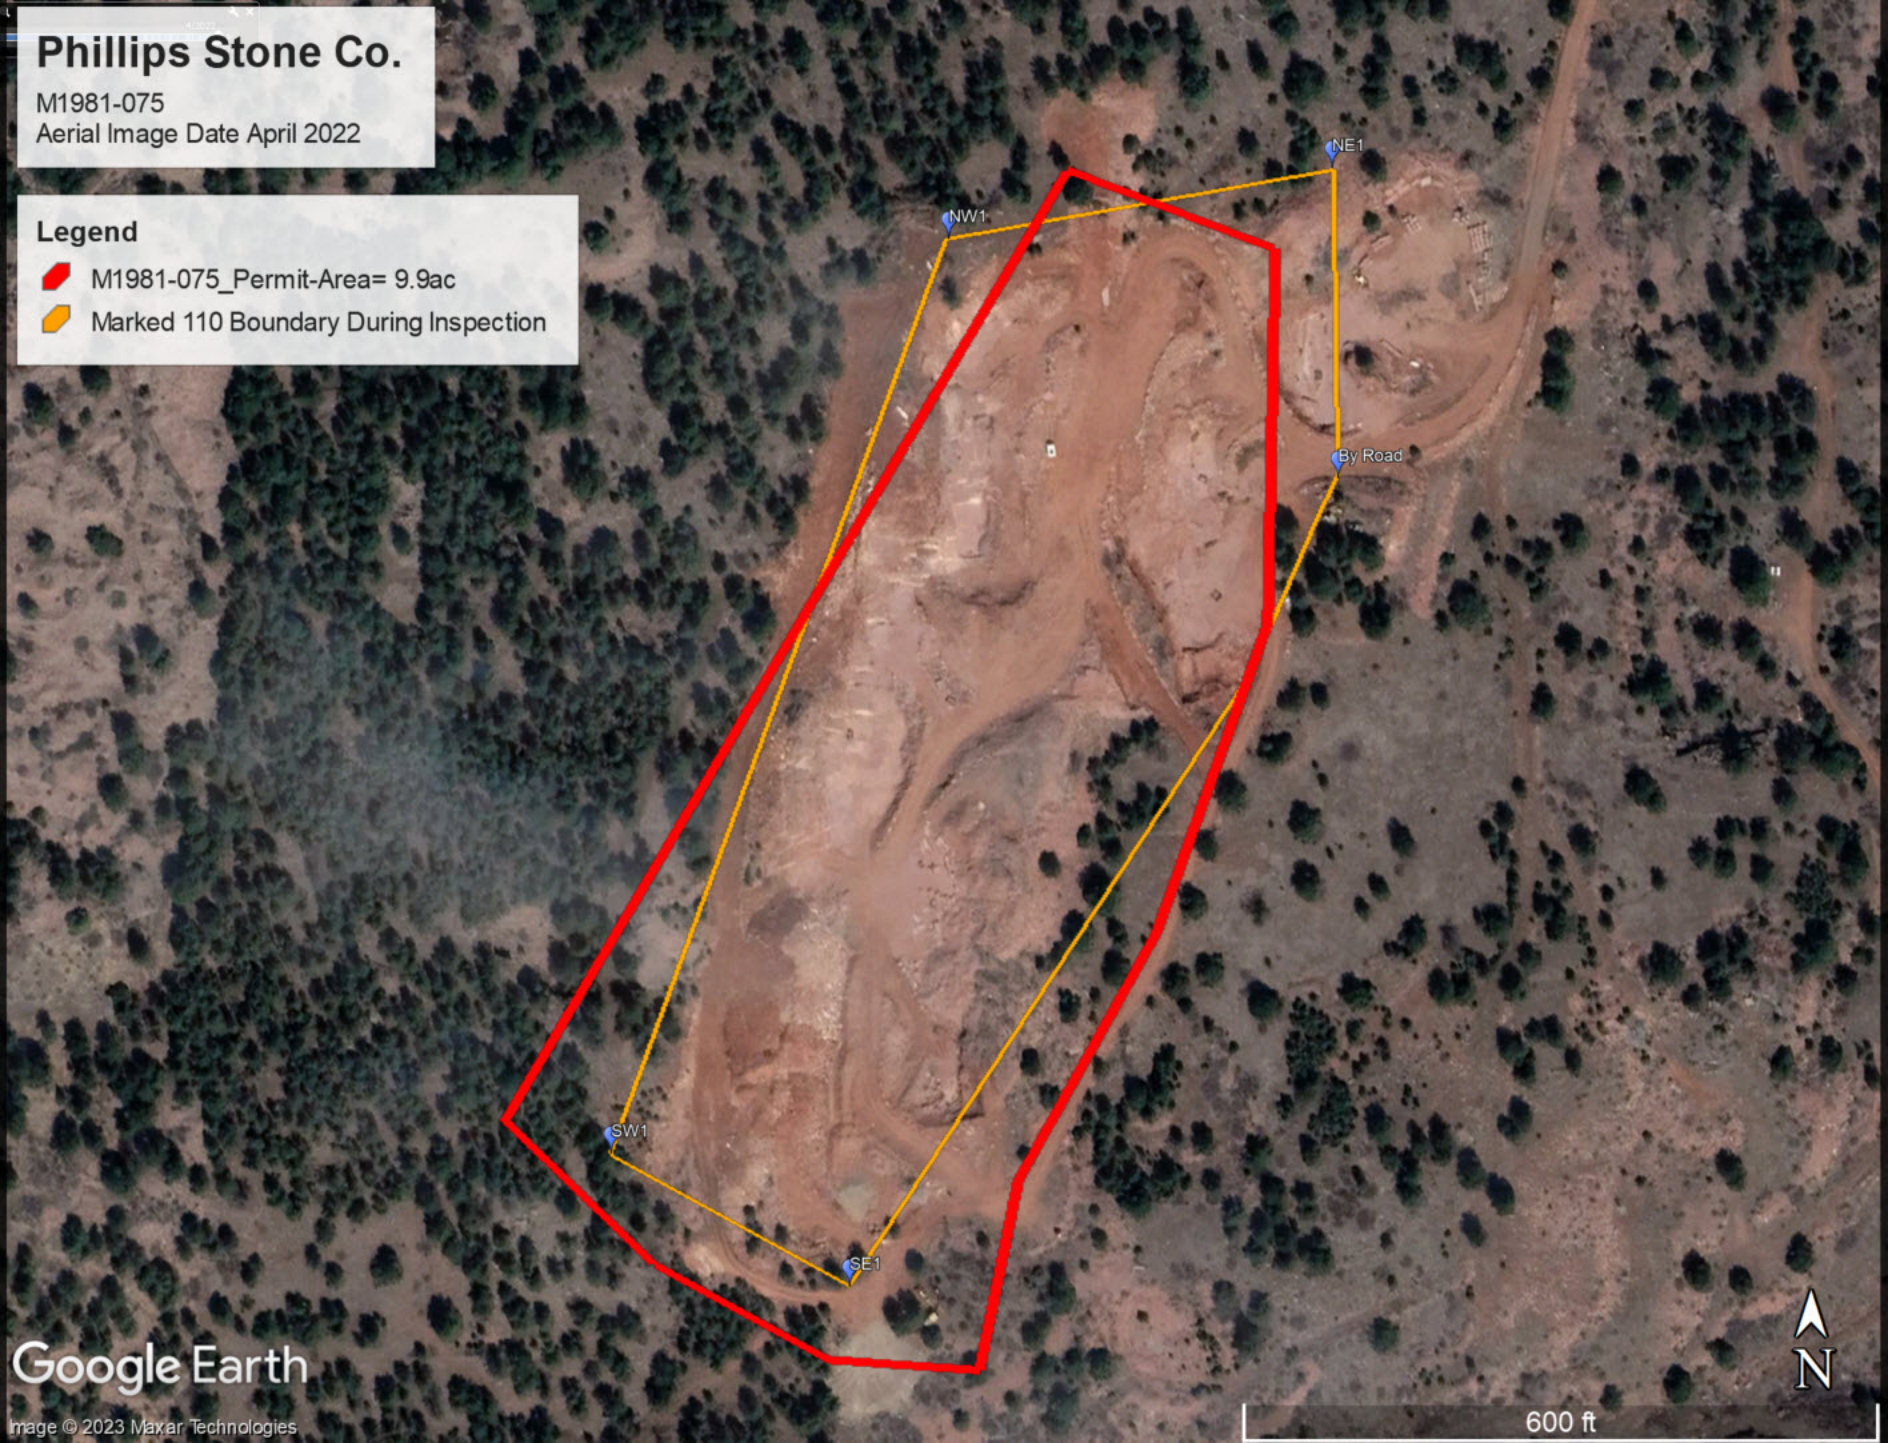
Marked 110 Boundary During Inspection
