**MINERALS PROGRAM INSPECTION REPORT**  
**PHONE: (303) 866-3567**

| <b>MINE NAME:</b><br>Highway 72 Mill Site | <b>MINE/PROSPECTING ID#:</b><br>M-2020-044 | <b>MINERAL:</b><br>Gold | <b>COUNTY:</b><br>Jefferson |
| <b>INSPECTION TYPE:</b><br>Illegal(Unpermitted Operation) | <b>WEATHER:</b> Clear | <b>INSP. DATE:</b><br>April 17, 2023 | <b>INSP. TIME:</b><br>13:00 |

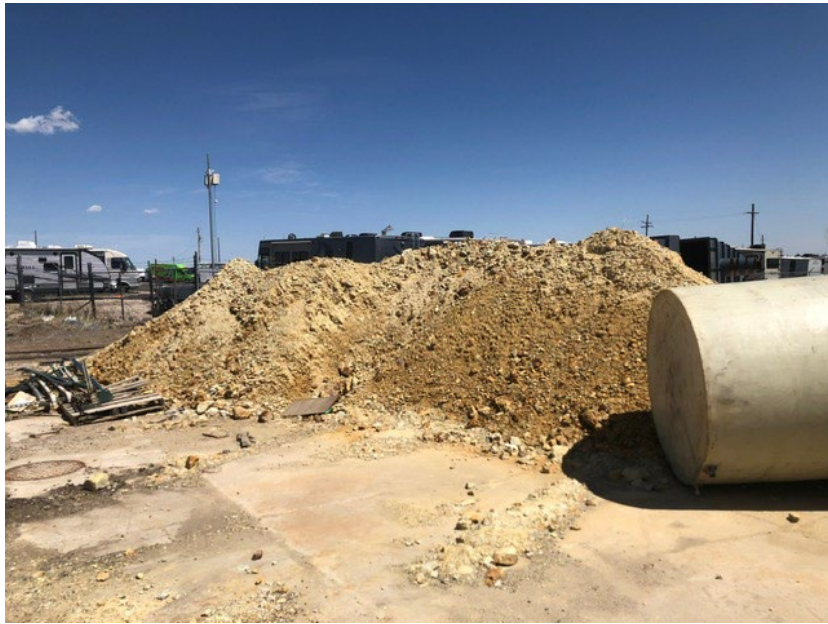
**Figure 1. Ore stockpiles adjacent to site access road.**

The Division verified the Mill site was largely in the same condition as it was during the July 1, 2022 inspection. The Division did not note any new equipment at the site. The ore stockpiles located along the west side of the facility appeared to be of the same size and configuration as they were during the previous inspection. Additionally, the cyanide solution tanks located along the west side of the building appeared to contain the same amount of solution as previously observed.

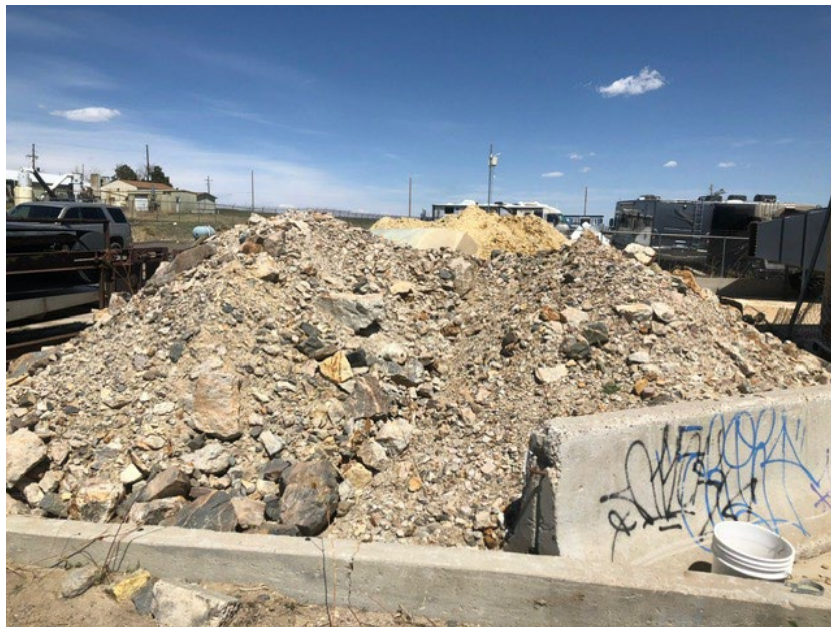
**Figure 2. Ore stockpiles adjacent to site access road.**

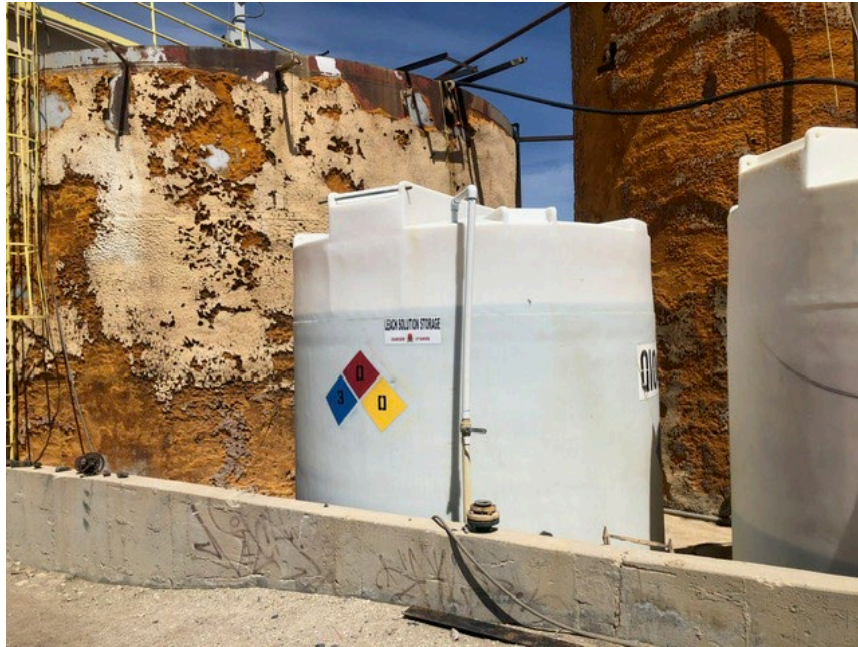
**Figure 3. Tanks with cyanide solution, outside of main building entrance**

The purpose of the inspection was to verify compliance with the Board's Cease and Desist Order and to assess the current conditions of the Mill site. Mr. Emslie provided Division staff with a tour of the facility and explained each step of the milling process. Mr. Emslie confirmed that the majority of the equipment at the facility was conventional milling equipment used in the ore beneficiation process. The milling process generally consists of crushing, grinding and flotation circuits. According to the Operator, after metals are recovered, the tailings are utilized as a manufactured sand for making bricks and for use as general fill material. The Operator stated the sand is inert and Toxicity Characteristic Leaching Procedure (TCLP) tests are performed on the final sand product. The Operator confirmed the TCLP test results are provided to their clients and are not submitted to any regulatory agencies. In addition, the Operator utilizes cyanide through the Merrill-Crowe process to produce a gold concentrate. The Operator stated the cyanide circuit is used in the recovery of gold from ore and from recycled electronics. During the inspection, the Operator informed the Division that potassium amyl xanthate (PAX) was also used in the flotation circuits. Both cyanide and PAX are considered to be designated chemicals pursuant to Hard Rock Rule 1.1(18), as they represent a potential threat to human, health, property or the environment.

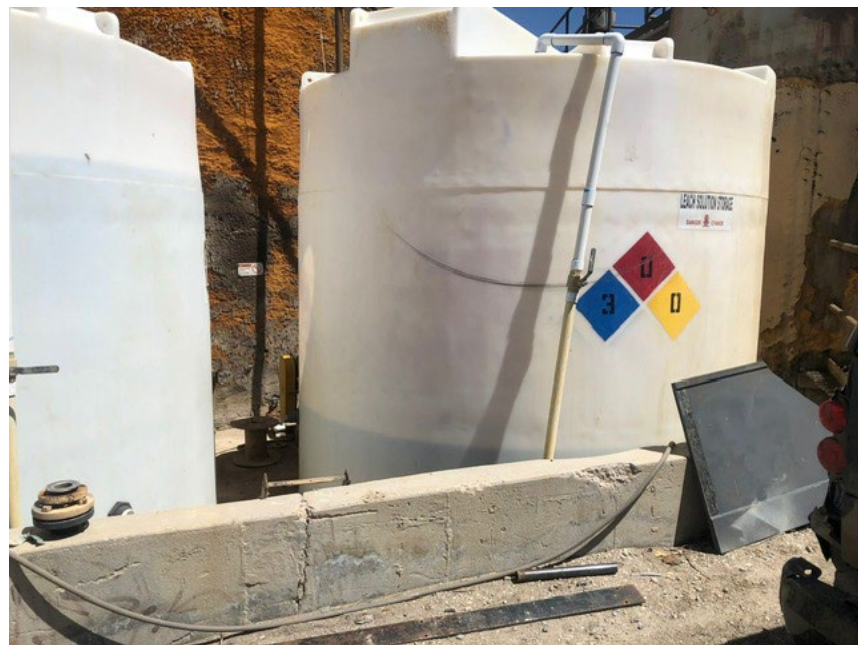
**Figure 4. Tanks with cyanide solution, outside of main building entrance.**
