Permit Number: C-1981-028 Mine Name: Keenesburg Strip Mine Operator: Coors Energy Company Operator Address: Mr. Ben Moline P.O. Box 4030 Golden, CO 80402	County: Weld Operation Type: Surface Permit Status: Permanent Cessation Ownership: Private
	Operator Representative Present: None
Operator Representative Signature: (Field Issuance Only)

Inspection Start Date: May 16, 2023 Inspection Start Time: 13:30 Inspection End Date: May 16, 2023 Inspection End Time: 14:30	Inspection Type: Coal Complete Inspection Inspection Reason: Normal I&E Program Weather: Clear
Joint Inspection Agency: None	Joint Inspection Contacts:
Post Inspection Agency: None	Post Inspection Contacts:
Inspector(s): Robert Zuber, P.E. Michael Cunningham	Inspector's Signature:

Inspection Topic Summary

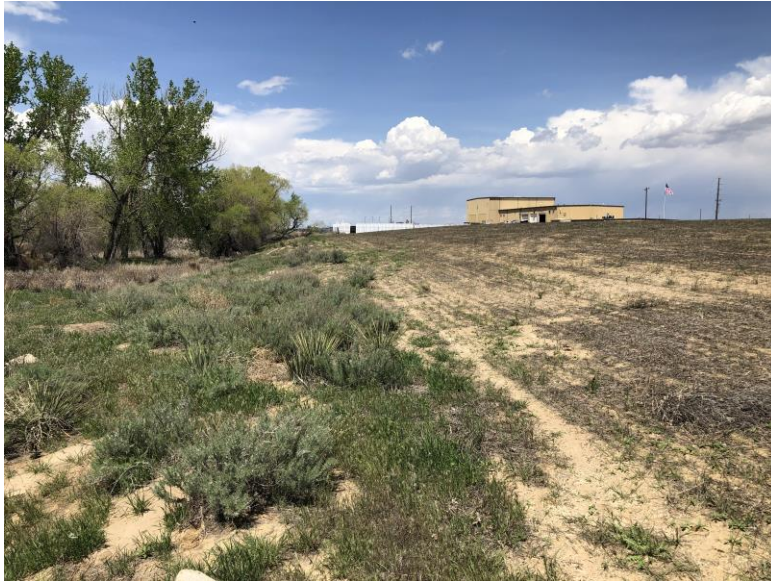
Poor vegetation growth was seen in some areas, including Area 38, the reclaimed soil piles south of the facilities. Cheatgrass continues to be a problem at the site, especially within the reclaimed road area next to Sediment Pond 2.

Area 38 (reclaimed soil pile area) on right, and Dugout Pond on left

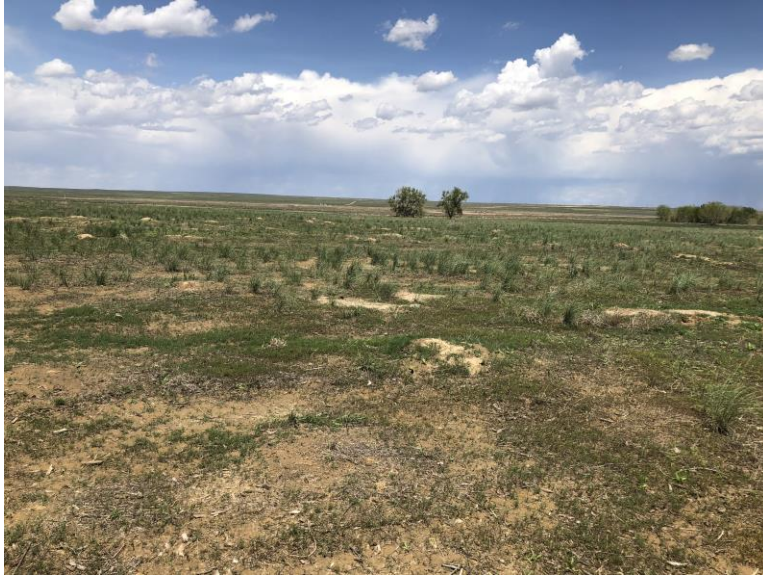
No erosion problems were seen onsite, despite significant rain events during the week before the inspection. Bare spots were seen in some areas. Also, many mounds of earth were seen in Area 36, likely created by prairie dogs. The steep area east of the Dugout Pond was stable.

Area 36, reclaimed long-term spoil area – earth mounds likely created by prairie dogs

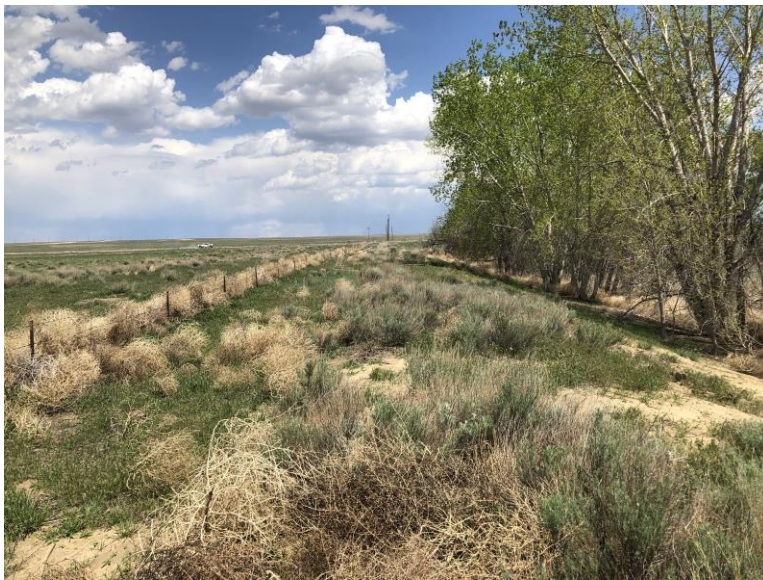
Sediment Pond 2 and the Dugout Pond contained little to no water (thick vegetation obscures the bottoms). They were not discharging during the inspection. There were no signs that either pond had discharged recently. No problems were observed.

Embankment below Sediment Pond 2
