Division of Reclamation,  
Mining and Safety

<b>Permit Number:</b> C-1996-084 <b>Mine Name:</b> Lorencito Canyon Mine <b>Operator:</b> New Elk Coal Company, LLC <b>Operator Address:</b> Mr. Mark Gray 12250 Highway 12 Weston, CO 81091	<b>County:</b> Las Animas <b>Operation Type:</b> Surface <b>Permit Status:</b> Permanent Cessation <b>Ownership:</b> Private
	<b>Operator Representative Present:</b>  Nick Mason
<b>Operator Representative Signature: (Field Issuance Only)</b>

<b>Inspection Start Date:</b> May 9, 2023 <b>Inspection Start Time:</b> 12:00 <b>Inspection End Date:</b> May 9, 2023 <b>Inspection End Time:</b> 14:00		<b>Inspection Type:</b> Coal Complete Inspection <b>Inspection Reason:</b> Normal I&E Program <b>Weather:</b> Clear	
<b>Joint Inspection Agency:</b>  None		<b>Joint Inspection Contacts:</b>	
<b>Post Inspection Agency:</b>  None		<b>Post Inspection Contacts:</b>	
<b>Inspector(s):</b>  Brock Bowles	<b>Inspector's Signature:</b>

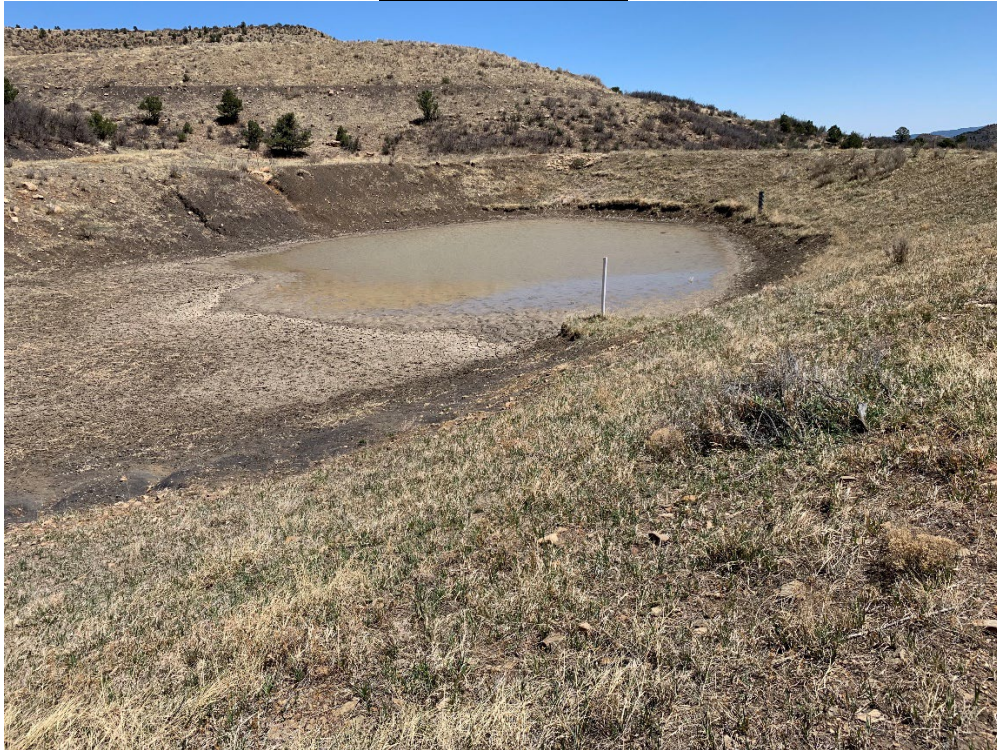
Photo 1 – Pond 6

Pond 6 contained a small amount of water and it was not discharging (photo 1). The primary and emergency spillways were clear of obstructions. The embankment appeared to be stable.

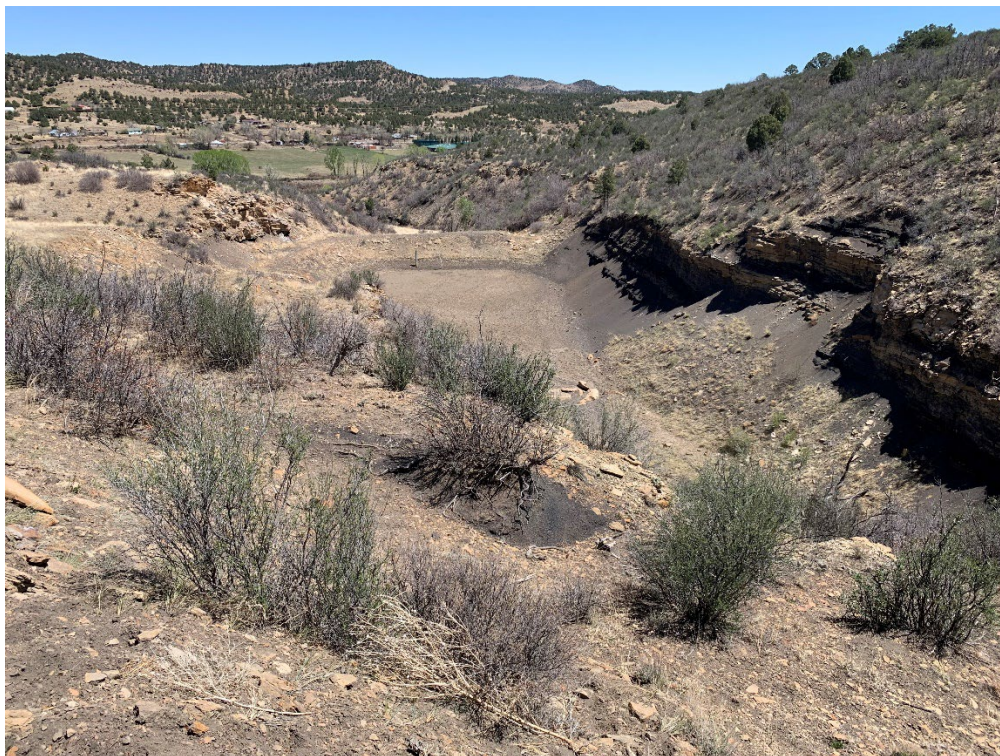
Photo 2 – Pond 8

Ponds 7, 8, 9 and 9A did not contain water (photo 2). The primary and emergency spillways were clear of obstructions and the embankments appeared to be stable.

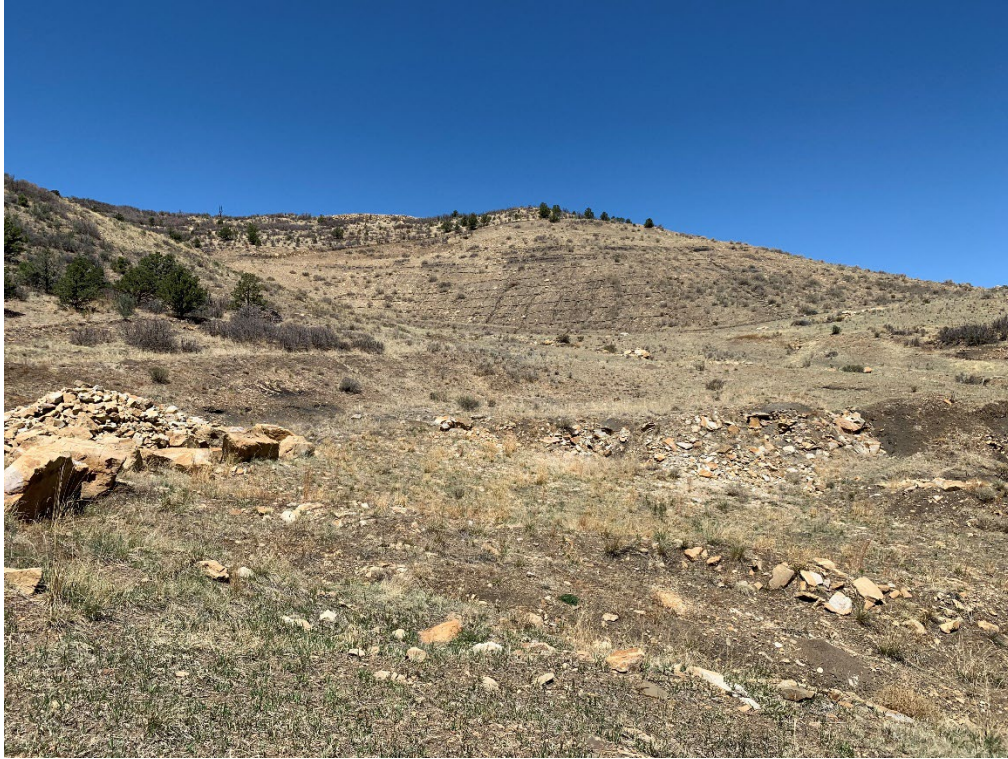
Photo 3 – Hillside and drainage above Pond 6

The eroded hillside above Pond 6 appears to be in the same condition as it has been reported in the past. Rills and gullies persist down the slopes with limited vegetation establishment (photo 3).
