**FW: Spill 2022-0641**

Attached is the final report regarding Spill 2022-0641 at the Uncompahgre Pit M-2013-007. This report was generated by ECOS Environmental & Disaster Restoration, Inc. The material is stored on a Recycled Asphalt Product (RAP) pile and will be recycled through our Hot Mix Asphalt Plant (HMA) Permit # 07PO0219 AIRS ID # 777-2896-001 in March. We will notify the Division once it has been recycled.

Location address: 67246 T Rd  
Montrose, CO, 81403

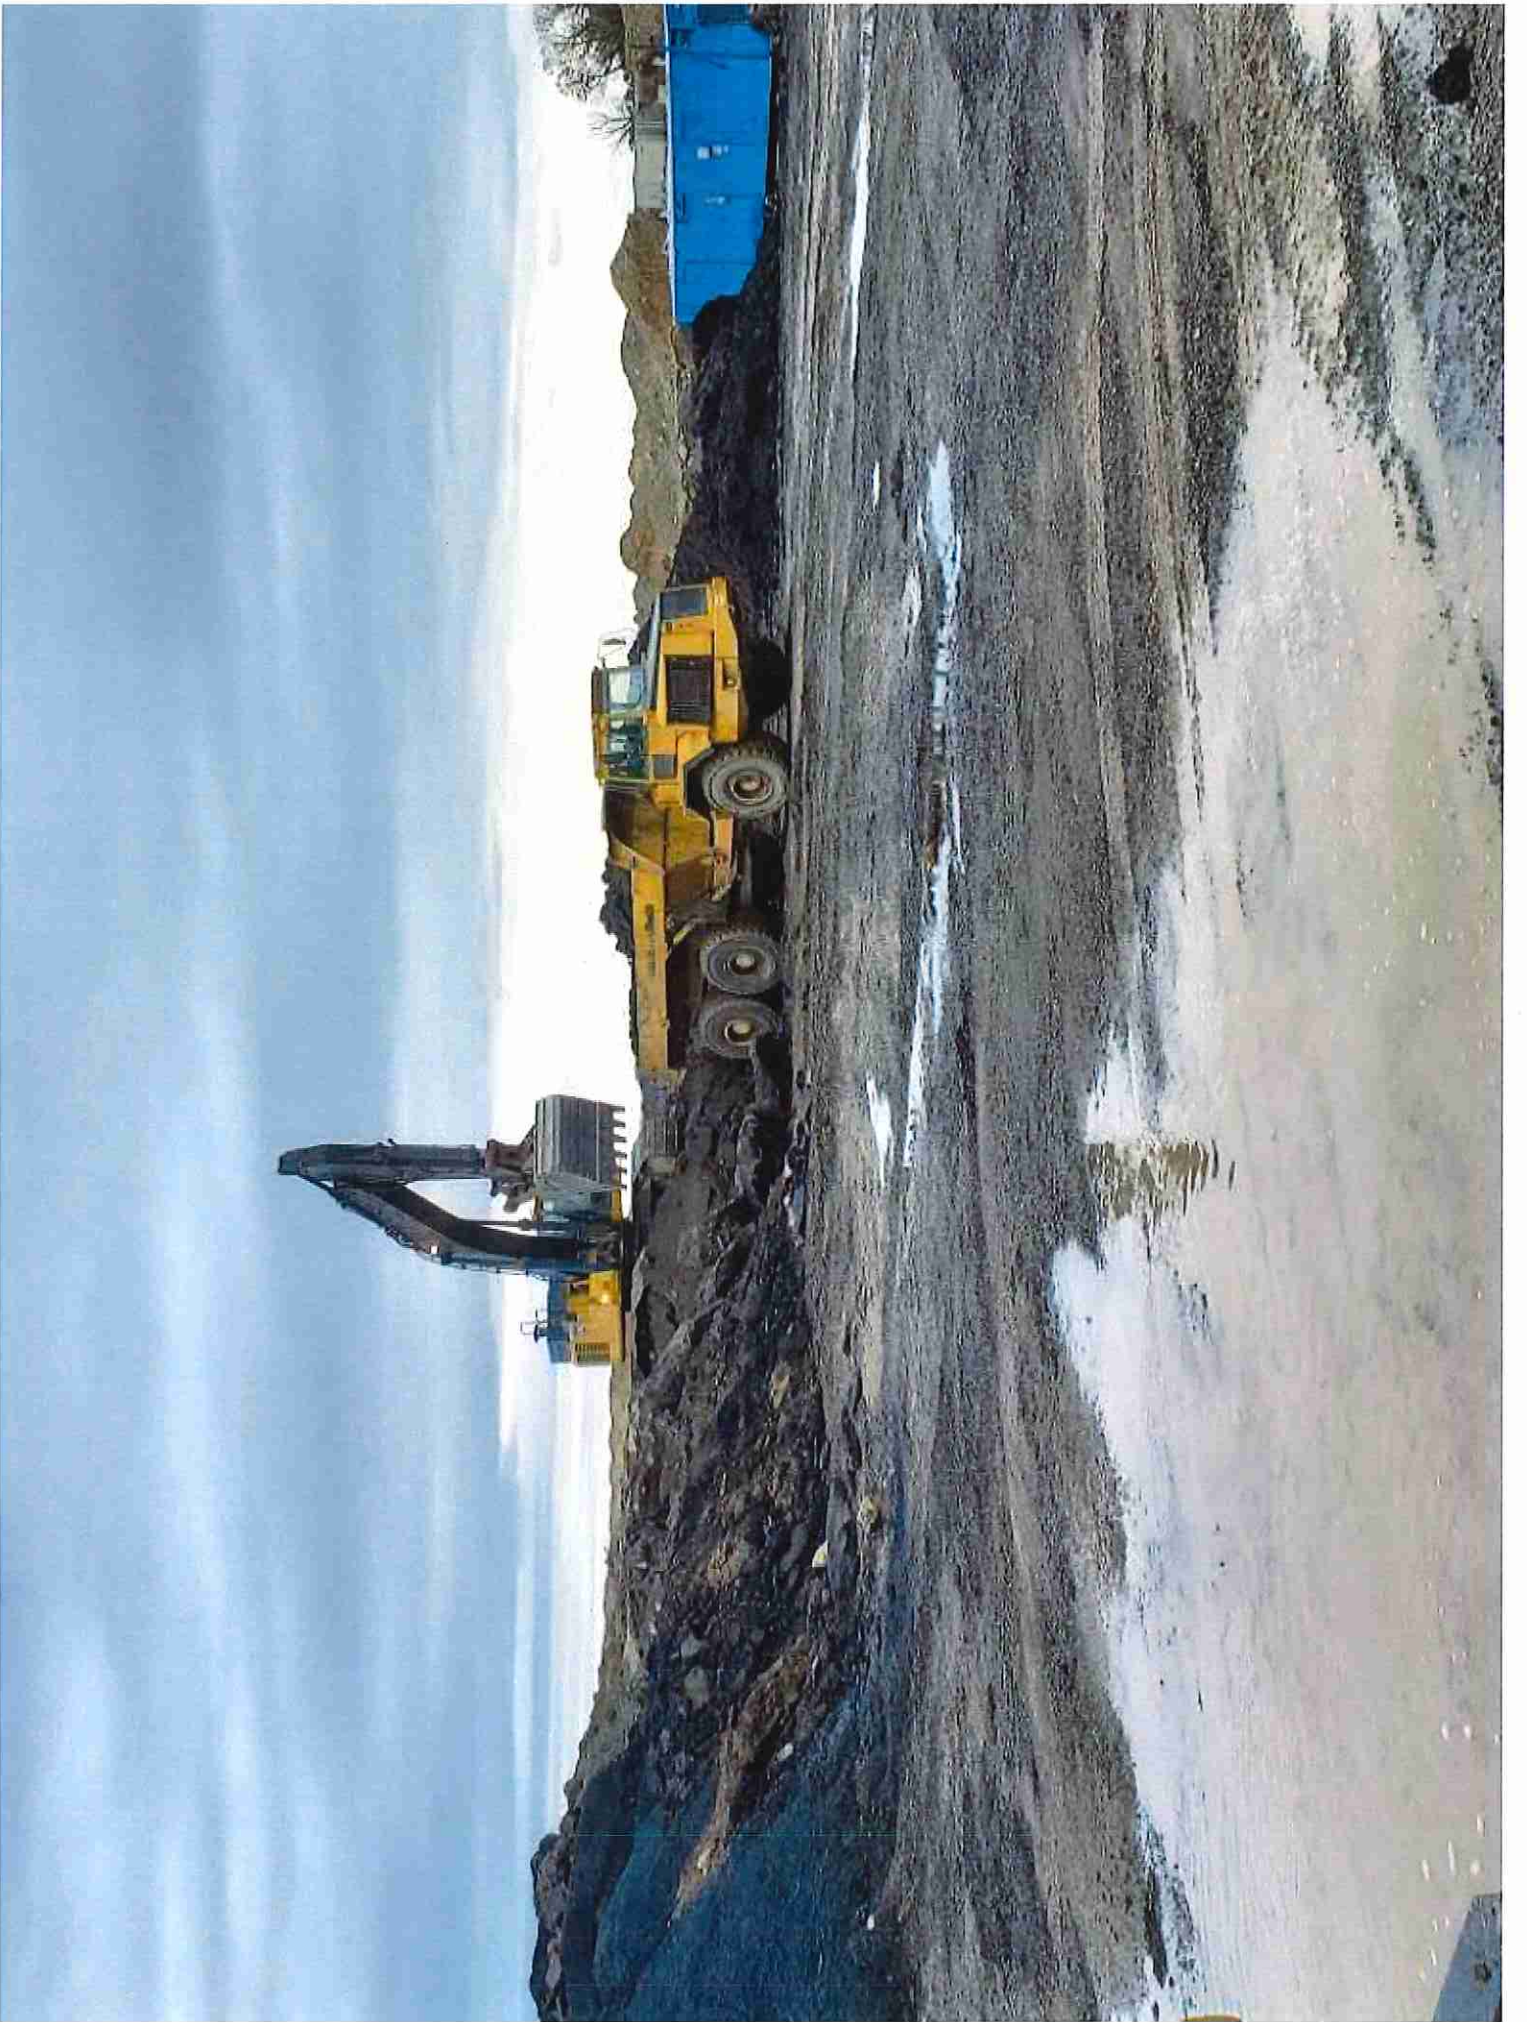
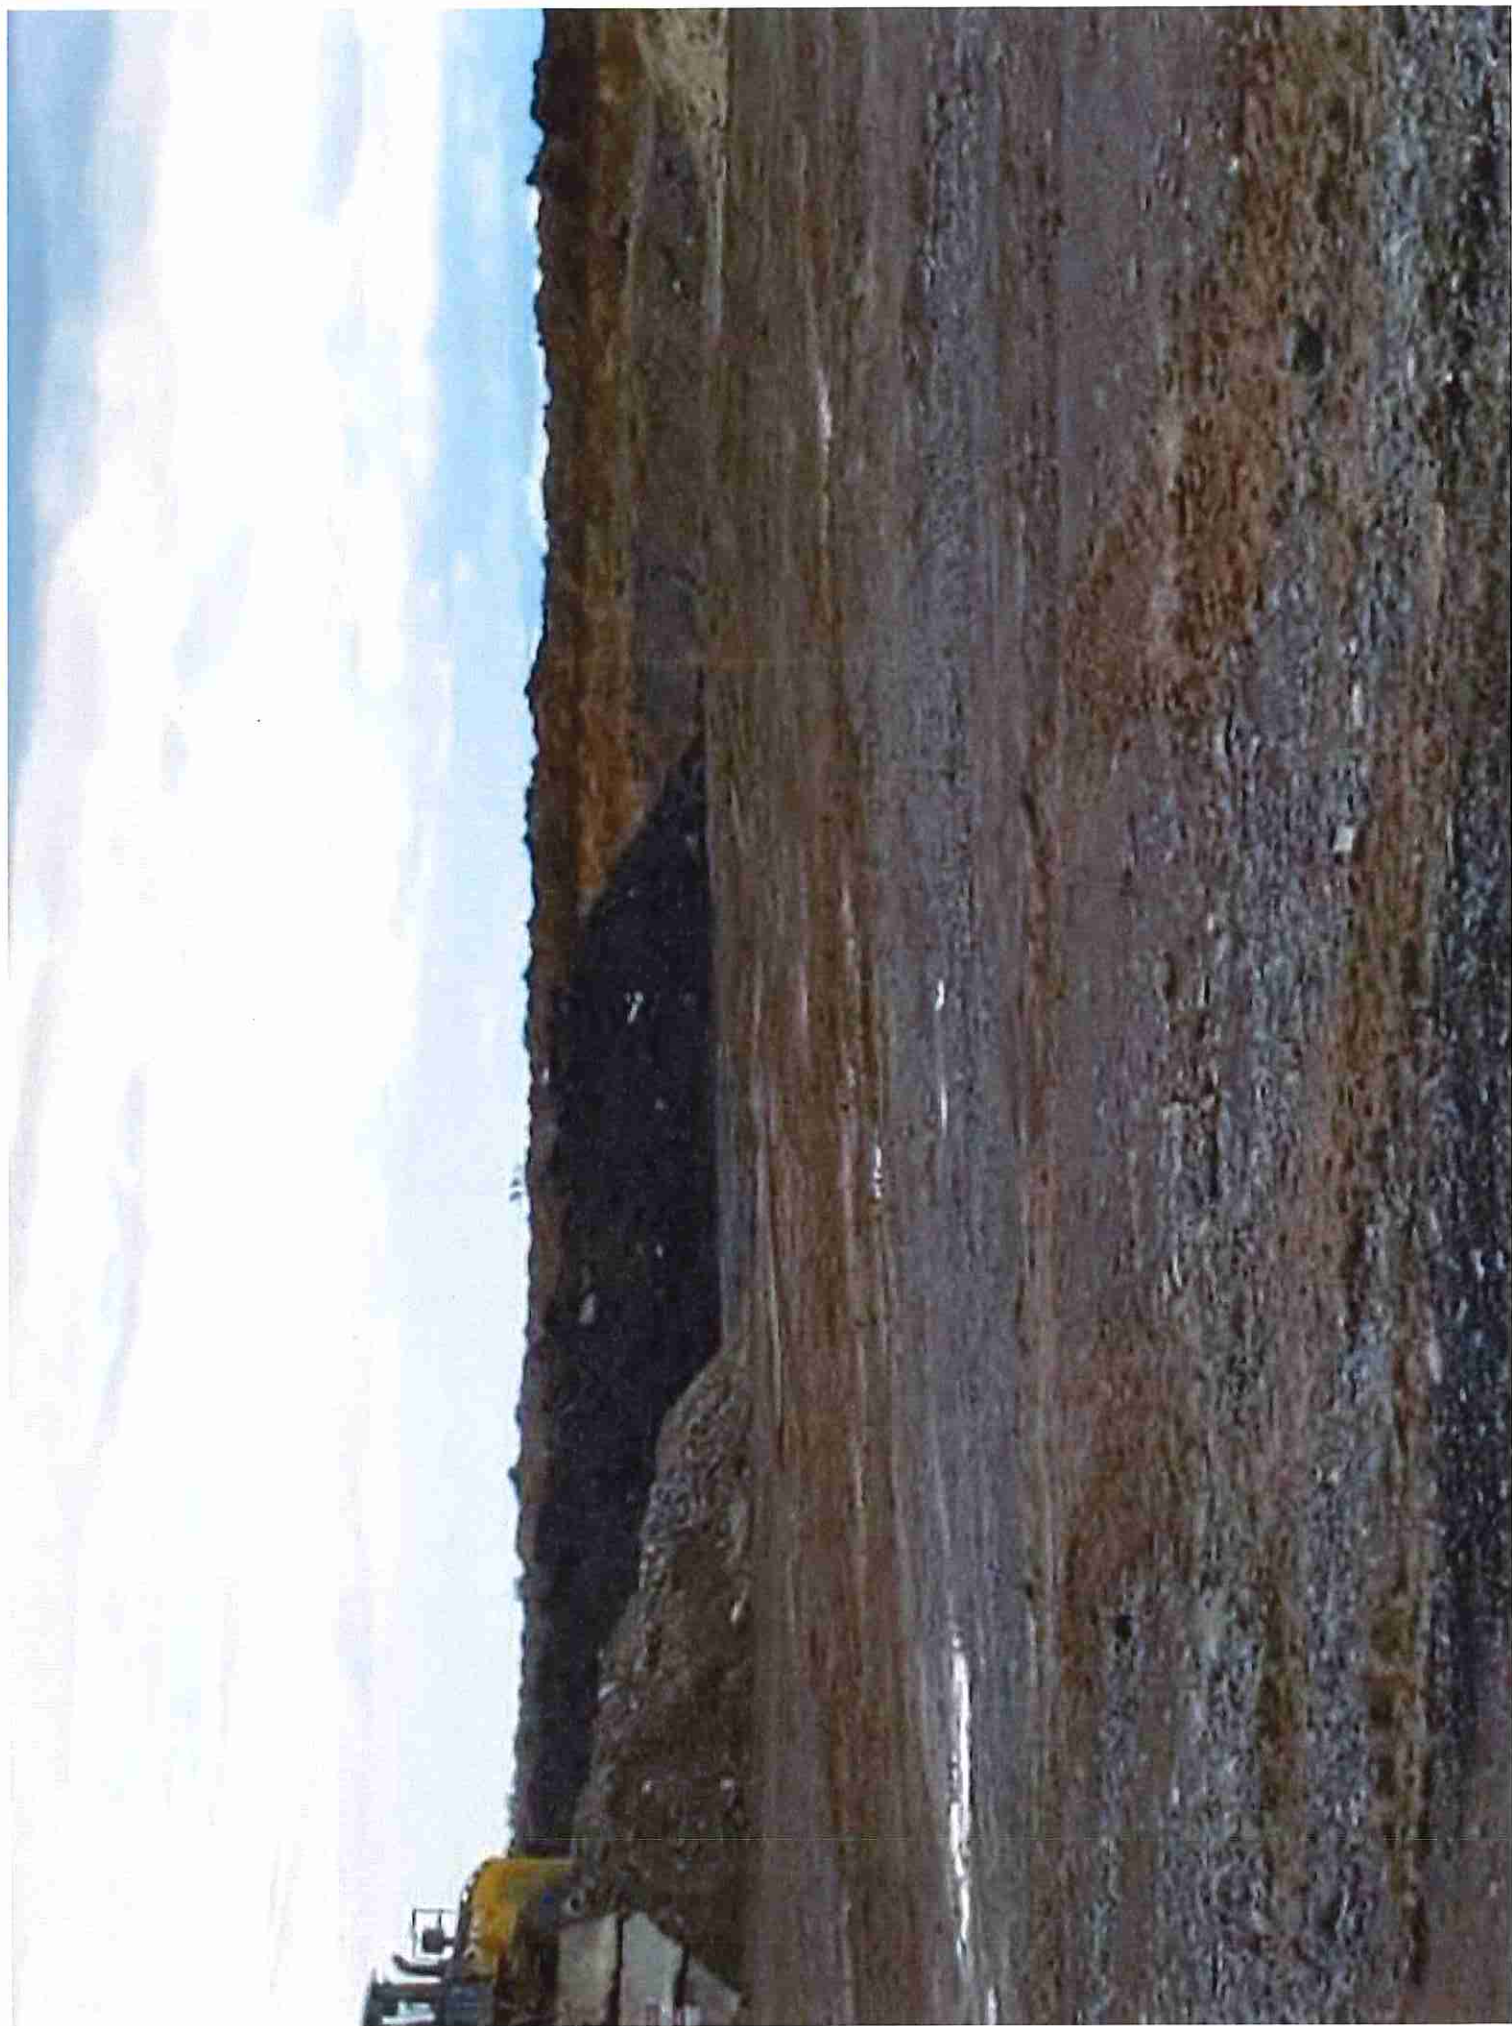
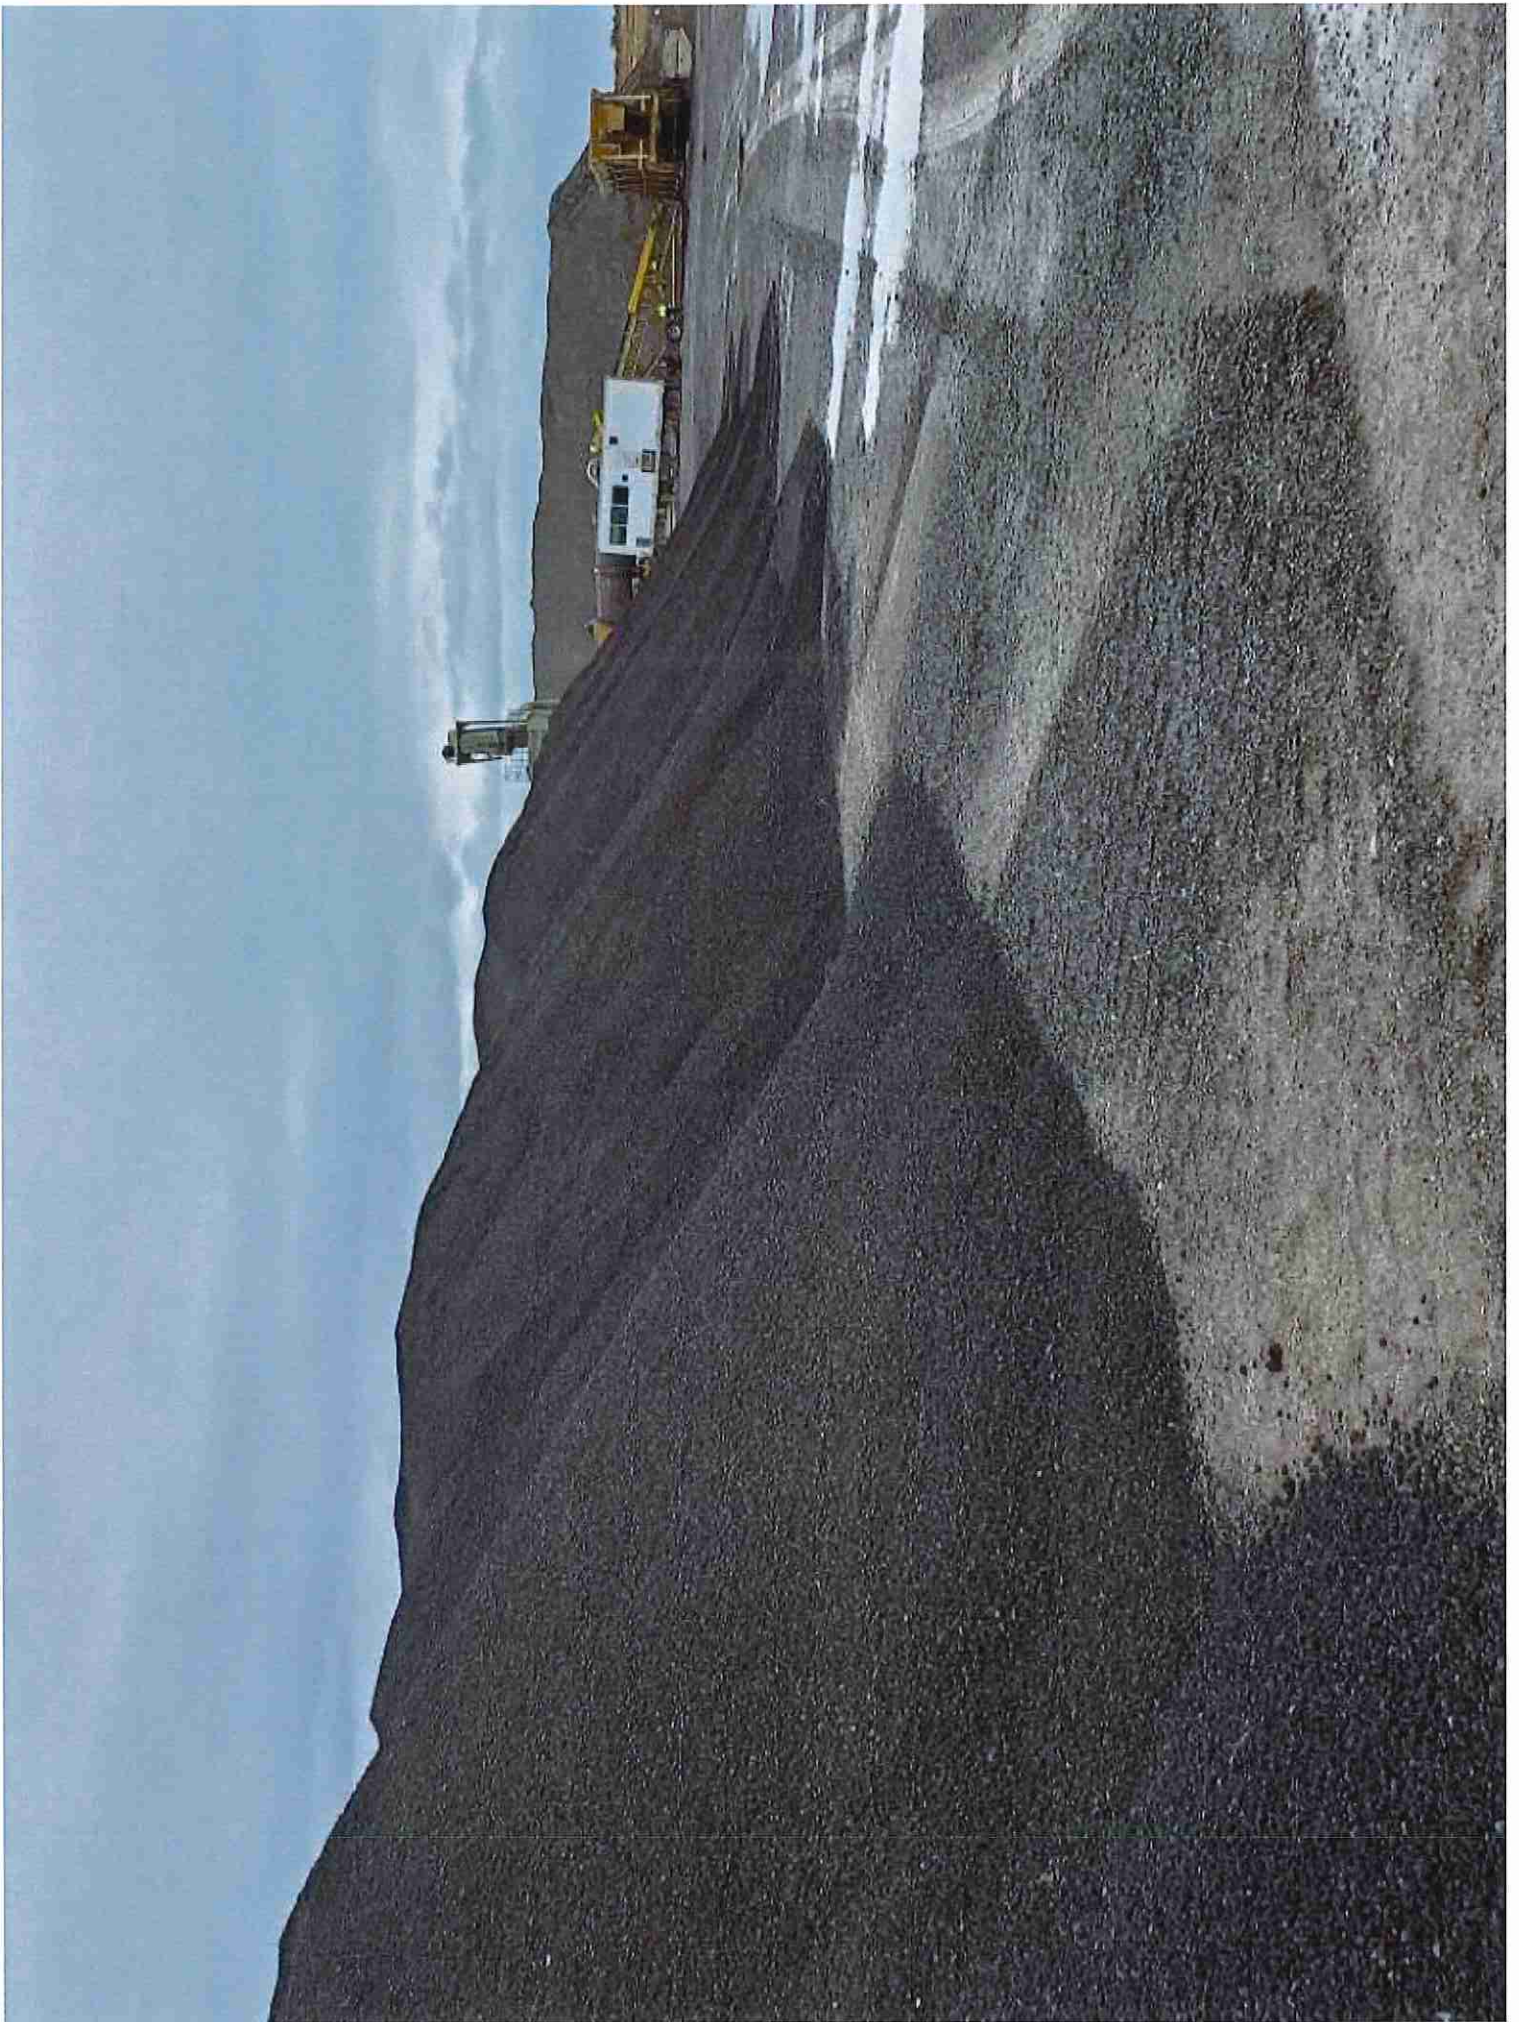
In regards to Spill 2022-0641 that I wrote to you on January 30<sup>th</sup>, 2023. We were able to crush and recycle the contaminated material through our HMA Asphalt Plant Permit #07PO0219 (see attached photos). We would like for Division to close out the Spill Report 2022-0641.

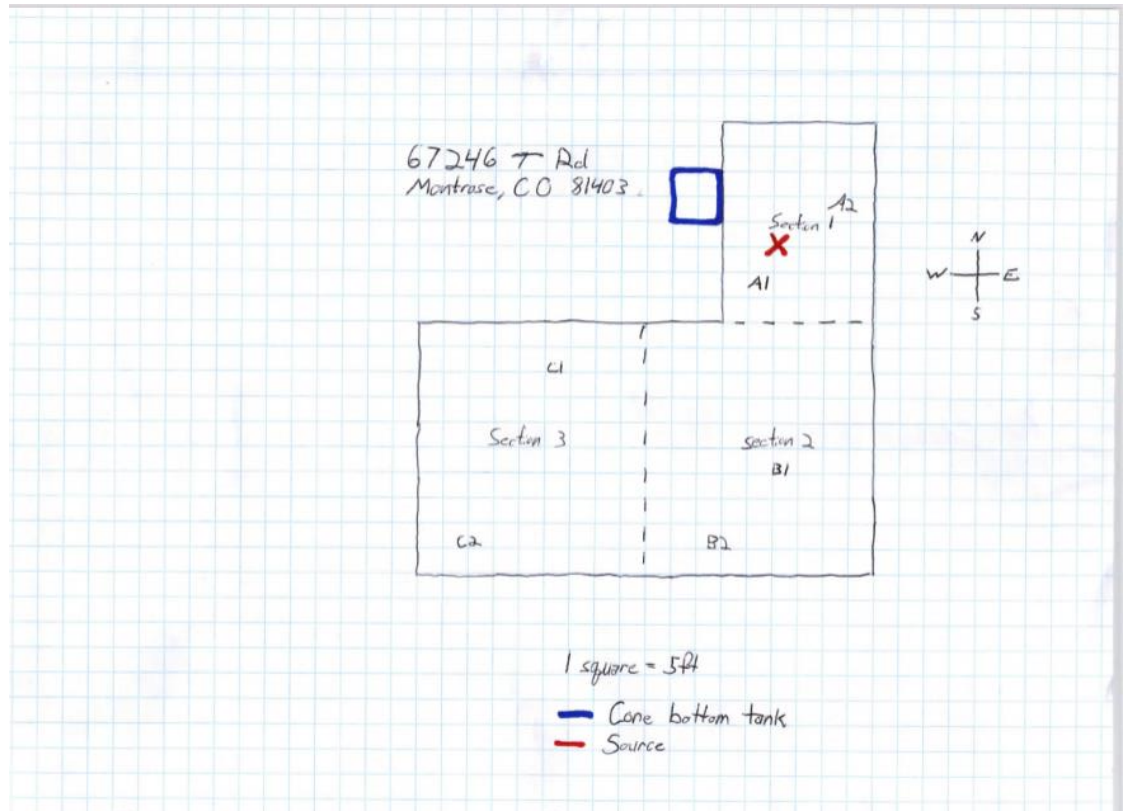
## SKETCH

The laboratory results, diagram of sample locations and photos are attached to this document for review.

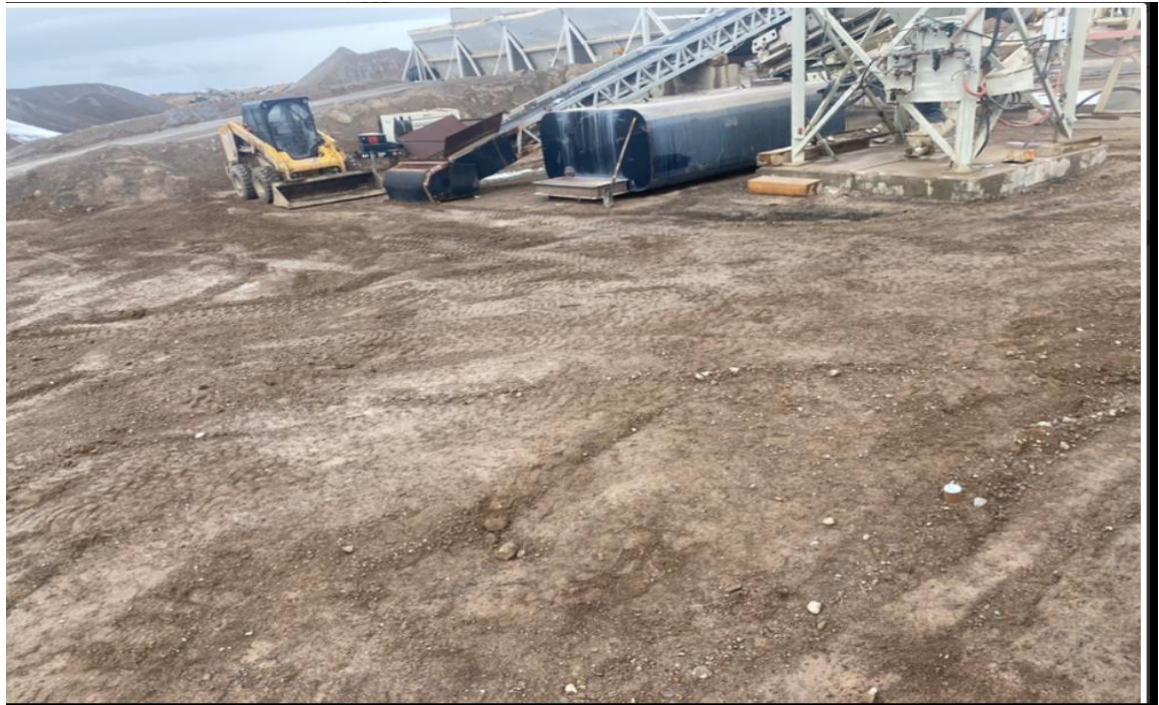
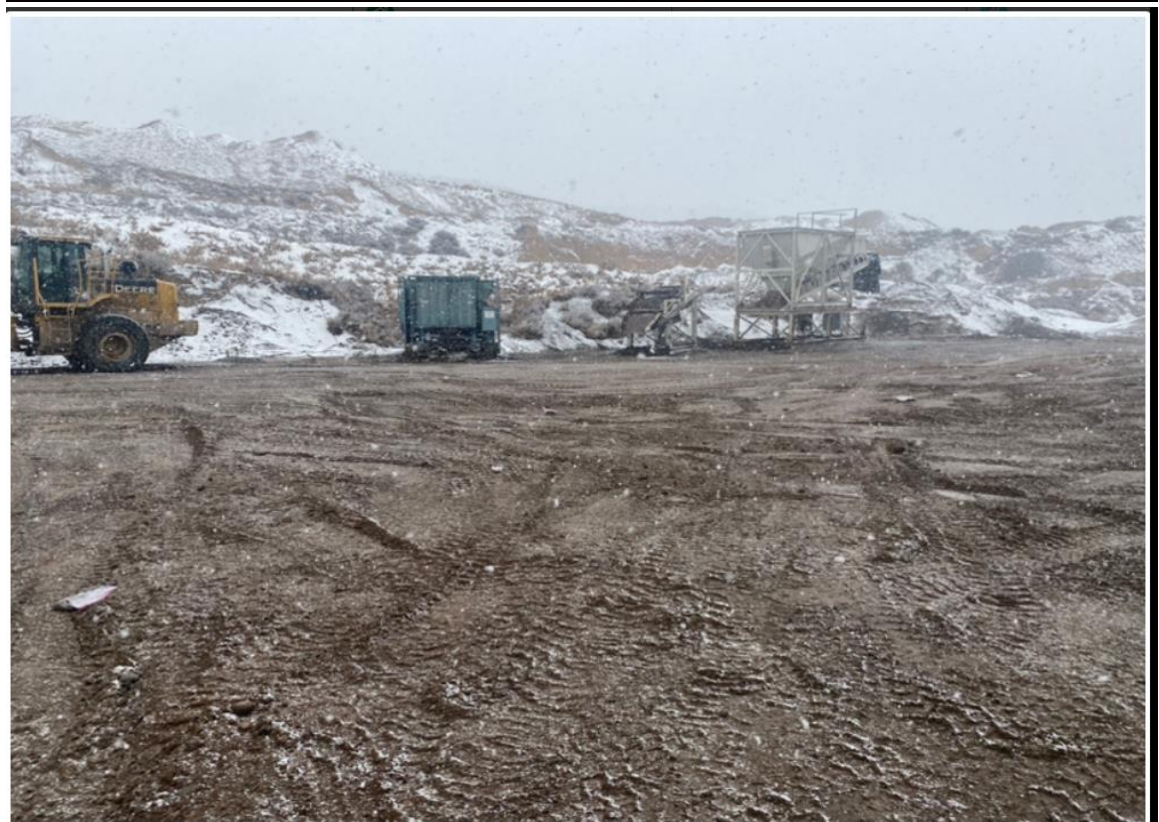
On 12/6/2022 ECOS Environmental performed a site visit once the impacted area was excavated. ECOS Environmental conducted a visual inspection and field PID testing of the impacted area. The impacted area was determined to be at acceptable PID readings, this was determined by placing the soil into sealed plastic bag, heating to ambient temperature of 75 degrees Fahrenheit, then inserting the PID probe into the bag headspace. The samples were collected from random locations at the initial site where the spill occurred and throughout the area of migration. The confirmation samples collected were placed into jars and prepared in a cooler for shipping and analysis by a independent laboratory.
