MINERALS PROGRAM INSPECTION REPORT
PHONE: (303) 866-3567

MINE NAME: Gunnell Mine	MINE/PROSPECTING ID#: M-2021-068	MINERAL: Gold and silver	COUNTY: Gilpin
INSPECTION TYPE: Preoperation Inspection	WEATHER: Cloudy	INSP. DATE: May 18, 2023	INSP. TIME: 09:00
OPERATOR: Jack D Tabb, LLC.	OPERATOR REPRESENTATIVE: Joe Forster	TYPE OF OPERATION: 110d - Designated Limited Impact	
REASON FOR INSPECTION: Preoperation Inspection	BOND CALCULATION TYPE: None	BOND AMOUNT:	
DATE OF COMPLAINT: NA	POST INSP. CONTACTS: None	JOINT INSP. AGENCY: None	
INSPECTOR(S): Brock Bowles	INSPECTOR'S SIGNATURE:

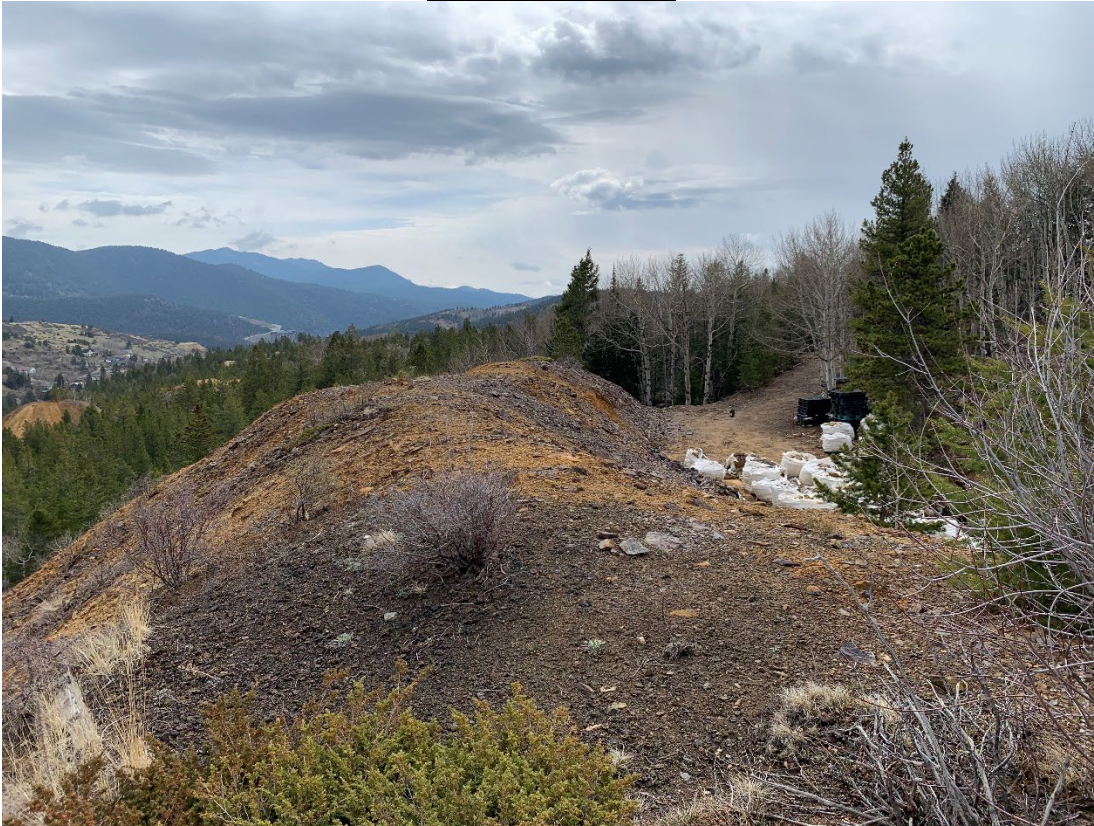
The proposed mine site is accessed from the south by an existing unimproved dirt road that was chained off several hundred feet before the proposed mine site. The proposed 1.38 acre permit area mostly consists of an old tailings pile. Some old super sacks were filled with tailings and staged next to the tailings pile (photo 1). These sacks are the same sacks noted in the original complaint noted in the December 9, 2021 inspection. It does not appear that additional material has been mined or moved (photo 2).

Photo 1 – Proposed mining area facing east, entrance road upper right

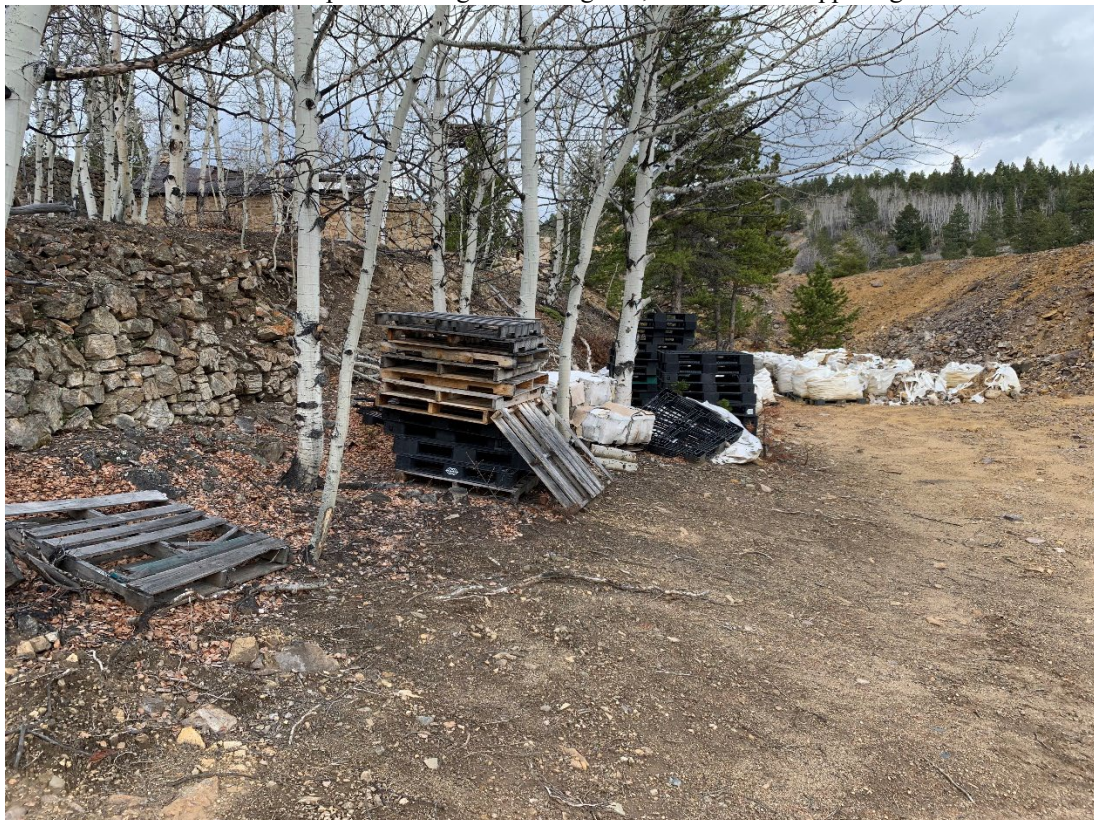
Photo 2 – Super sacks in staging area next to tailing pile

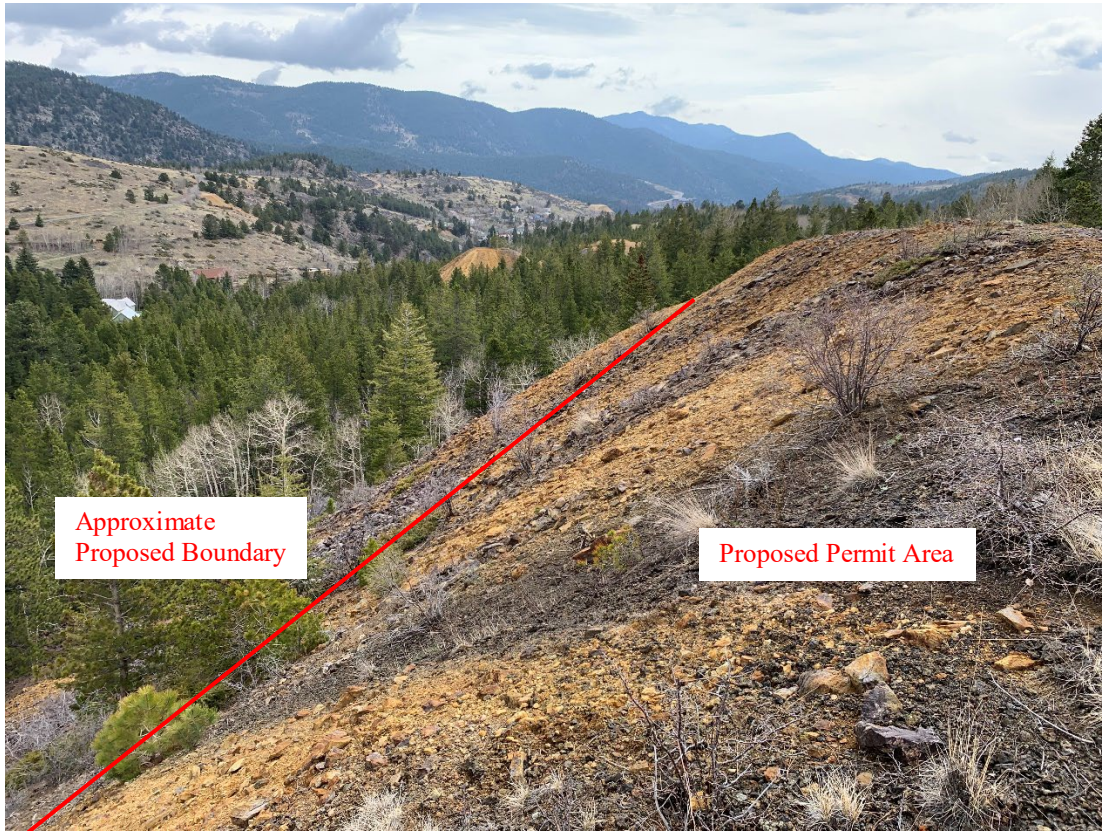
Only the top part of the pile is proposed to be permitted. The north part of the permit area is a steep hillslope that extends beyond the permit boundary (photo 3). Special precautions will have to be taken on the north side so material does not fall down the tailings pile and off the permit area.

Photo 3 – Approximate northern permit boundary

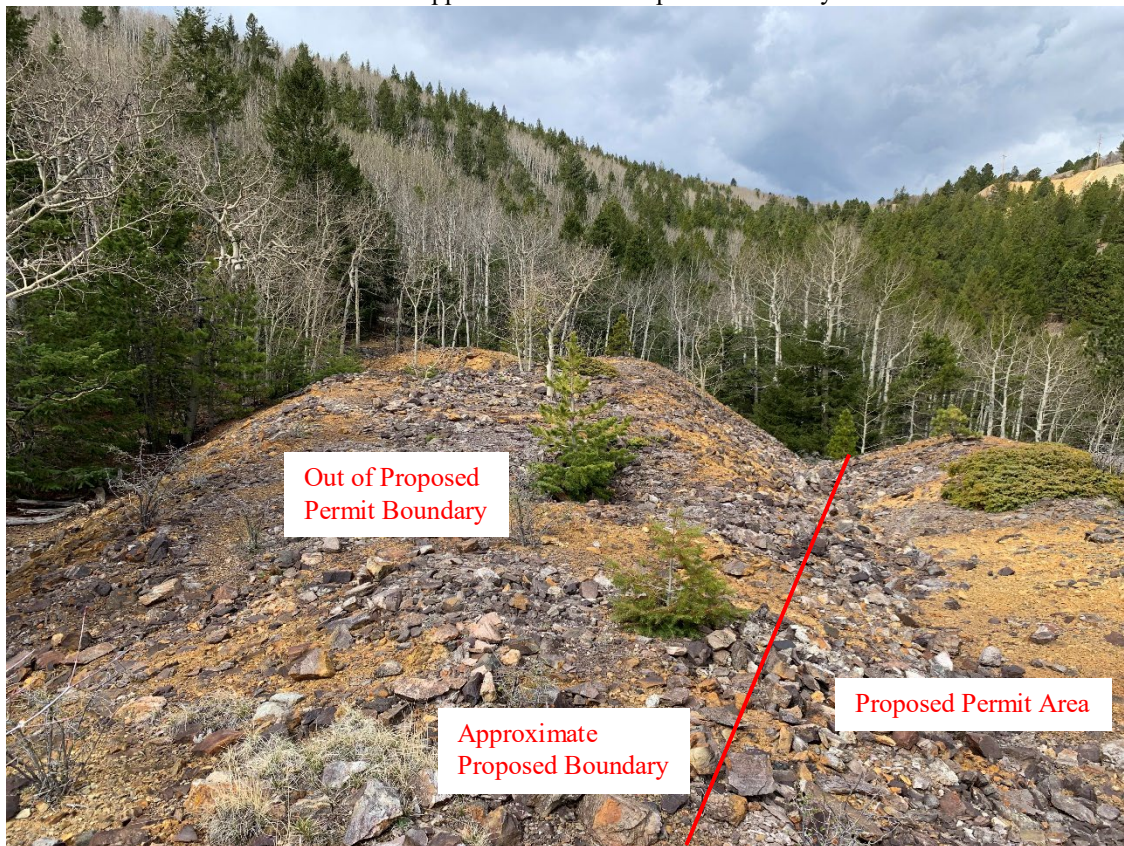
The west end of the pile will also need special consideration because the pile extends to the south beyond the permit boundary (photo 4). The part of the pile that extends beyond the permit boundary cannot be disturbed in any way or it will be considered an off-site impact. This includes the side of the pile collapsing beyond the permit boundary.

Photo 4 – West end of proposed permit boundary

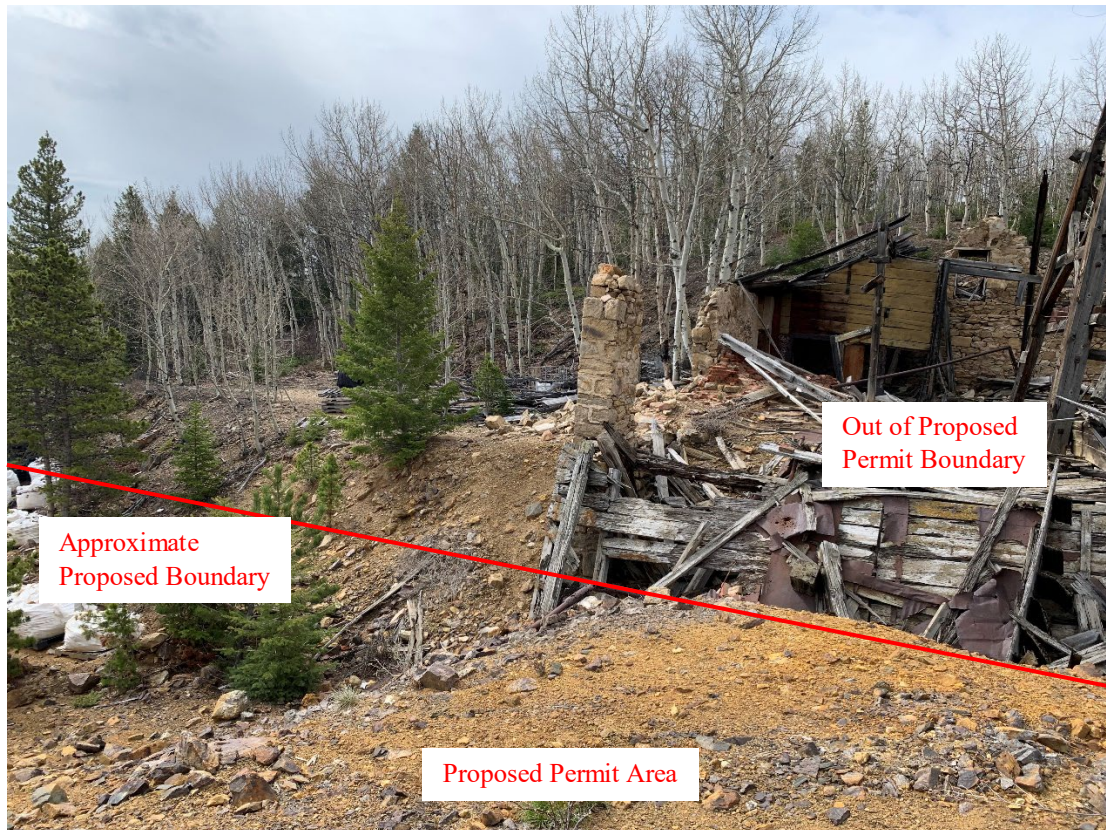
The proposed southern boundary is immediately adjacent to the old Grand Army building which is not in the permit boundary (photo 5). Special considerations will have to be taken not to disturb any part of this building because it is beyond the permit boundary. Any disturbance to this structure will be considered an off-site impact.

Photo 5 – Grand Army Structure immediately adjacent to permit boundary

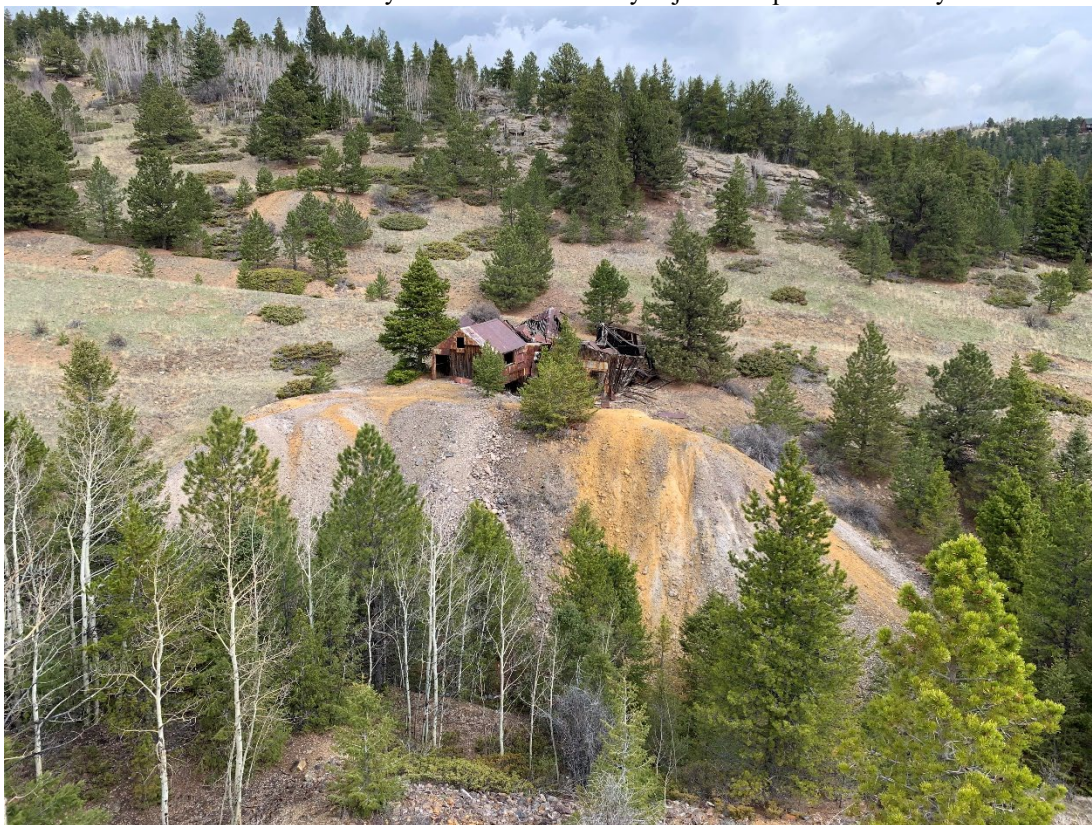
The Bonanza structure across the valley (photo 6) lies within 200 feet of the proposed permit boundary and will have to be documented in the permit and a structure agreement sign by the current owner.

Photo 6 – Bonanza structure within 200' of proposed permit boundary
