MINERALS PROGRAM INSPECTION REPORT
PHONE: (303) 866-3567

MINE NAME: Brownwood Pit	MINE/PROSPECTING ID#: M-1979-059	MINERAL: Sand and gravel	COUNTY: Larimer
INSPECTION TYPE: Monitoring	INSPECTOR(S): Brock Bowles	INSP. DATE: February 15, 2022	INSP. TIME: 09:00
OPERATOR: Coulson Excavating Company, Inc.	OPERATOR REPRESENTATIVE: Ken Coulson	TYPE OF OPERATION: 112c - Construction Regular Operation	
REASON FOR INSPECTION: Normal I&E Program		BOND CALCULATION TYPE:	BOND AMOUNT: \$89,136.00
DATE OF COMPLAINT: NA		POST INSP. CONTACTS: None	JOINT INSP. AGENCY: None
WEATHER: Clear	INSPECTOR'S SIGNATURE:

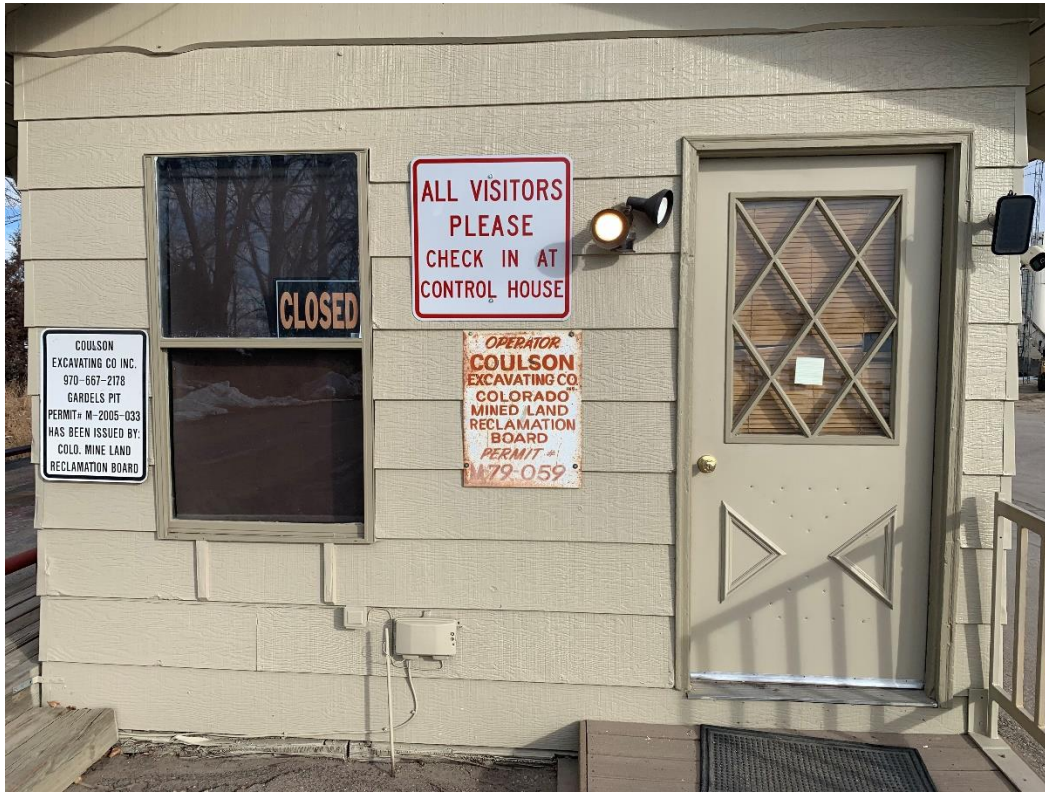
The permit entrance sign was in place on the scale house at the mine entrance (photo 1).

Photo 1 – Mine entrance sign on scale house

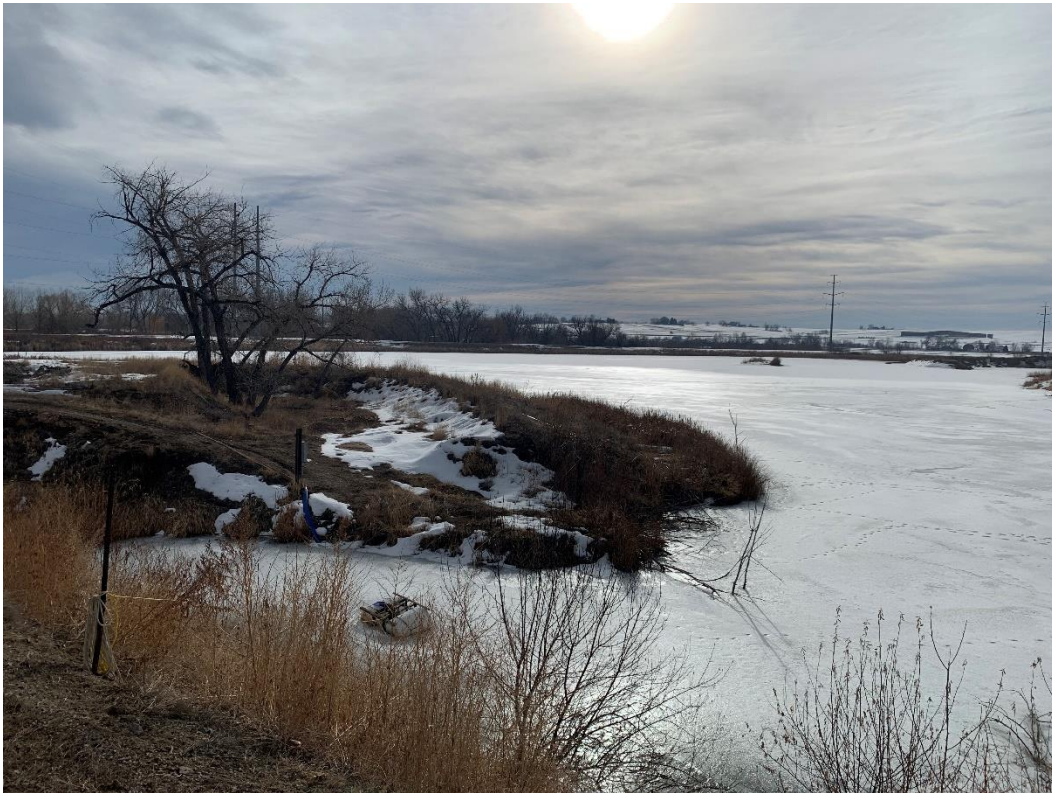
The NE Pond is approximately 12 acres in size and was frozen and snow covered (photo 2) for this inspection. The operator stated that the pond is not clay lined. This is inconsistent with the reclamation plan approved in AM3 (2015) which shows that NE Pond will be reclaimed to a 10 acre clay lined pond.

Photo 2 – Northeast Pond, facing south

The two above items were approved more than 5 years ago and have yet to be implemented. The operator needs accomplish one of the following:

- a) Submit a reclamation schedule within the next 60 days outlining how the approved reclamation plan will be implemented within the next 12 calendar months **or**
- b) Submit a technical revision within the next 60 days to update the reclamation plan.

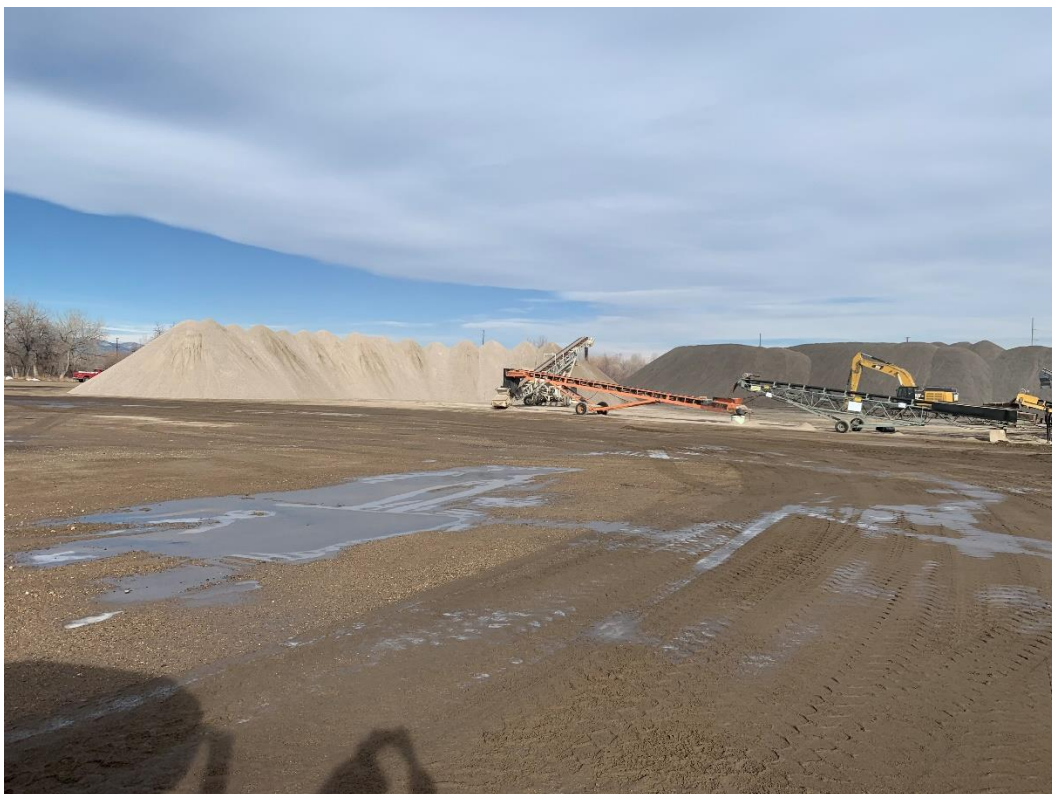
The area north of the asphalt plant is currently being used for recycling asphalt and concrete (photo 3). Other stockpiles were stacked around the site (photo 4).

Photo 3 – Processing area north of asphalt plant

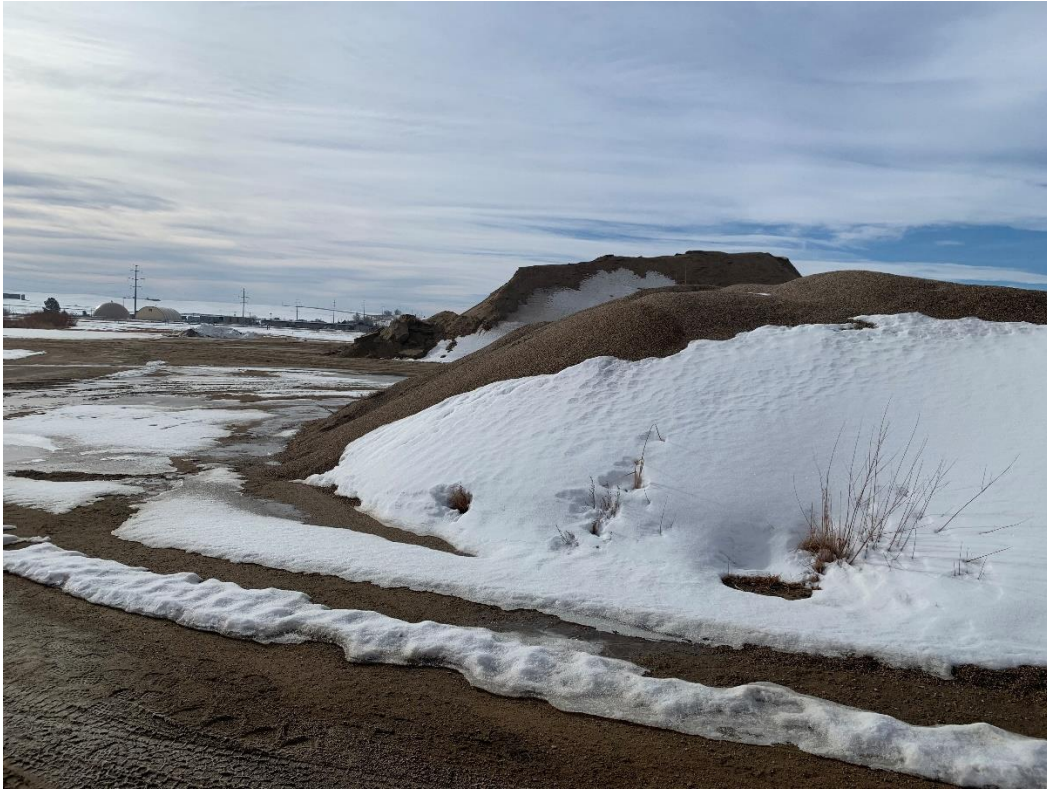
Photo 4 – Stockpiles of product onsite

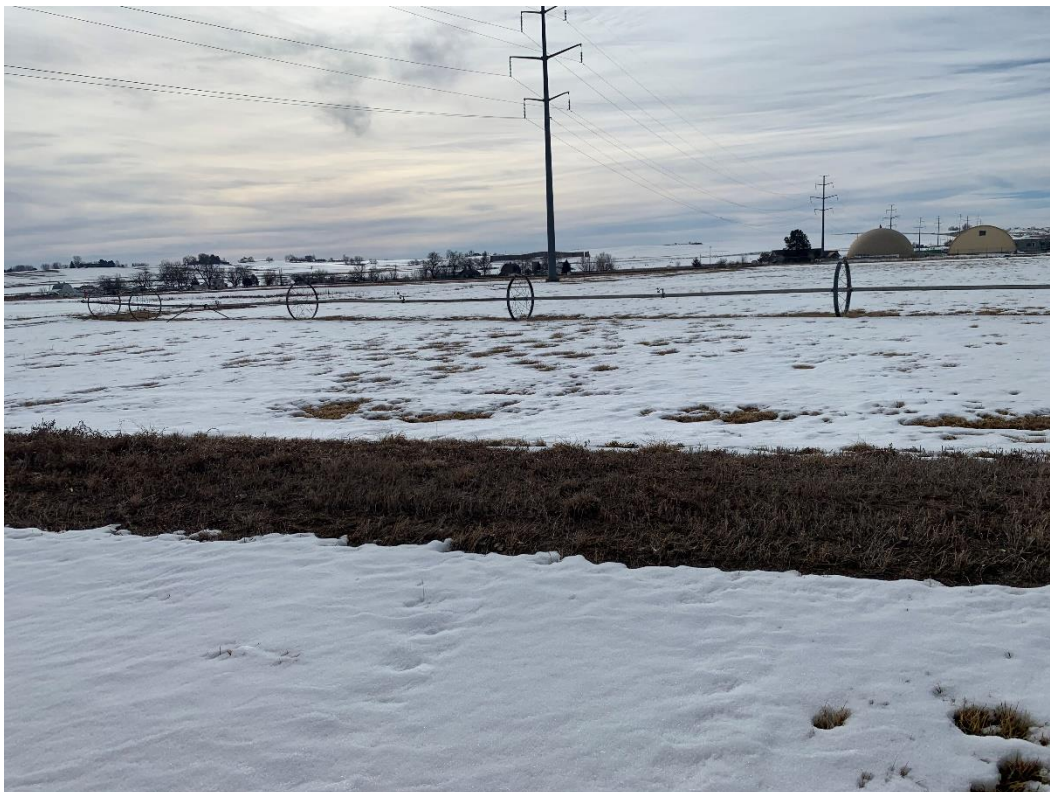
The SE reservoir is sloped to approximately 3h:1v and the slopes are well vegetated. The pond has been approved as a lined reservoir by DWR in 2012 (WDID 0403398). The area to the west of the SE reservoir has been reclaimed to an irrigated agricultural field (photo 5).

Photo 5 – Southern agricultural field, facing south
