Division of Reclamation,  
Mining and Safety

### PERMIT INFORMATION

### INSPECTION INFORMATION

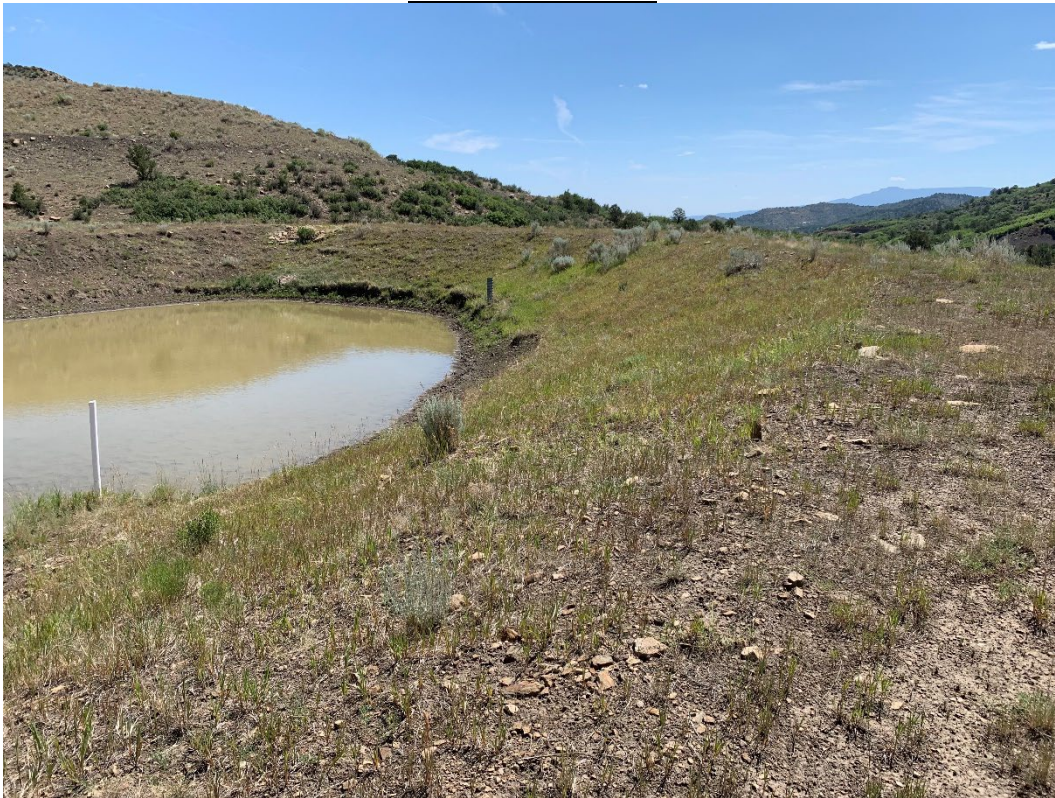
Photo 1 – Pond 6

Pond 6 contained water. The pond was not discharging as the water level was well below the primary spillway (photo 1). The primary and emergency spillways were free of obstructions. The embankment was vegetated and appeared to be stable.

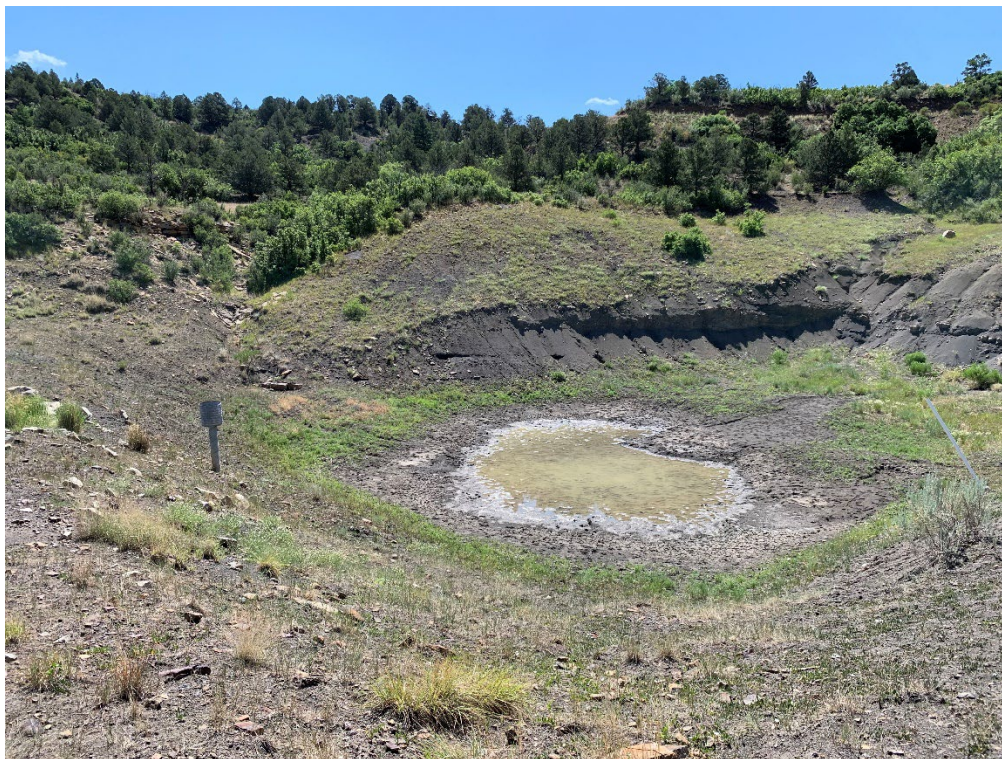
Photo 2 – Pond 9, primary discharge on left

Pond 9 contained a small puddle of water (photo 2). The pond was not discharging. The primary and emergency spillways were free of obstructions and appeared operational. The embankment had some vegetation and appeared to be stable.

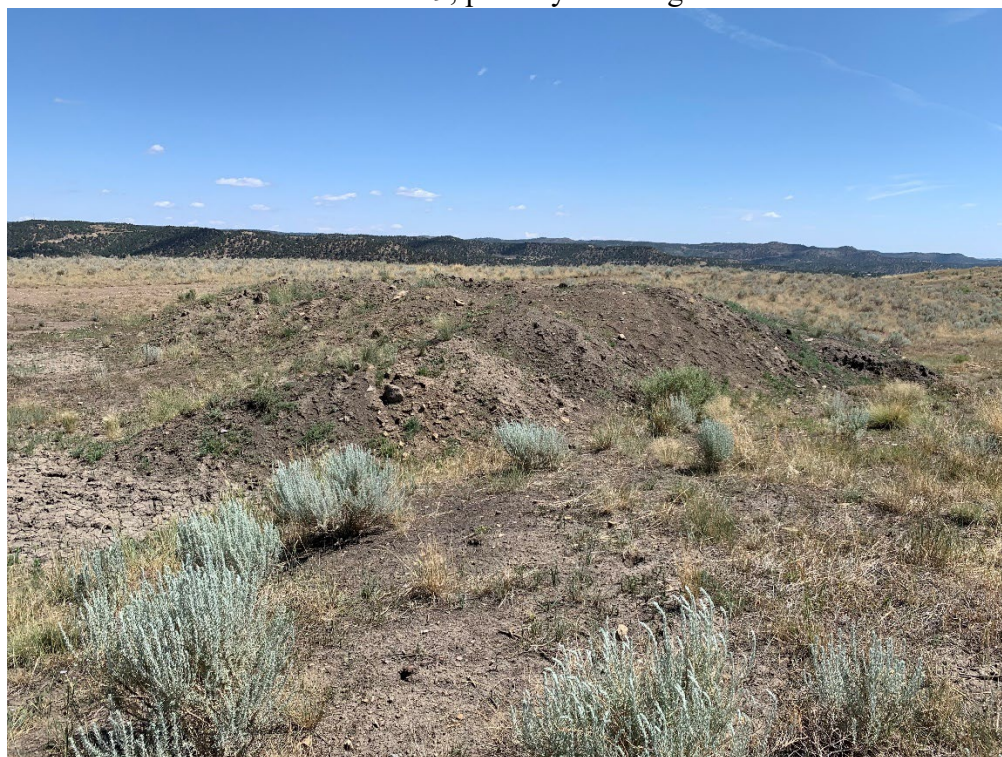
Photo 3 – Pond cleanings pile

The pond cleanings pile is located above Fill 8 and a little to the west of ditch D13 (photo 3). The material is staged in this location to dry. The pile appears to be stable and not eroding. Some vegetation is starting to get established.
