## M1980136, Chambers Pit, March 2023 Inspection Report

### MINERALS PROGRAM INSPECTION REPORT

<b>MINE NAME:</b> Chambers Pit	<b>MINE/PROSPECTING ID#:</b> M-1980-136	<b>MINERAL:</b> Sand and gravel	<b>COUNTY:</b> Eagle
<b>INSPECTION TYPE:</b> Monitoring	<b>WEATHER:</b> Clear	<b>INSP. DATE:</b> March 23, 2023	<b>INSP. TIME:</b> 10:00
<b>OPERATOR:</b> Oldcastle SW Group, Inc. dba United Comp County	<b>OPERATOR REPRESENTATIVE:</b> Scott Barney	<b>TYPE OF OPERATION:</b> 112c - Construction Regular Operation

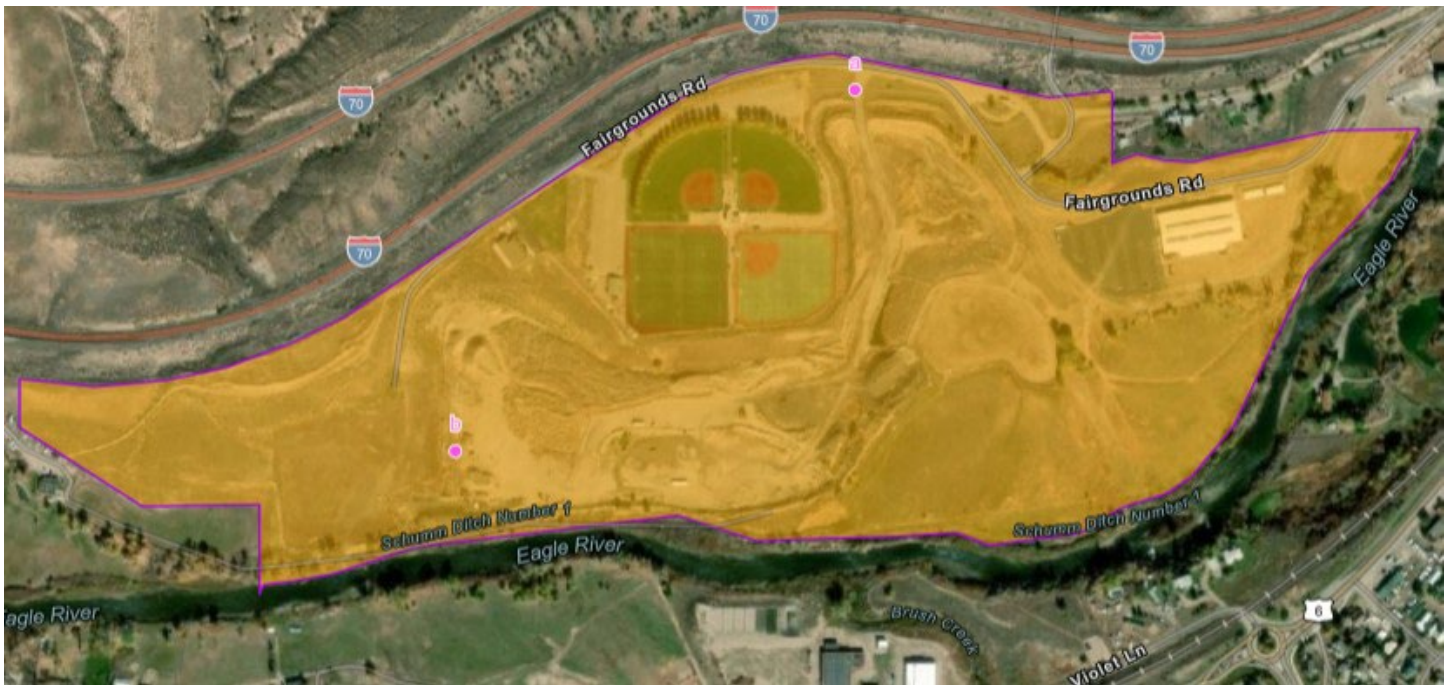
Figure 1: Inspection map

This inspection was conducted as part of the normal monitoring program established by the Colorado Division of Reclamation, Mining and Safety (Division). The inspection was conducted by Leigh Simmons of the Division, and accompanied by Scott Barney of United Companies (a subsidiary company of the permittee). The Chambers Pit is a 112c operation with a total permit area of 135 acres, located west of Eagle, with access off Fairgrounds Road. There was no activity at the site at the time of the inspection. The pre-mining land use of the site was Cropland, and, following the approval of AM-1, the site will ultimately be reclaimed to a land use of Recreation. Per the most recent Annual Report, 90 acres are currently affected and 45 have been backfilled, spread with 10" of topsoil, and seeded. No increase in disturbed acres were anticipated in 2023, and another 45 acres was expected to be reclaimed. The locations of photos taken during the inspection are shown on the screenshot of the field map.

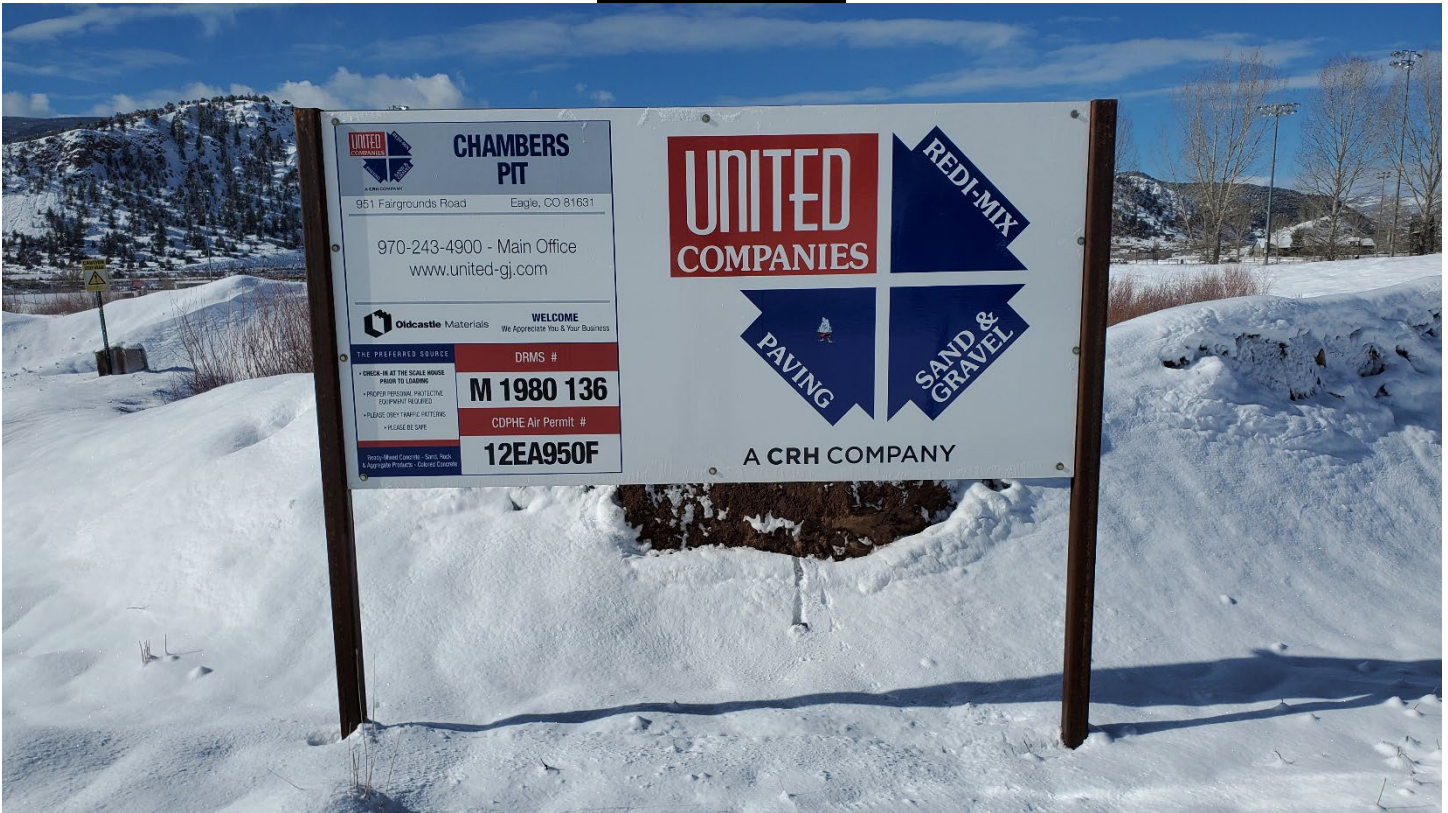
The mine ID sign was in place at the site entrance. Most of the site was fenced and secured behind a locked gate. Some land within the permit boundary (Fairgrounds Road, the baseball fields and the parking area to the east) was outside of the secured fenced area and was accessible by the public.

Figure 2: Mine ID sign (a)

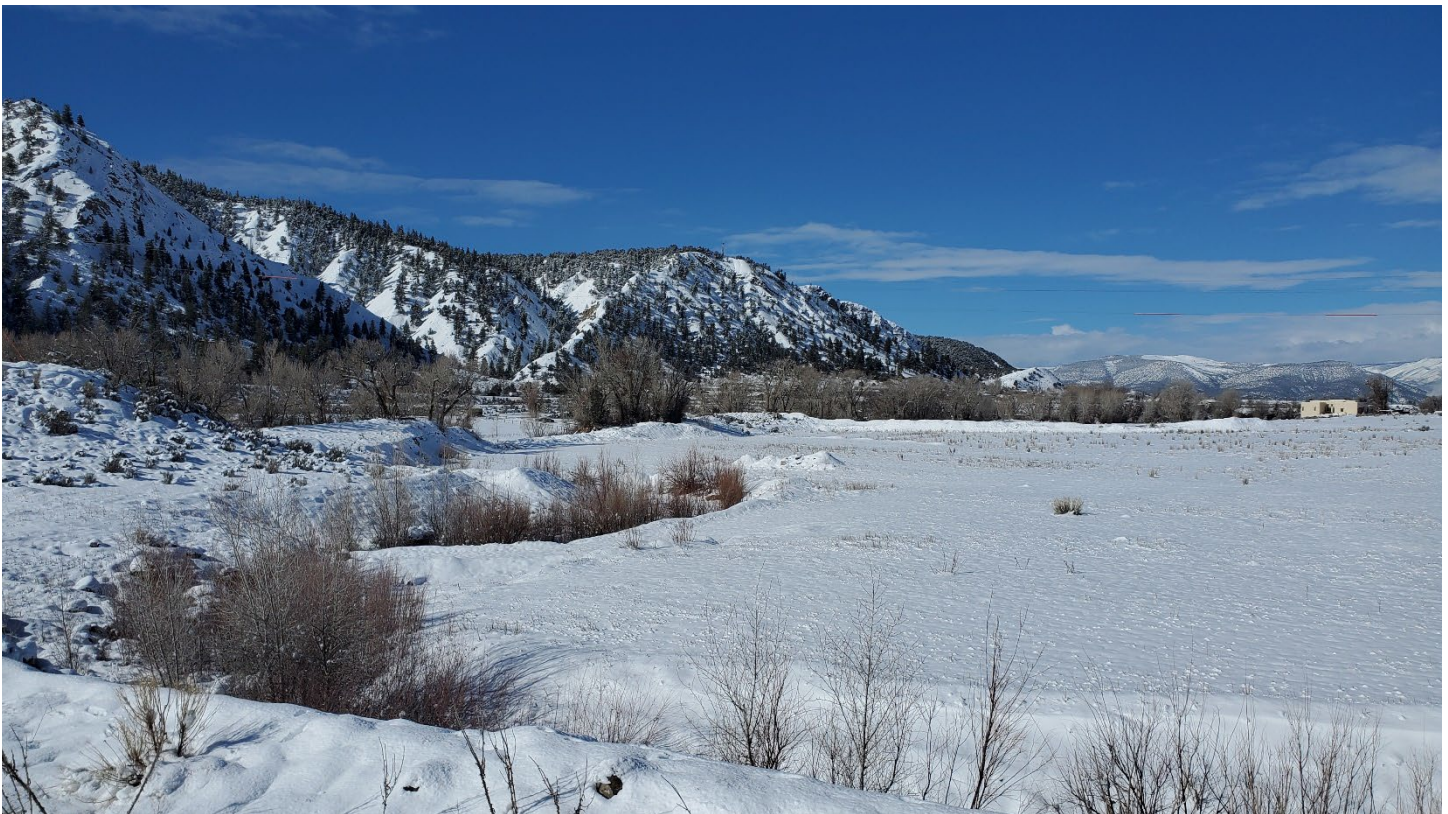
Given the snow cover, an assessment of reclamation success could not be made.

Figure 3: Reclaimed land at the west of the permit area (b)

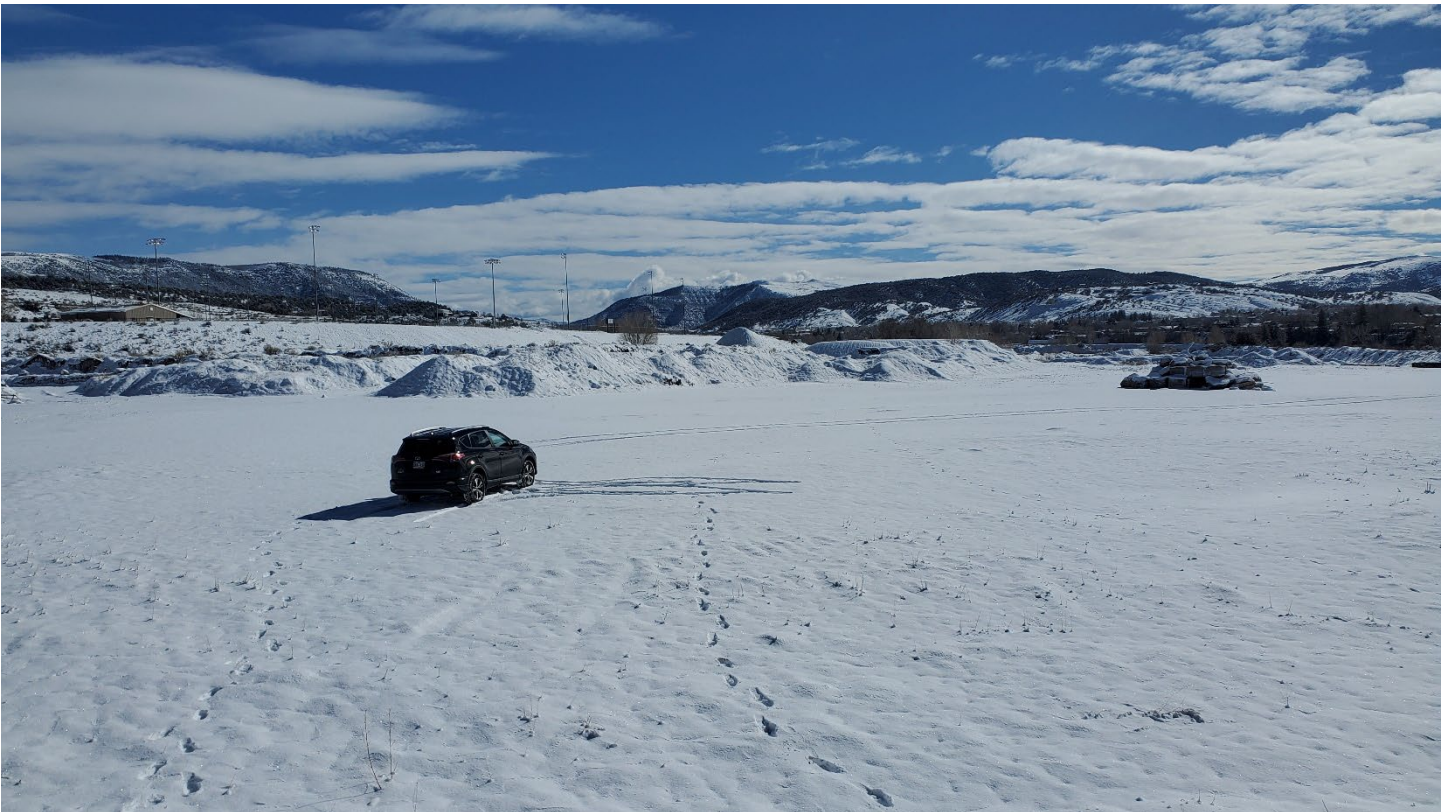
Figure 5: View to the north east, showing baseball fields (b)
