MINERALS PROGRAM INSPECTION REPORT
PHONE: (303) 866-3567

MINE NAME: Mahogany Research Project – Public Land Prospecting	MINE/PROSPECTING ID#: P-2003-018	MINERAL: Oil shale	COUNTY: Rio Blanco
INSPECTION TYPE: Monitoring	WEATHER: Clear	INSP. DATE: July 25, 2023	INSP. TIME: 07:30
OPERATOR: Shell Frontier Oil & Gas Inc.	OPERATOR REPRESENTATIVE: Samantha Baker	TYPE OF OPERATION: MP - Mineral Prospecting	
REASON FOR INSPECTION: Normal I&E Program	BOND CALCULATION TYPE: None	BOND AMOUNT: \$2,656,462.00	
DATE OF COMPLAINT: NA	POST INSP. CONTACTS: DRMS	JOINT INSP. AGENCY: U.S.BLM	
INSPECTOR(S): Amy Yeldell	INSPECTOR'S SIGNATURE:

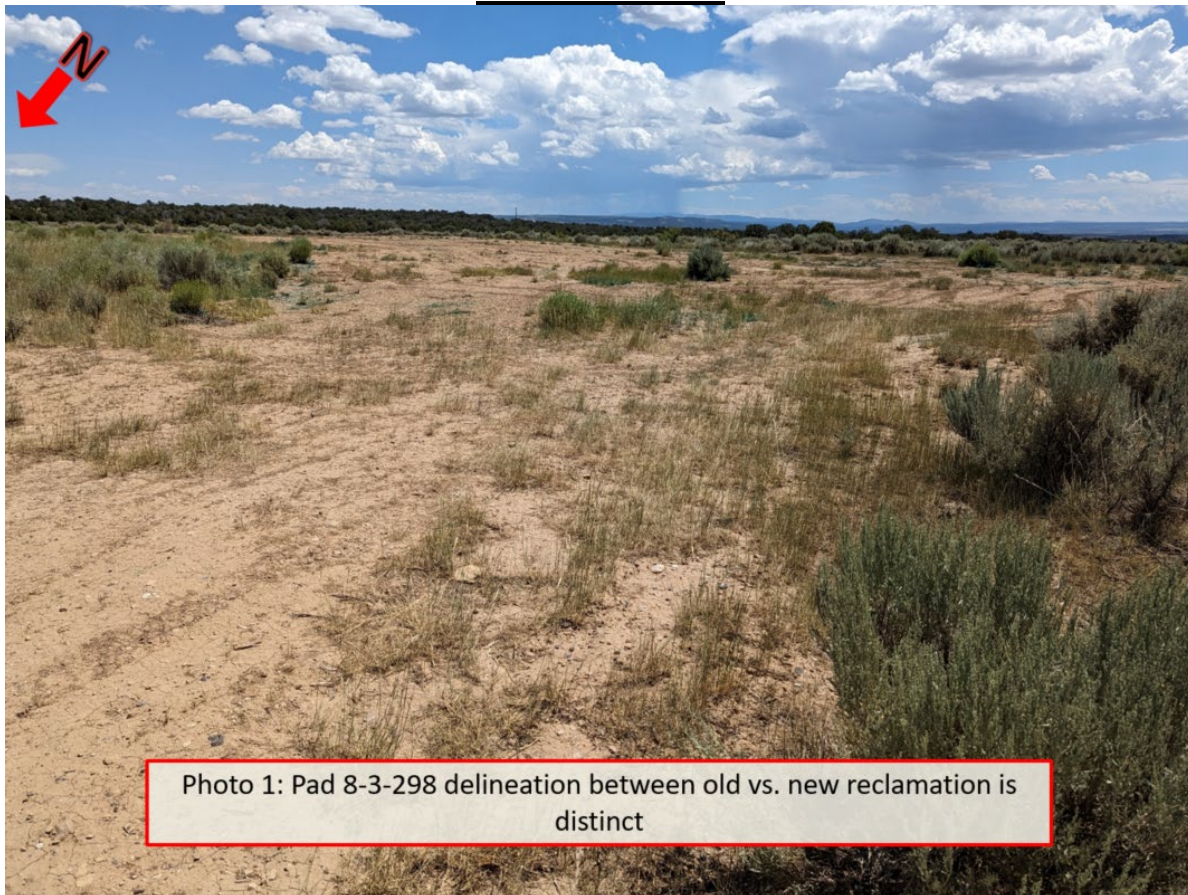
Pad 8-3-298: This pad is located on private property though it is on a public land NOI. The interim reclamation of this pad (perimeter) has well established grasses and some shrubs. There are some weeds but generally desirable vegetation is resilient. The recently reclaimed areas (middle) are nearly void of desirable vegetation. Only a few shrubs and grasses were present. Evidence of germination but juvenile die off was observed. Weeds were observed but they have been recently sprayed. Soil samples have been done on this pad. This fall soil amendments will be utilized as a test pad for trouble sites. See Photos One and Two.

Photo 1: Pad 8-3-298 delineation between old vs. new reclamation is distinct

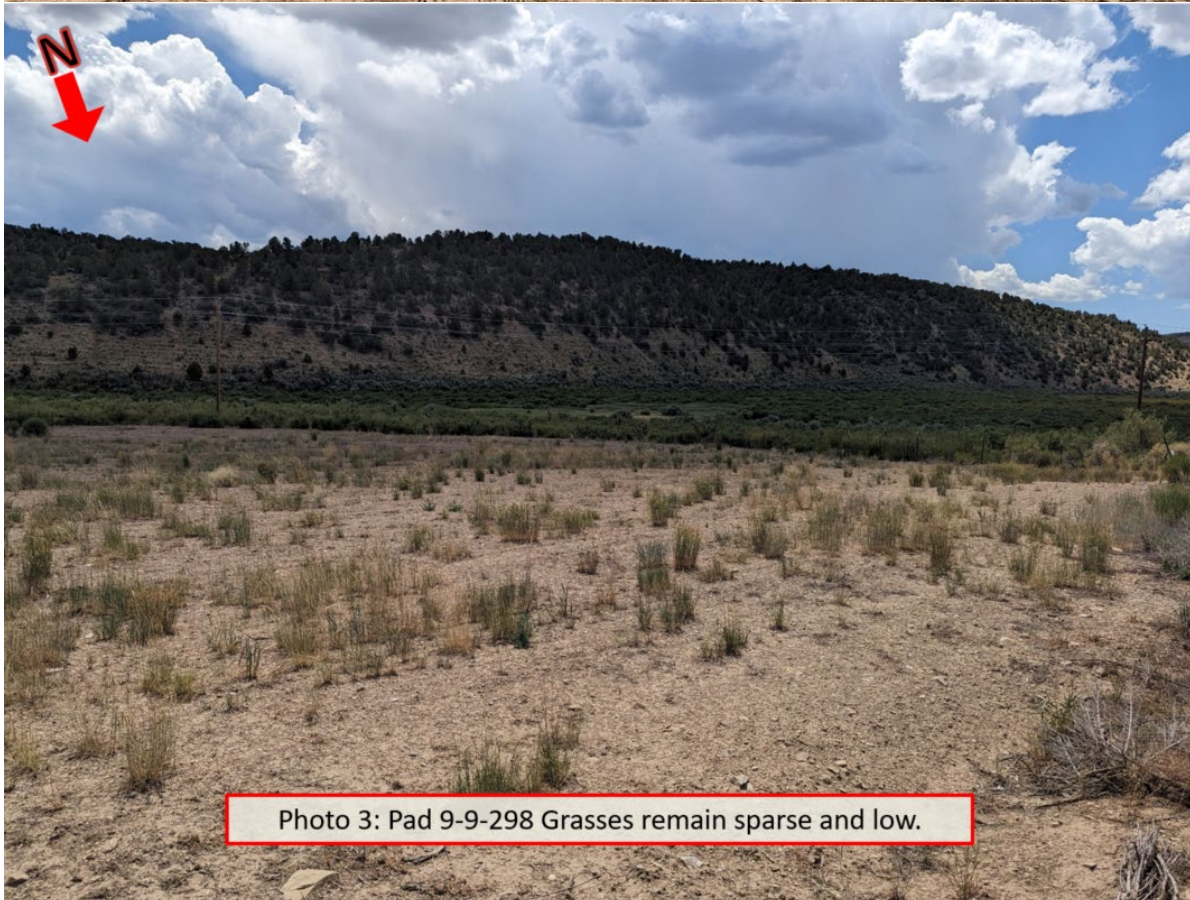
Pad 9-9-298: The pad is located right off roadway and remains fenced off from cattle. Establishment of desirable species, mostly grasses are progressing. There are very few shrubs so far and grasses remain low. Little to no weeds were observed. Surrounding areas are mature shrubs with little grass understory. Overall vegetative cover is approximately 20%. See Photos Three and Four.

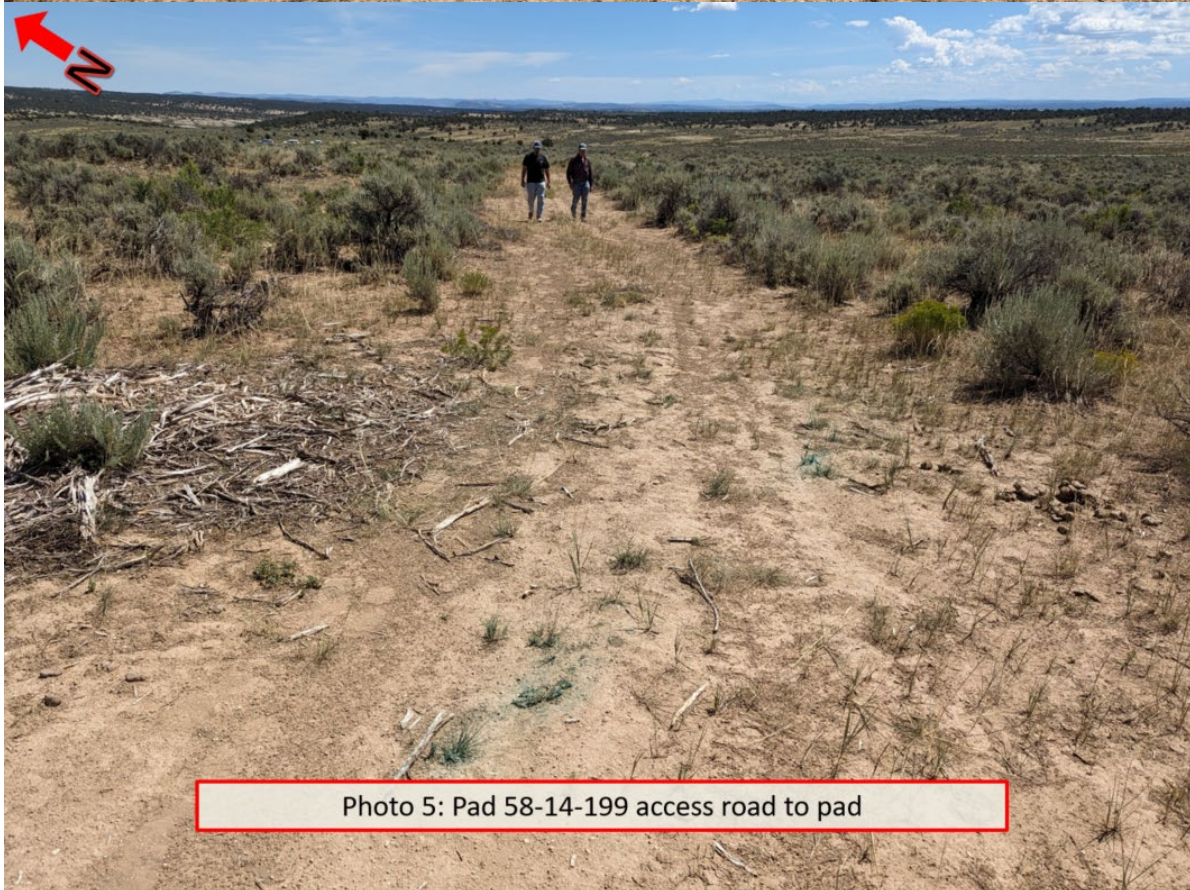
Pad 58-14-199: This pad has an extremely long access road. T-posts have been placed off of the county road indicating that it's reclaimed to detour traffic/use. Vegetation along the road is very hit or miss. Areas are nearly all bare or densely populated with desirable grasses and shrubs. This pad is also out in the open and subject to winds, drying out soils further. The pad itself has sparse but decent grass established. Overall vegetation is very low as this pad has been heavily grazed. Without relief from grazing pressure, grasses will likely remain stunted. A few shrubs have begun to germinate but are less than a foot tall. Previously Russian Thistle was problem at this site. Only a few were observed. This year Halogeton seems to be the weed of concern as it was located throughout the pad and access road. See Photos Five and Six.
