MINERALS PROGRAM INSPECTION REPORT
PHONE: (303) 866-3567

MINE NAME: 2006/07 Geo-Hydro Drill & Core Prgm-Public	MINE/PROSPECTING ID#: P-2006-036	MINERAL: Oil shale	COUNTY: Rio Blanco
INSPECTION TYPE: Monitoring	WEATHER: Clear	INSP. DATE: July 25, 2023	INSP. TIME: 07:30
OPERATOR: Shell Frontier Oil & Gas Inc.	OPERATOR REPRESENTATIVE: Samantha Baker	TYPE OF OPERATION: MP - Mineral Prospecting	
REASON FOR INSPECTION: Normal I&E Program	BOND CALCULATION TYPE: None	BOND AMOUNT: \$293,326.33	
DATE OF COMPLAINT: NA	POST INSP. CONTACTS: DRMS	JOINT INSP. AGENCY: U.S.BLM	
INSPECTOR(S): Amy Yeldell	INSPECTOR'S SIGNATURE:

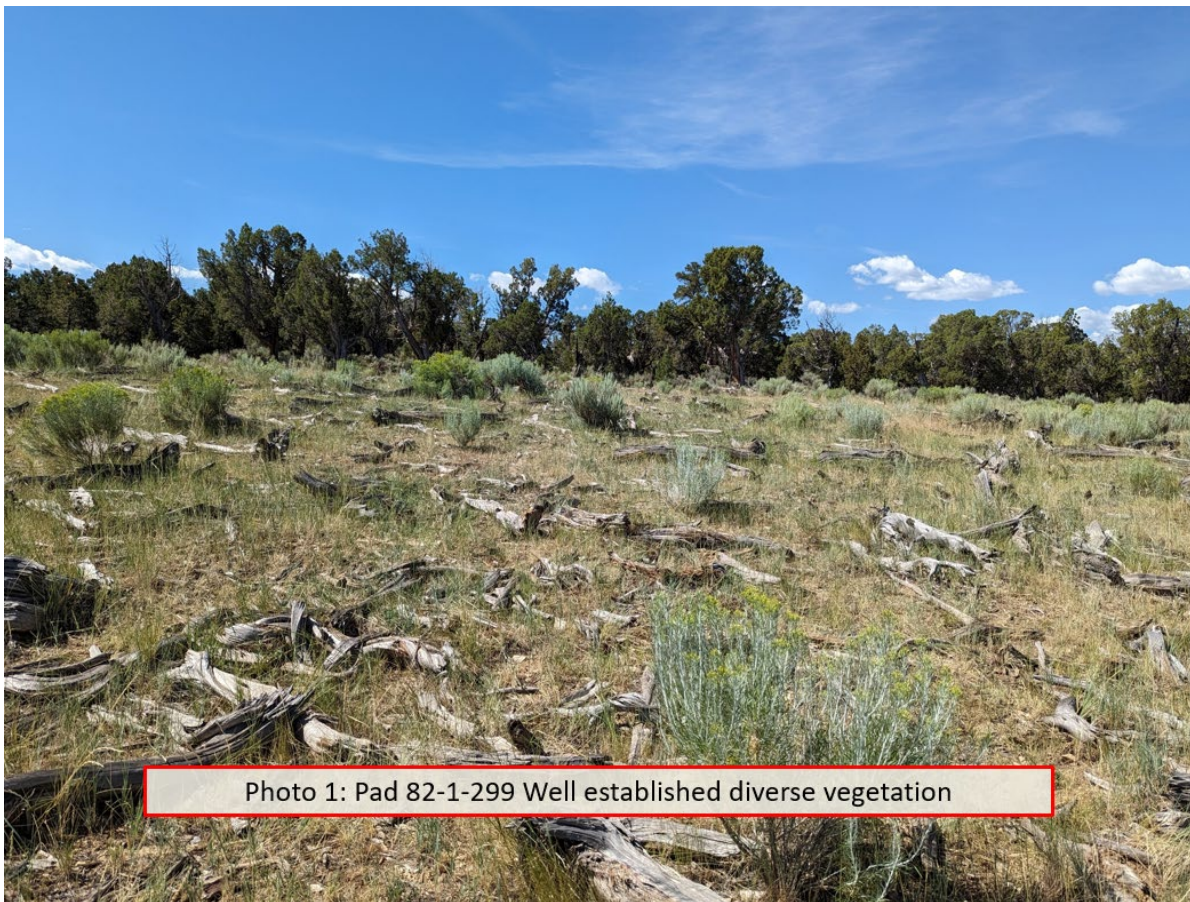
*Pad 82-1-299: Previously this pad has struggled to have desirable grasses and out complete the Cheatgrass. Noxious weed now appear to be effectively managed and little to no noxious species were observed. Overall there is good diversity. There is some evidence of grazing but vegetation appears sustainable even with pressure. Overall the site appears to be stabilized with vegetative cover. Photo One.

Photo 1: Pad 82-1-299 Well established diverse vegetation

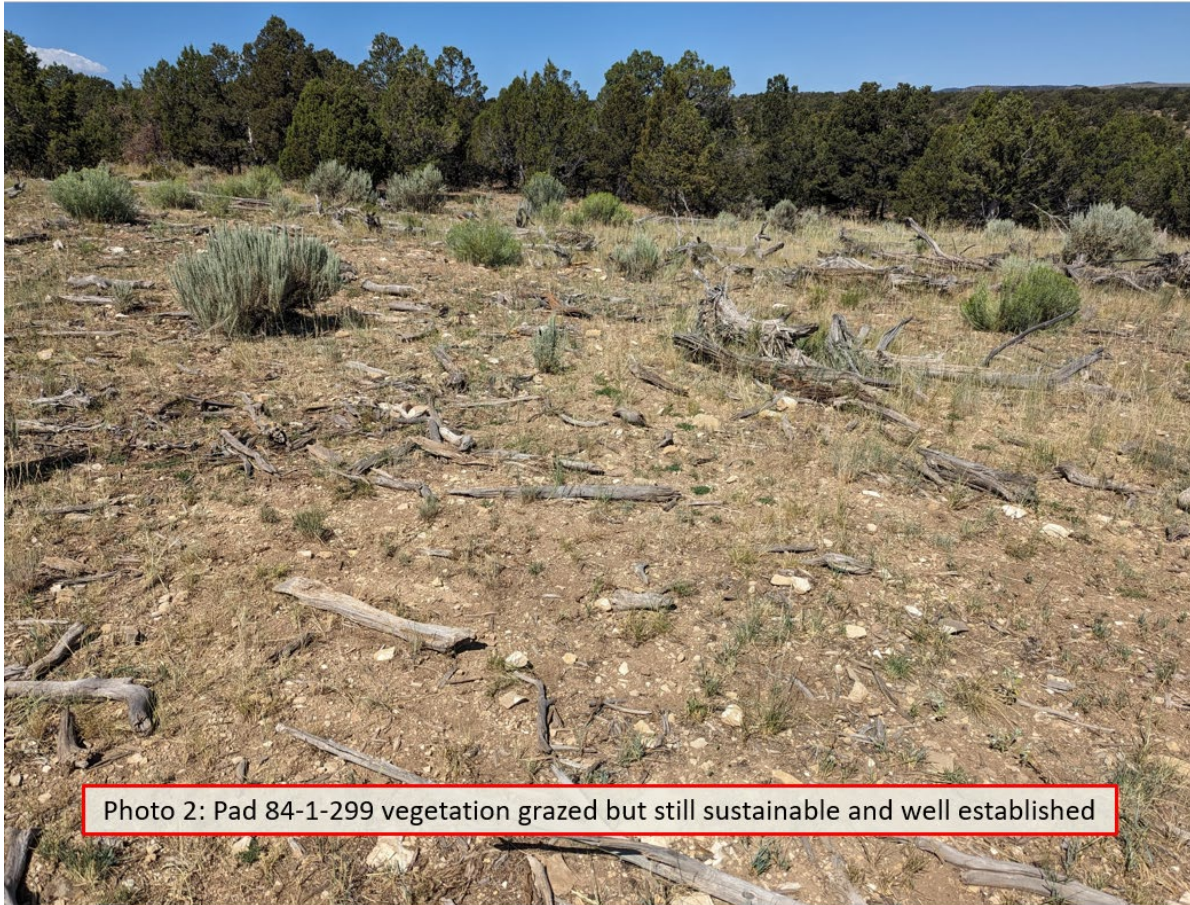
*Pad 84-1-299: Vegetation on this pad has rebounded from last year's heavy grazing and weeds. Evidence of grazing is significantly less and only patches are affected. There is a diverse mix of shrubs and grasses with sufficient cover to prevent erosion. Little to no weeds were observed. Photo Two.

Photo 2: Pad 84-1-299 vegetation grazed but still sustainable and well established

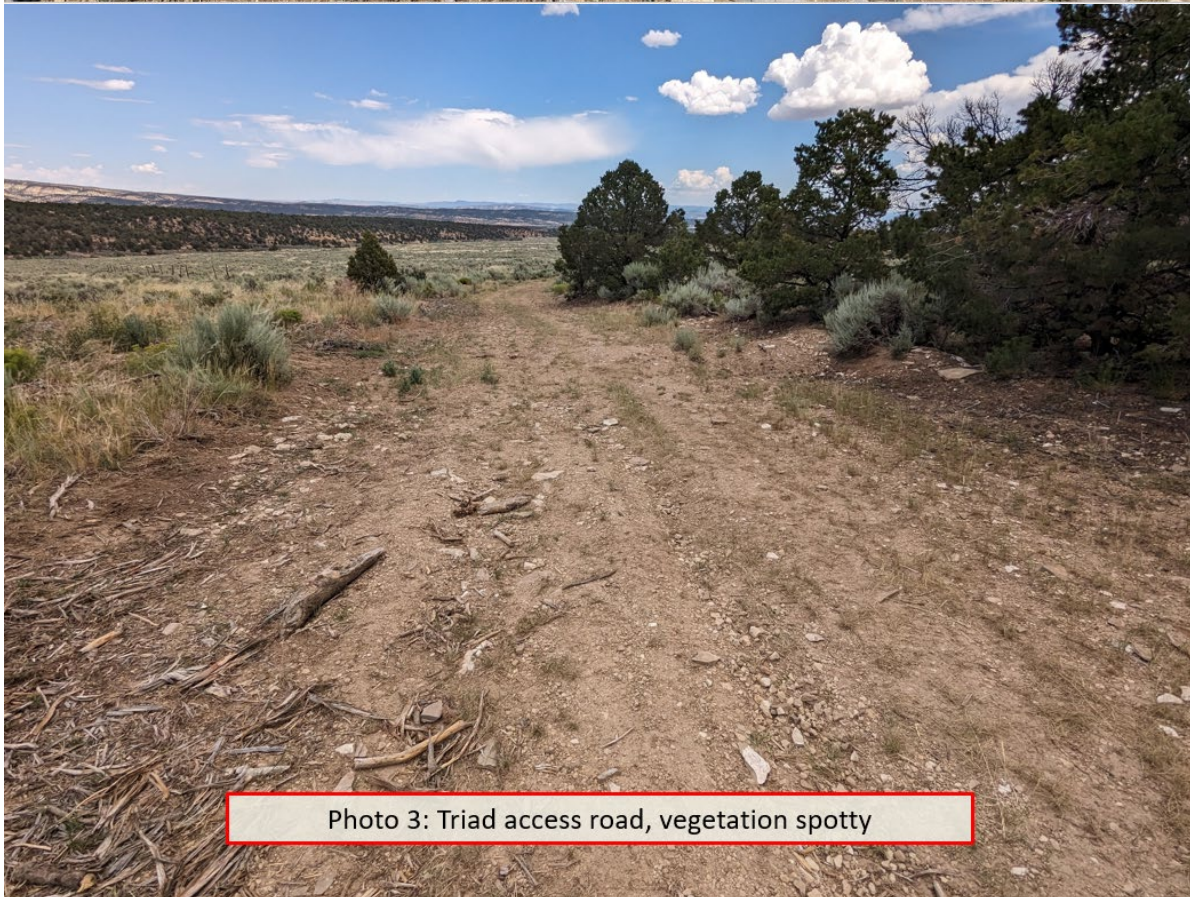
Triad Access Road and pads: Previously the adjacent lands have been hydro-axed (shrub mowing) by the BLM to break up dense patches of sagebrush and allow for establishment of more grasses. None of the permitted lands have been affected by this activity however the loss in wind breaks has result in dryer conditions on the pads. Vegetation on the access road is sparse, approx. 30% cover of primarily grasses. Noxious weeds such as Russian Thistle continue to be a problem. The operator will continue to manage noxious species. Photos Three and Four.

Photo 3: Triad access road, vegetation spotty

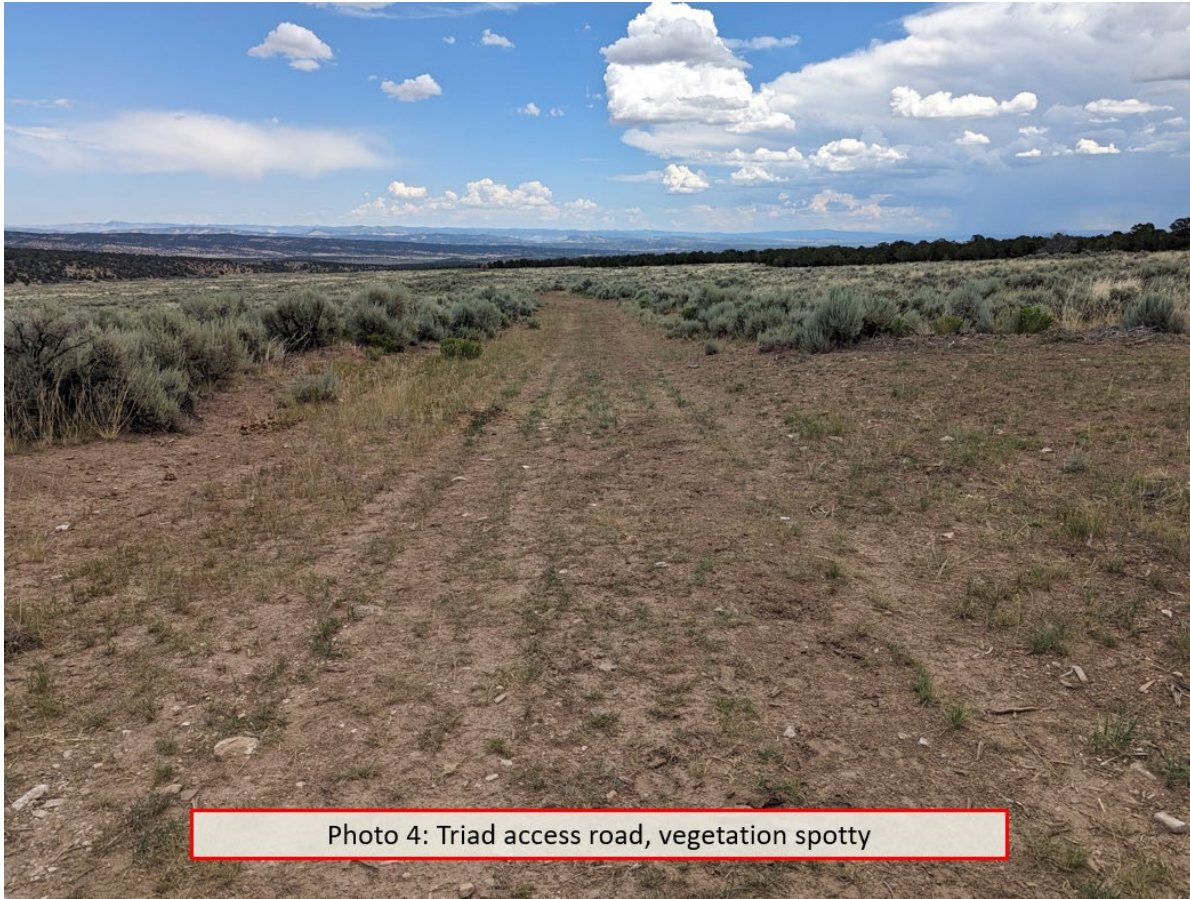
Photo 4: Triad access road, vegetation spotty
