Keenesburg Mine Site Inspection Report

2nd Quarter

6/9/2023

COORS ENERGY KEENESBURG MINE

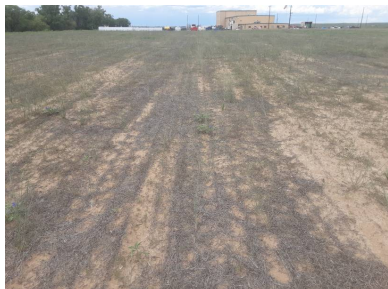
Recently reclaimed area was densely covered in Russian thistle summer 2022 now showing signs of significantly less cover of nuisance weeds. Noted native grasses and forbs starting to establish (photo 1).

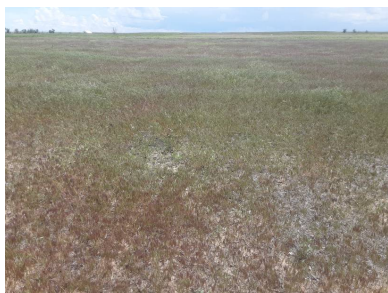
Recently reclaimed area densely populated in cheatgrass. Did not notice native grass establishment. Monitor and maintenance required before reseed area (photo 2).

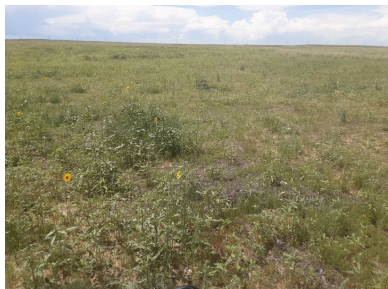
Area covered in nuisance broadleaf weeds. Some native grass establishment. Mow summer 2023 (photo 3).

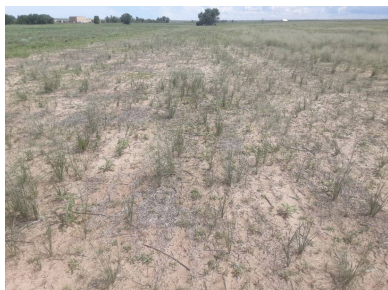
Noticeable native grass establishment in Area. Minimal cheatgrass or nuisance weed establishment. No follow up mowing or seeding required at this time (photo 4).

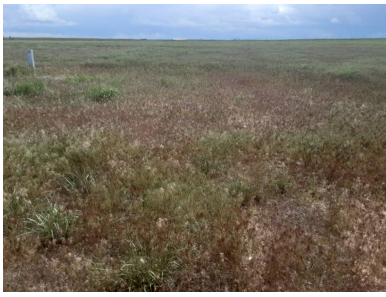
Area density populated with cheatgrass. Noticed no native vegetation. Monitor to establish vegetation baseline. Maintenance required before reseeding (photo 5)

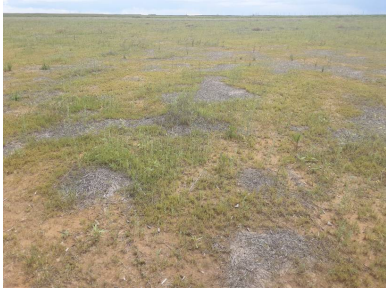
Dense carpet of Russian thistle. Minimal native vegetation noticeable in Area. Mow late summer and reseed fall 2023 (photo 6)

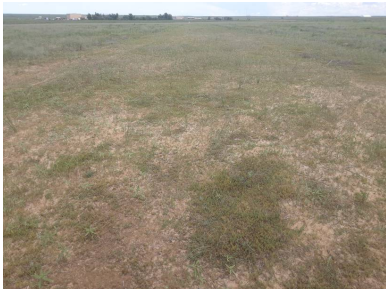
Nuisance weeds and cheatgrass with noticeable native vegetation. Continue to monitor, avoid mowing so as not to spread cheatgrass (photo 7).

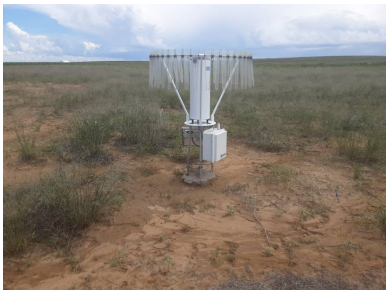
Weather station appears functional (photo 8).

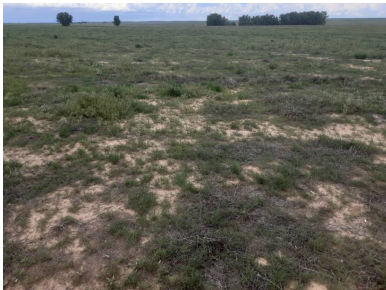
Continued summer mowing in Area (photo 9)

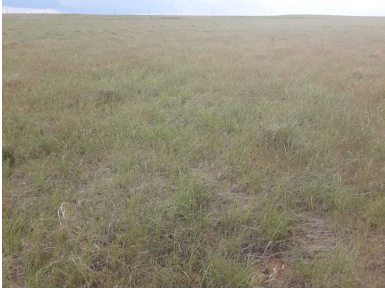
Consider preemergent treatment to control cheatgrass in areas where native vegetation is present. Consult veg monitoring report for native vegetation cover (photo 10).
