C1980007, West Elk Mine, August Inspection Report

PERMIT INFORMATION

Permit Number: C-1980-007 Mine Name: West Elk Mine Operator: Mountain Coal Company, LLC Operator Address: Ms Nicki Poulos 5174 Highway 133 Somerset, CO 81434	County: Delta, Gunnison Operation Type: Underground Permit Status: Active Ownership: Private
	Operator Representative Present: Ed Ogrodny
Operator Representative Signature: (Field Issuance Only)

Inspection Start Date: August 16, 2023 Inspection Start Time: 10:00 Inspection End Date: Inspection End Time:	Inspection Type: Coal Complete Inspection Inspection Reason: Normal I&E Program Weather: Clear
Joint Inspection Agency: None	Joint Inspection Contacts:
Post Inspection Agency: None	Post Inspection Contacts:
Inspector(s): Leigh Simmons	Inspector's Signature:

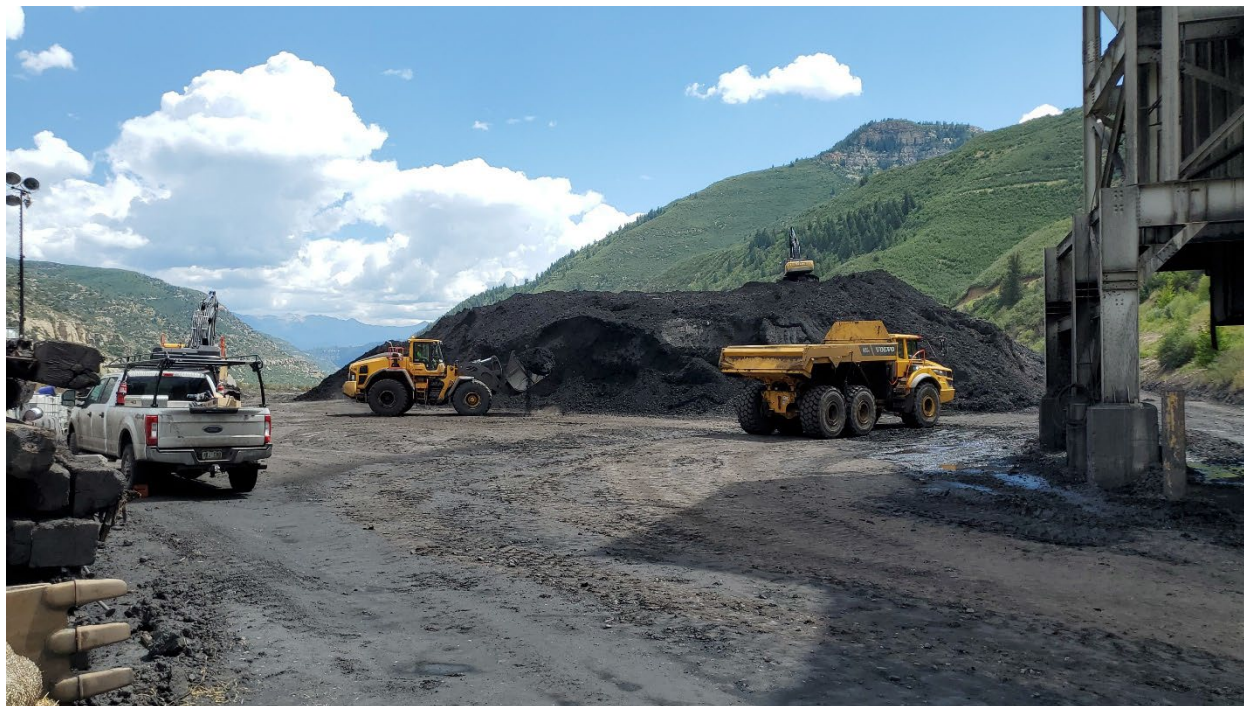
The temporary refuse pile on the RPE was estimated at around 100,000 tons. Three haul trucks were transporting material to the RPEE at the time of the inspection. The haul trucks each took three bucket loads from the wheel loader per trip. An excavator was working the material on top of the temporary pile in an effort to dry it out more quickly.

Figure 5: Haul trucks being loaded on RPE

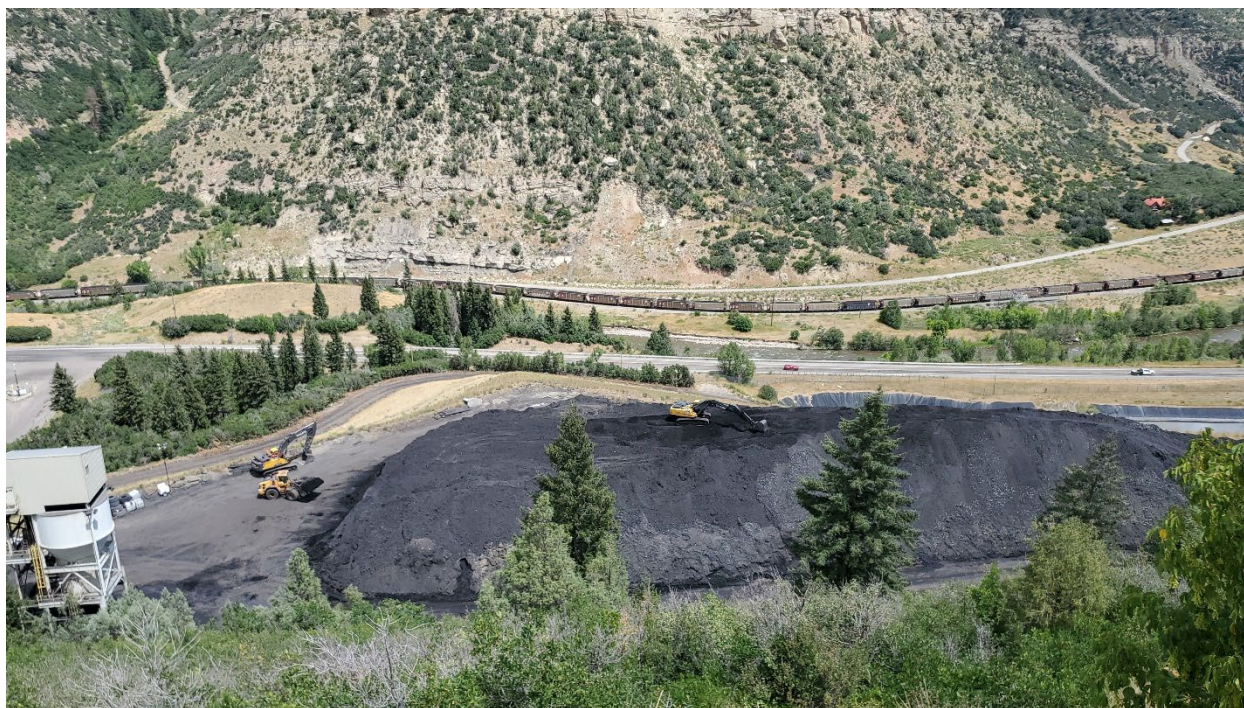
Figure 6: Temporary refuse pile on RPE

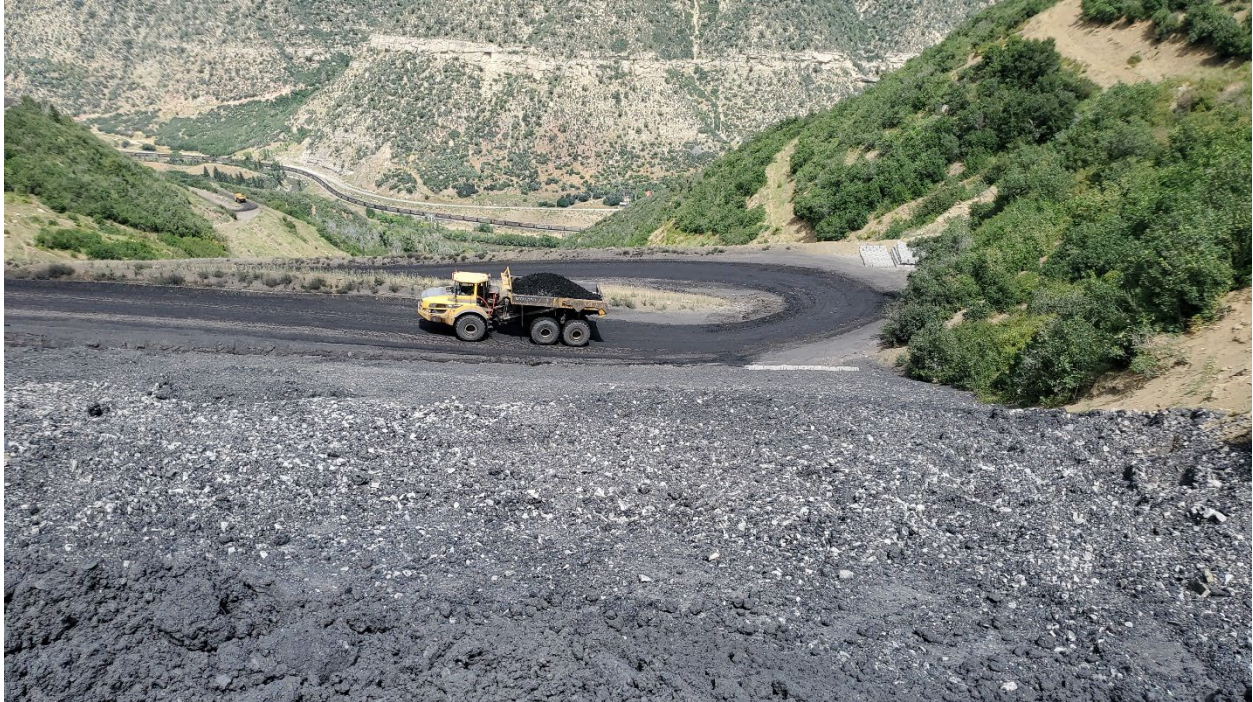
Figure 7: Refuse being transported to RPEE

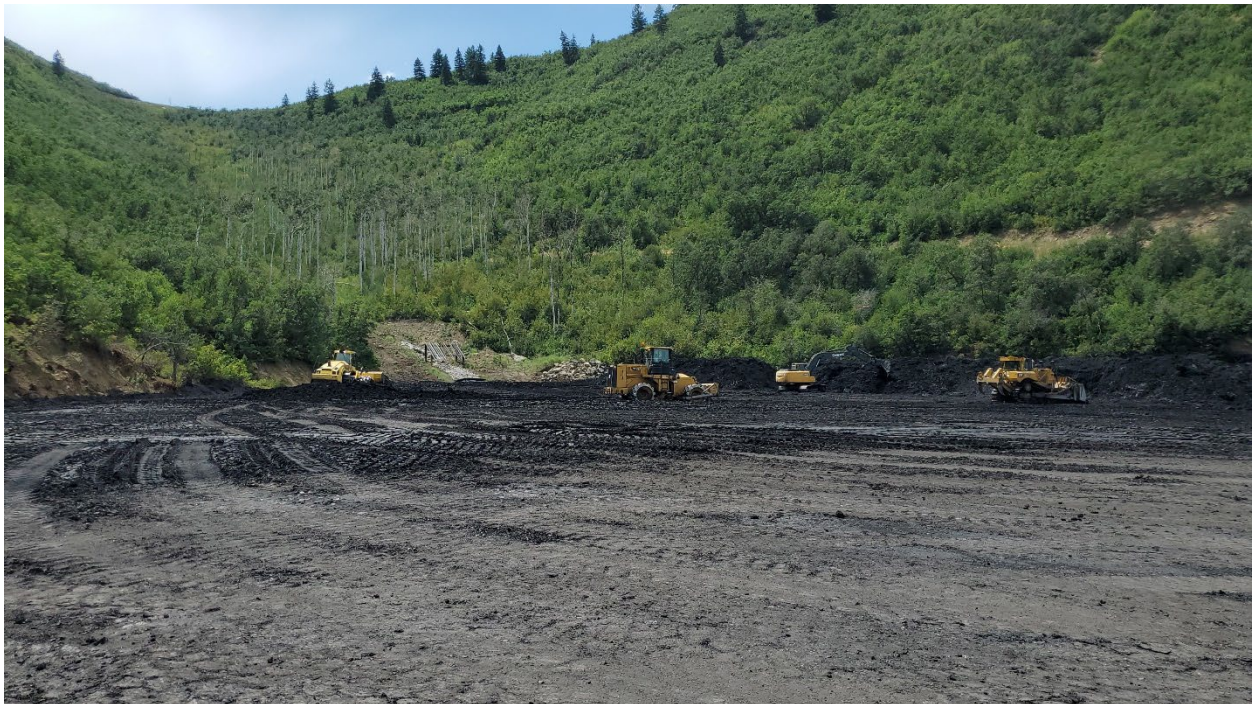
Three compactors, a dozer, an excavator and a grader were working on top of the RPEE to spread, dry and compact material. The surface of the pile was much smoother and more regular than it had been on recent inspections. An engineer from Lambert and Associates typically comes to the site twice a week to conduct compaction tests. The surface of the pile was graded to drain to the north west. The north west corner of the pile was quite a bit lower than the design, and the out-slope of the pile could continue to be built up, but it will be necessary for MCC to extend the underdrain of the pile fairly soon.

Figure 8: Compaction of refuse in progress on RPEE

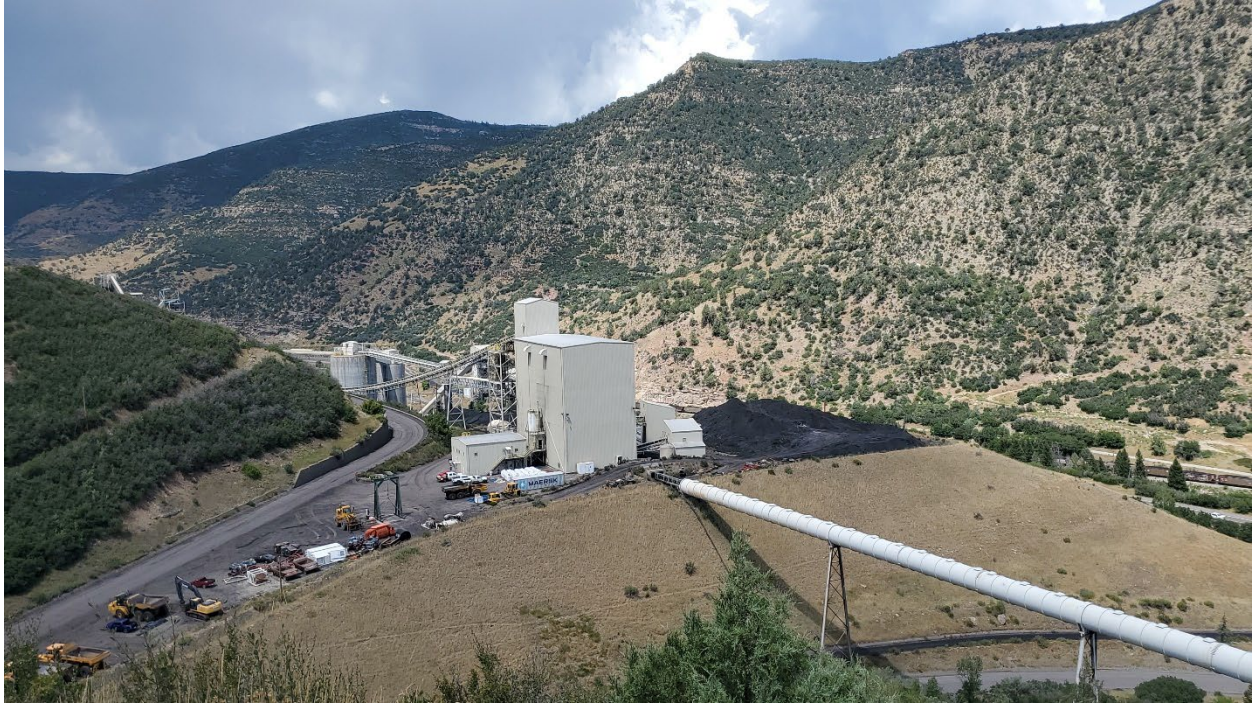
A further 10,000 tons of refuse and 20,000 tons of fines were temporarily stockpiled on top of the Lower Refuse Pile (LRP).

Figure 9: Temporary stockpile of fines and refuse on LRP

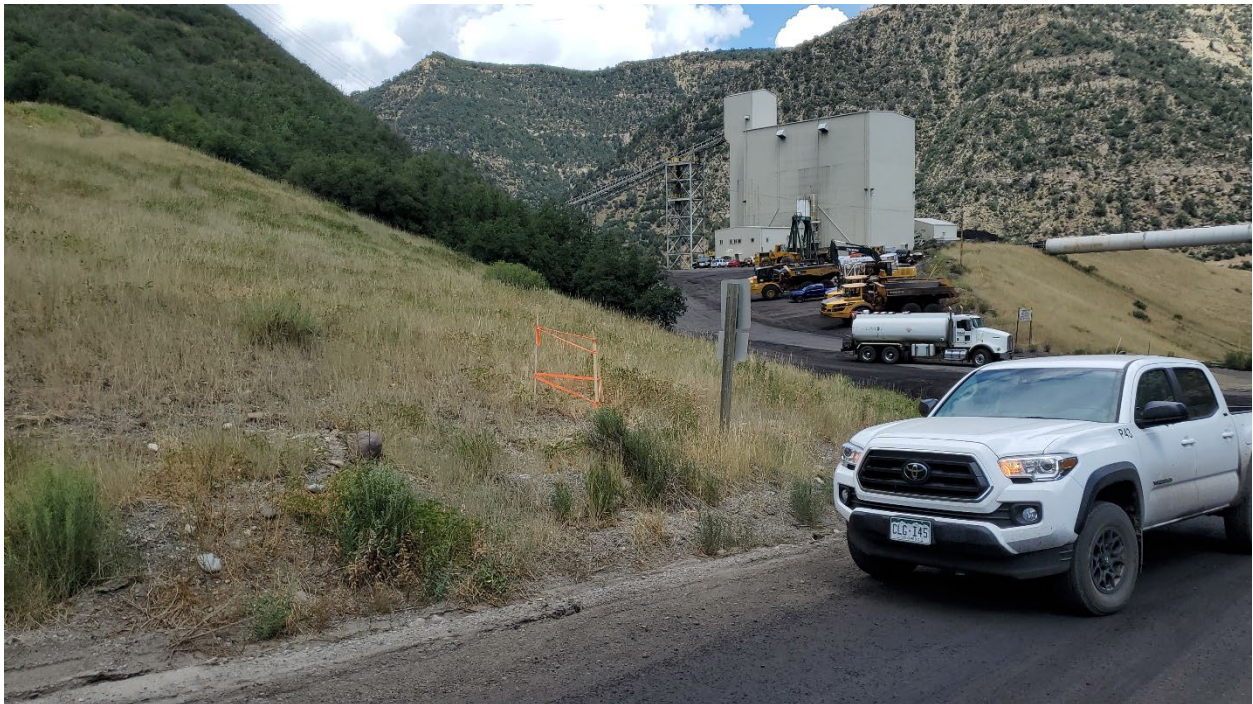
The location for the Box Canyon Well (approved with MR-474) had been surveyed and marked, but construction of the drill pad had not yet begun.

Figure 10: Surveyed location for Box Canyon Well
