MINERALS PROGRAM INSPECTION REPORT
PHONE: (303) 866-3567

MINE NAME: Rich Pit	MINE/PROSPECTING ID#: M-1985-218	MINERAL: Sand and gravel	COUNTY: Pueblo
INSPECTION TYPE: Monitoring	WEATHER: Clear	INSP. DATE: July 13, 2023	INSP. TIME: 08:30
OPERATOR: Martin Marietta Materials, Inc.	OPERATOR REPRESENTATIVE: Phillip Courtney and Rusty Cochran	TYPE OF OPERATION: 112c - Construction Regular Operation	
REASON FOR INSPECTION: Normal I&E Program	BOND CALCULATION TYPE: Complete Bond	BOND AMOUNT: \$344,500.00	
DATE OF COMPLAINT: NA	POST INSP. CONTACTS: None	JOINT INSP. AGENCY: None	
INSPECTOR(S): Amber Michels	INSPECTOR'S SIGNATURE:

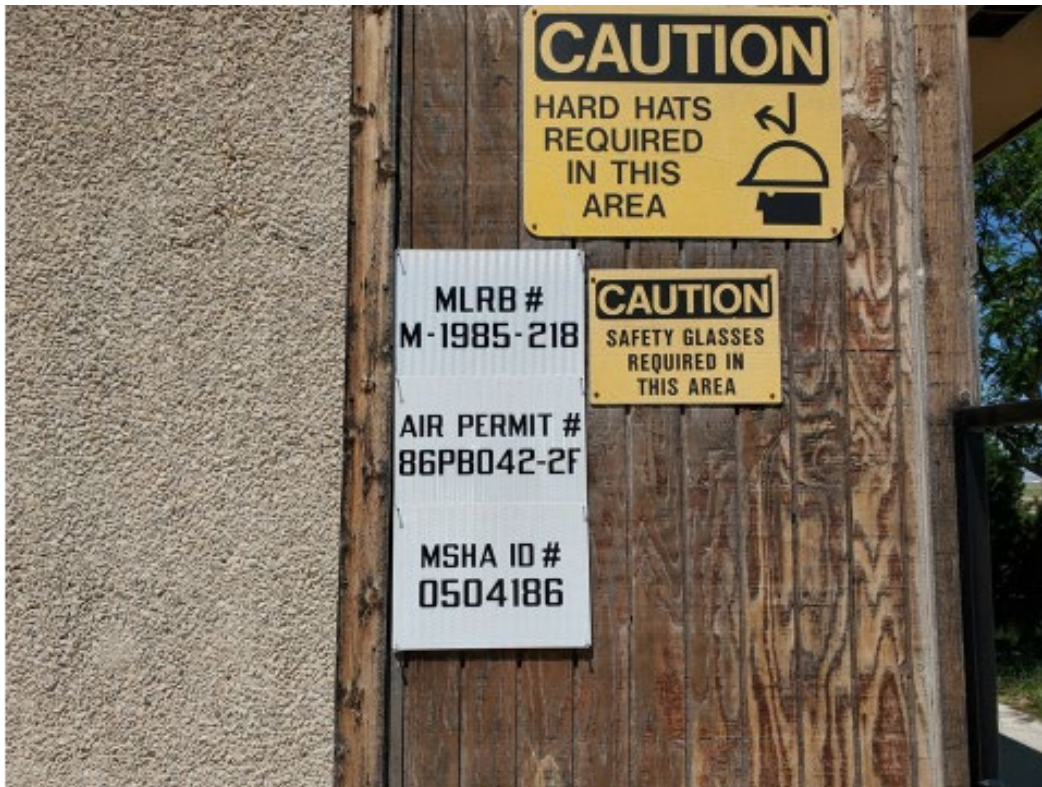
Photo 1: Looking at the permit sign posted outside of the office.

A mine sign posted in compliance with Rule 3.1.12(1) was posted at the entrance to the site (Photos 1 & 2, Maps 1 & 2).

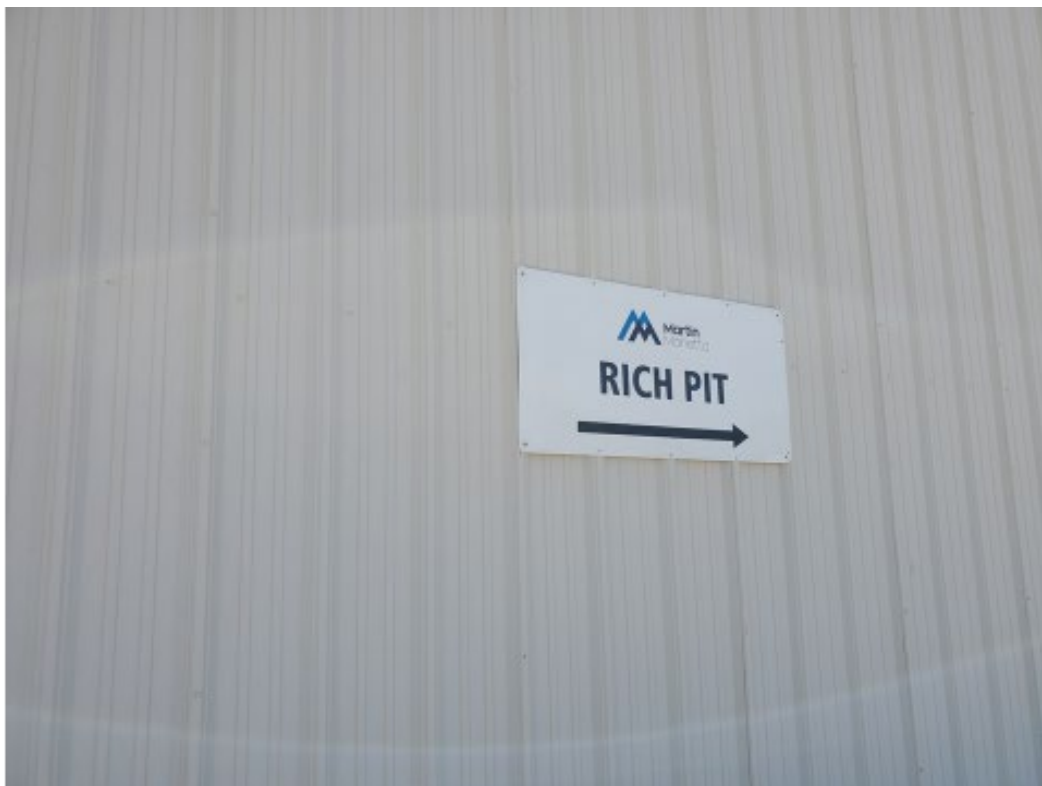
Photo 2: Mine name posted on the building leading to the processing site.

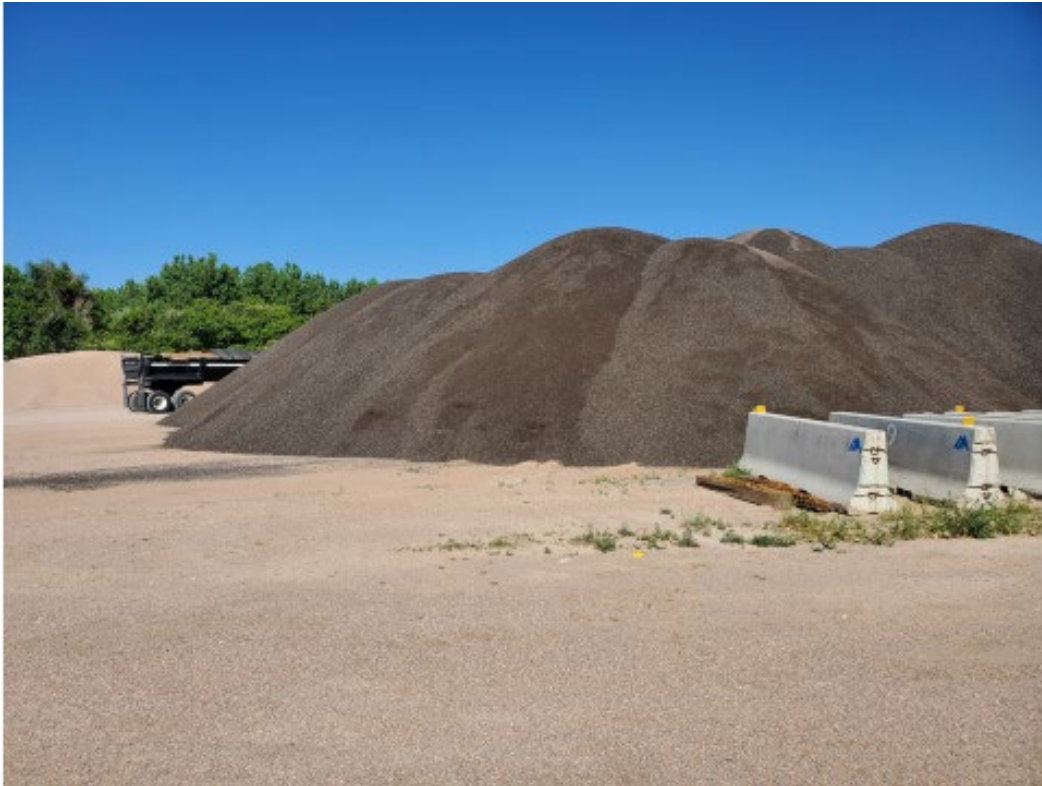
Photo 3: Looking west at a recycled asphalt stockpile. Material was milled off of the highway and stored onsite. The material was scheduled to leave the site after the inspection.

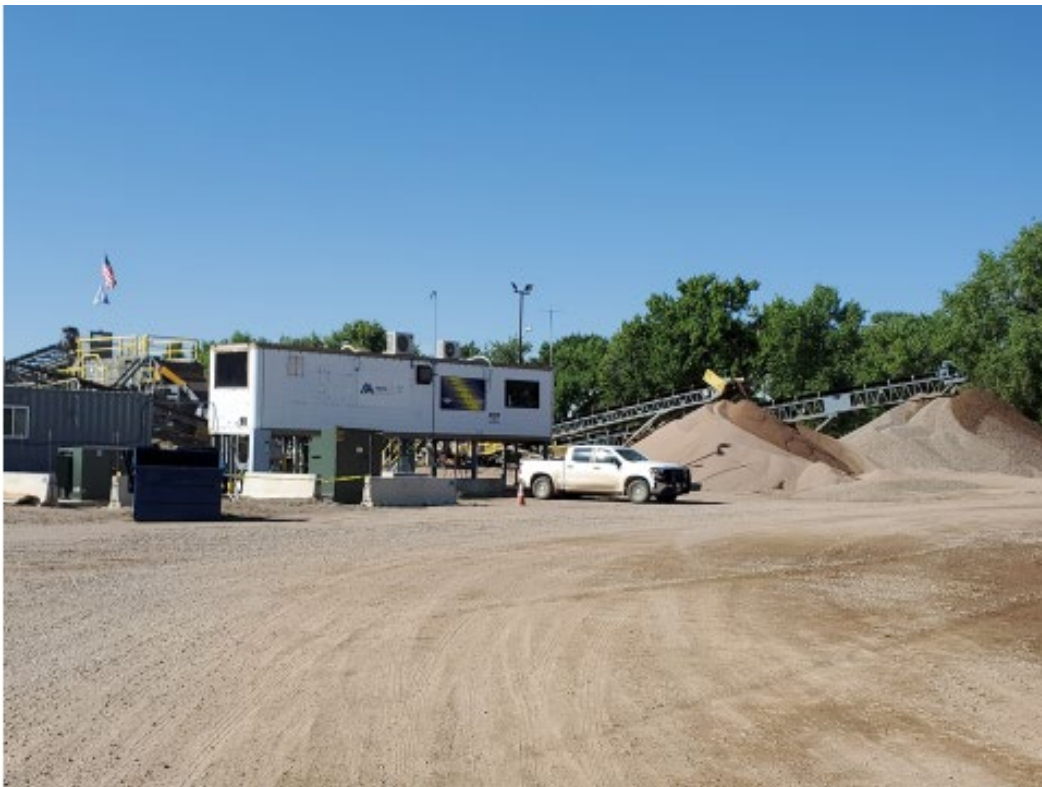
Photo 4: Looking south at the processing equipment and product stockpiles.

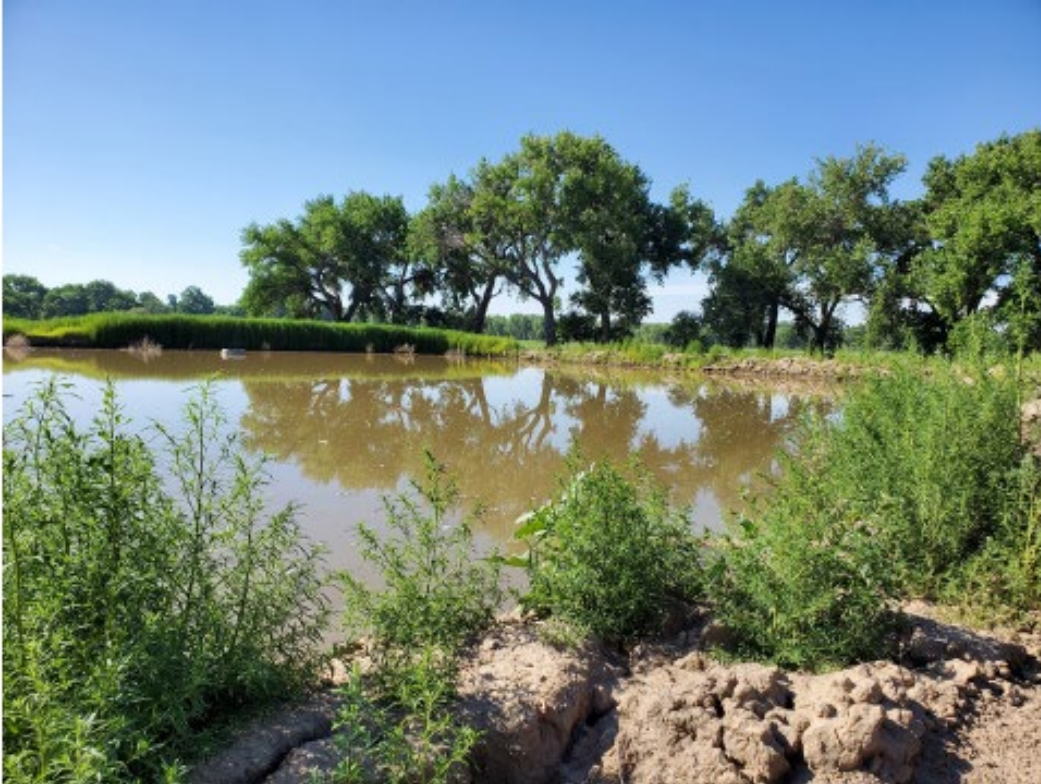
Mining resumed in June 2021. The Operators created freshwater settlement ponds from which water is recycled for use in processing (Photos 5-8; Maps 1-2), and a new actively mined de-watered pit (Photos 19-25; Maps 1-2). The new ponds and Lake #2 are accounted for in the Operator's Supplemental Water Supply Plan (SWSP) with the Division of Water Resources, but the new pit area is not yet included. As of now, the new pit is marked as a "proposed mining area" on the SWSP's map. This has been **cited as a problem** for exposing ground water without a valid well permit, substitute water supply plan, or approved water augmentation plan for the site. The Operator must include the area that has been mined since mining resumed in 2021, in their SWSP permit. Additionally, the Operator must apply for an amendment to their permit to account for this un-approved pit excavation.

Photo 5: Looking south at the middle settling pond.

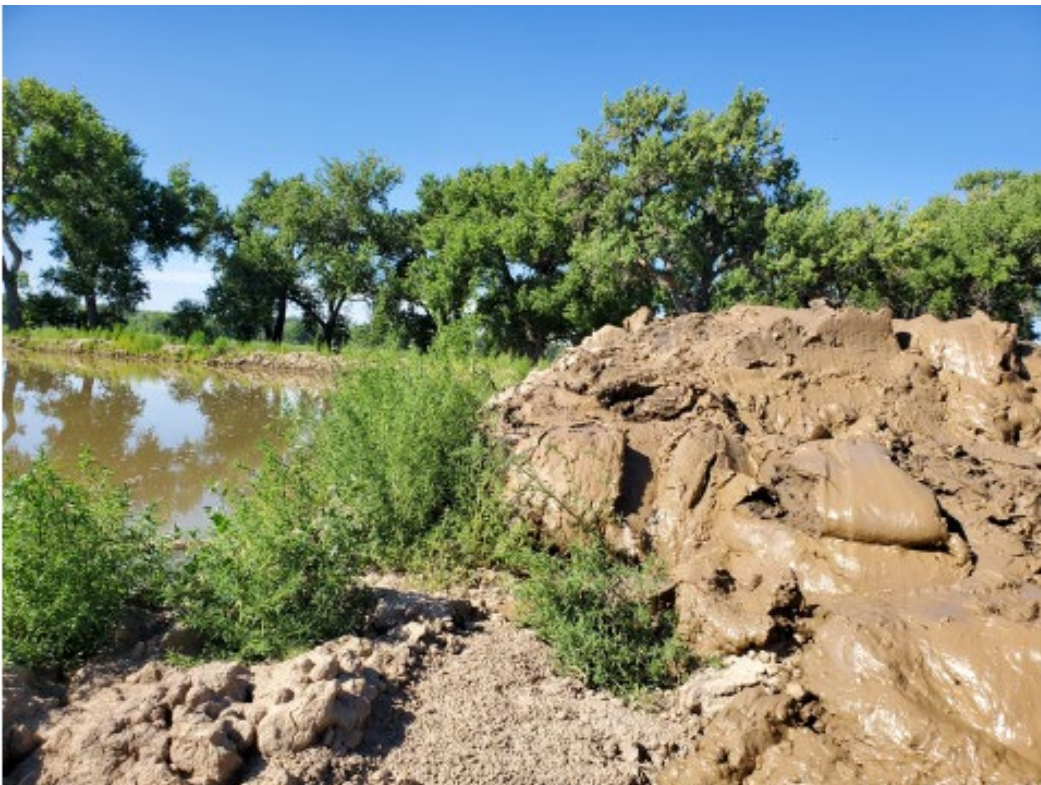
The freshwater ponds constructed onsite are used for recycling purposes during processing. These ponds do not discharge. The mud created as processing waste is routinely removed from the ponds using a long-reach excavator, and placed along the berms (see Photos 6-7). The Operators stated that the ponds were initially eight feet deep from ground level, but the berms have increased the depth of the ponds to about 16 feet deep. The Operator also stated that their plan is to eventually dewater Lake #2, bring the water up to the plant for processing, and in doing so they'll close the northern two recycling ponds. At that time they expect they'll request an increase in their allowed discharge, and are prepared to increase their sampling frequency for their discharge permit. A recently constructed pipeline for the eventual de-watering of Lake #2 was observed during the inspection. The Division reminds the Operator that a revision to the permit is required before these changes can be implemented.

Photo 6: Looking west at the processing waste extracted from the north pond.

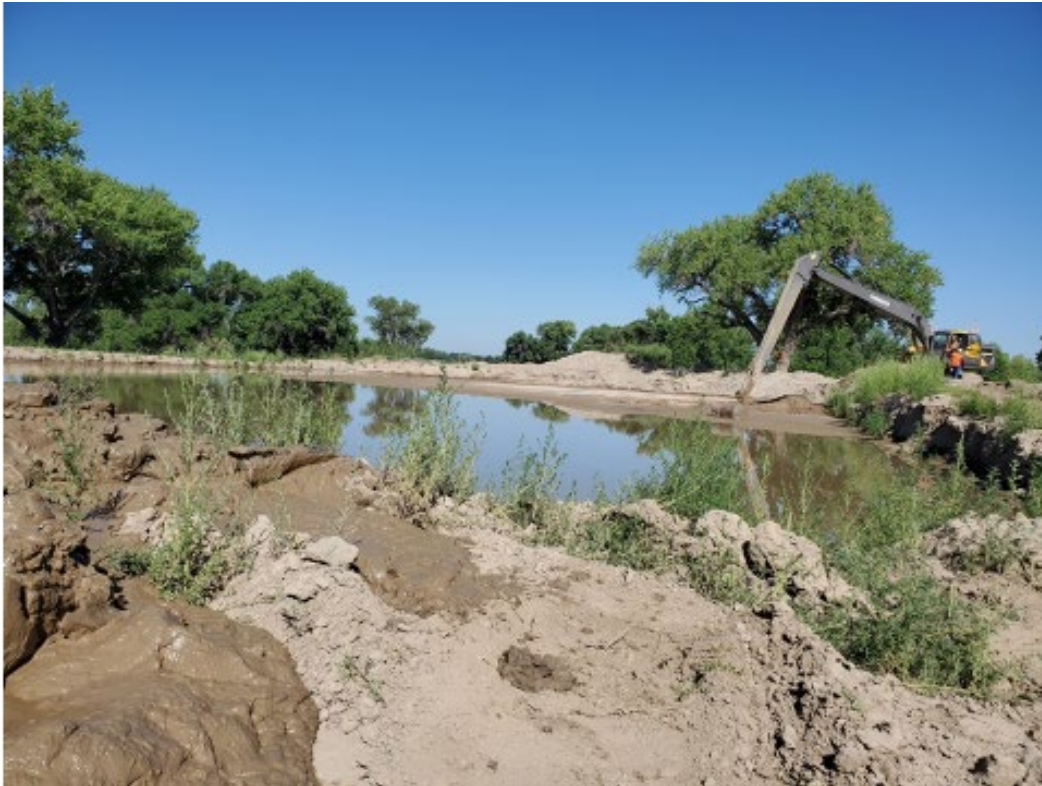
Photo 7: Looking north at the north pond. An excavator is removing the muddy waste and placing it along the berm separating the north and middle pond.

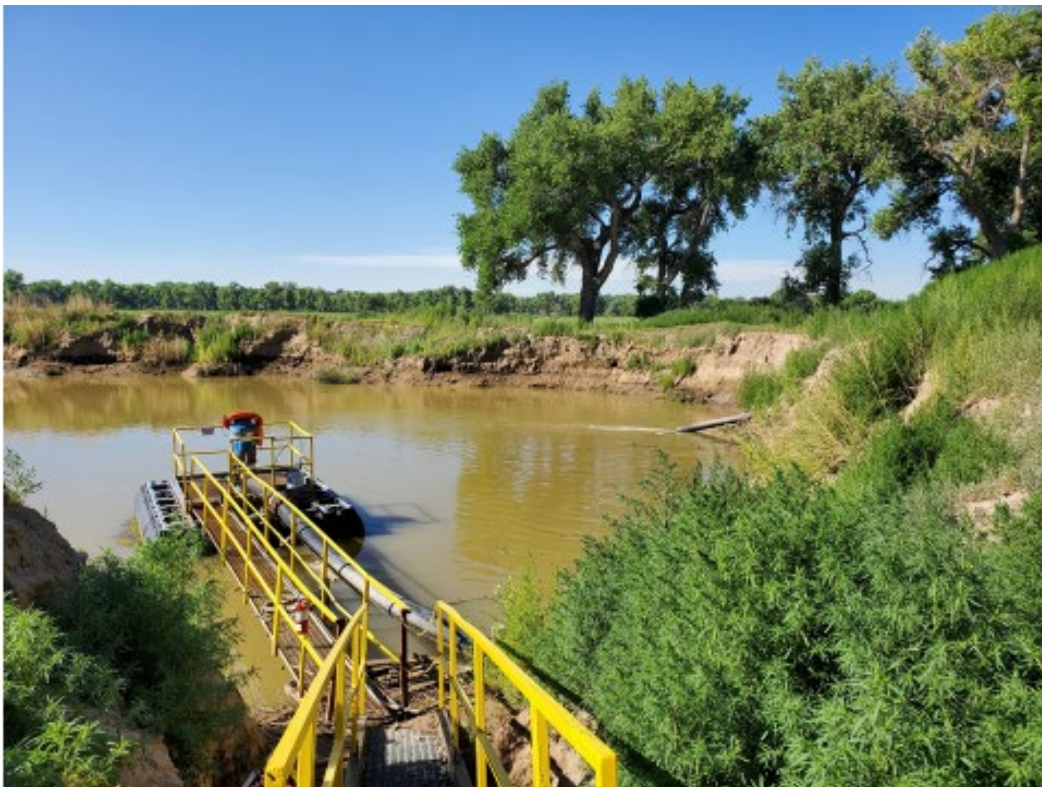
Photo 8: Looking at the southern-most pond.

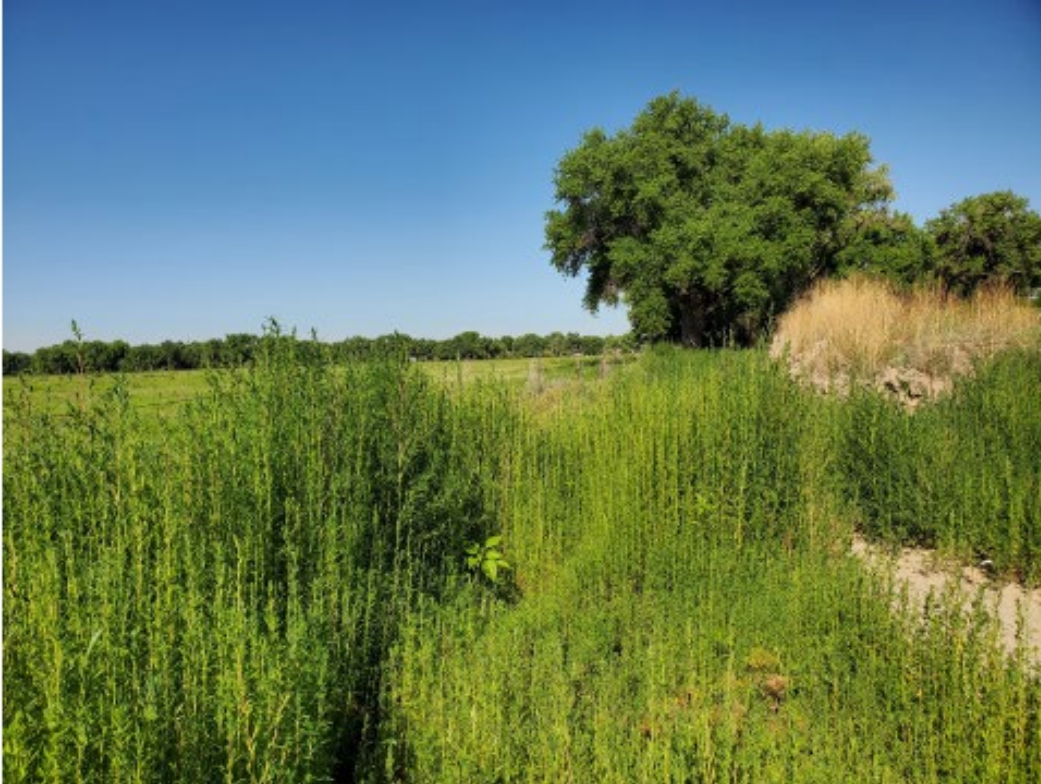
A few boundary markers were observed onsite (Photos 9, 15, 16, and 18; Map 1). Many of the boundaries are

delineated by fencing in the area. The fences do not appear to follow the approved map precisely (Figure 3), however, they do seem to follow land boundaries owned by the Operator.

Photo 9: Looking north-west along the fence line delineating the western boundary.

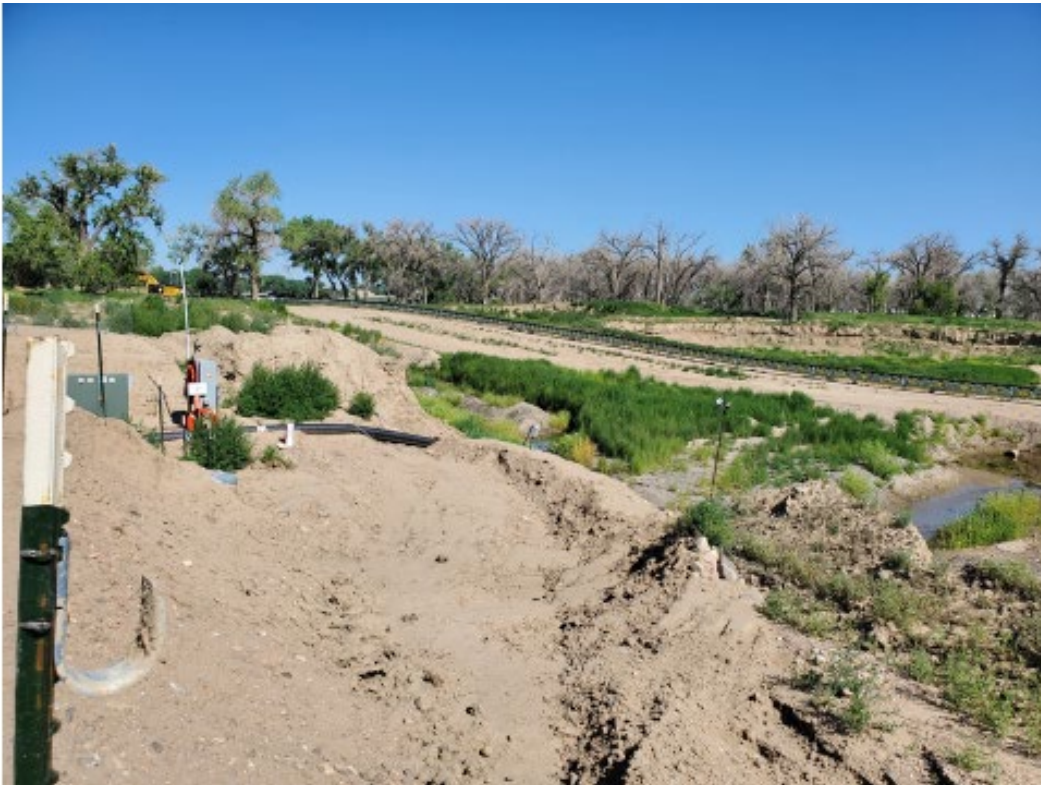
Currently mining is being conducted in 10 acres increments. However, the Division estimates that approximately 29.5 acres have been actively mined since mining resumed in June 2021 in an area that has not been approved to be mined (northern purple polygon on Map 1). AM1 stated that this area was proposed to be affected eventually, but prior to mining, the Operator would submit revisions to update the mining plan to account for new mining disturbance. The Division believes the Operator to be in **violation** for failure to comply with the approved mine plan. The Operator will be brought before the Mined Land and Reclamation Board for a hearing pursuant to Rules 3.3.2.

Photo 10: Standing on the eastern edge of Lake #2, looking north-east at the northern edge of the current active mining pit.

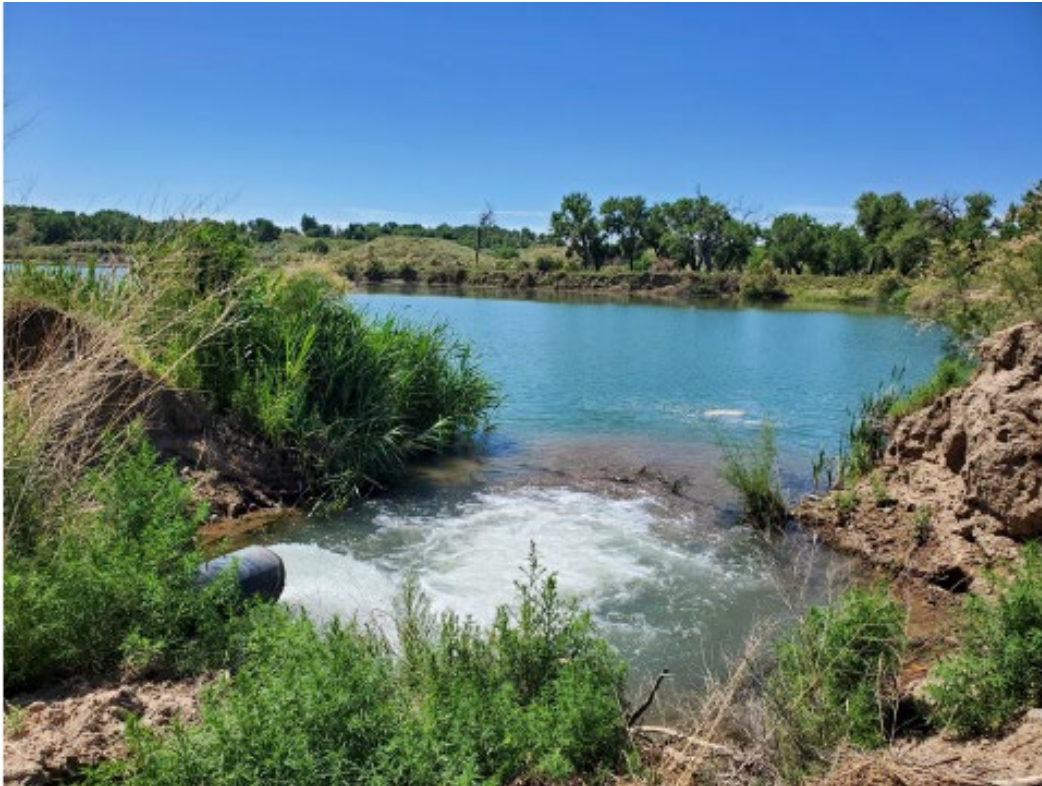
PROBLEM: The Division has no evidence that the Operator has a valid well permit, substitute water supply plan, or approved water augmentation plan for the exposed groundwater in a new pit being excavated at the site. This is a problem related to 34-32.5-116(4)(h) of the Colorado Revised Statutes and 3.1.6(1)(a) of the Construction Materials Rules and Regulations governing injury to existing water rights.

Photo 11: Looking west from the eastern border of Lake #2 at the dewatered pit outlet.

CORRECTIVE ACTIONS: The Operator shall demonstrate that the operation is in compliance with the Office of the State Engineer, show evidence that the operator is taking measures to bring the site into compliance with the SEO, or backfill the pits to at least two feet above the groundwater surface by the corrective action date specified.

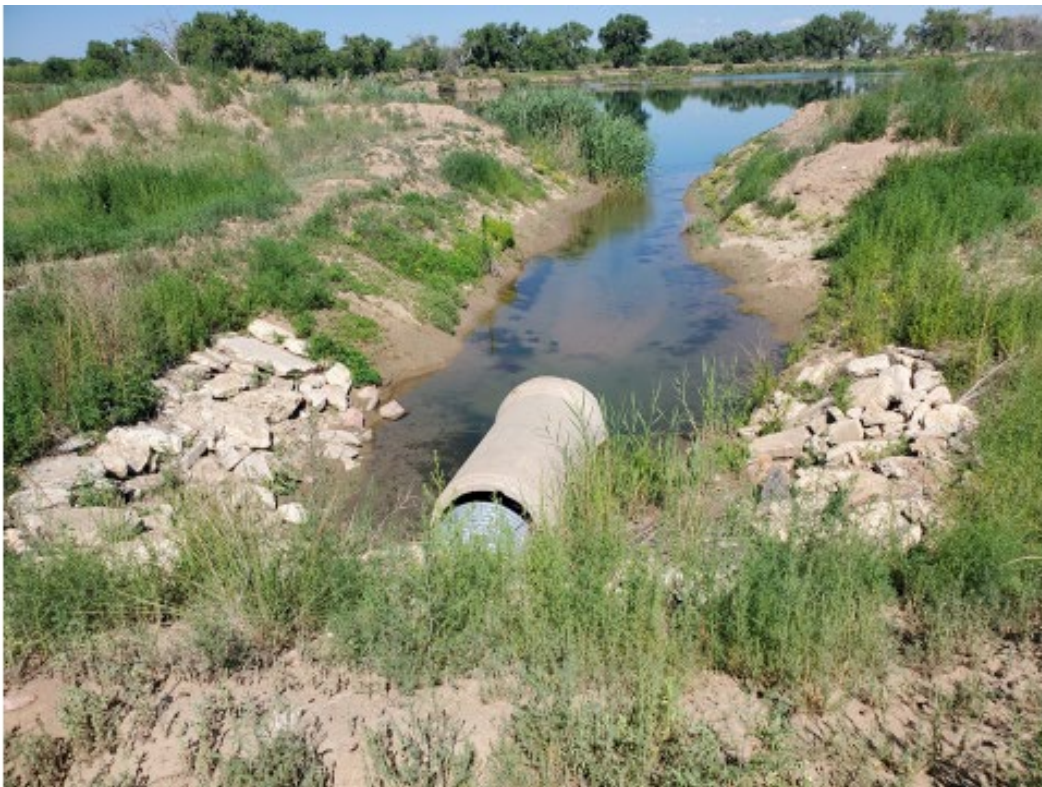
Photo 12: Looking north-east at the discharge inlet at Lake #2.

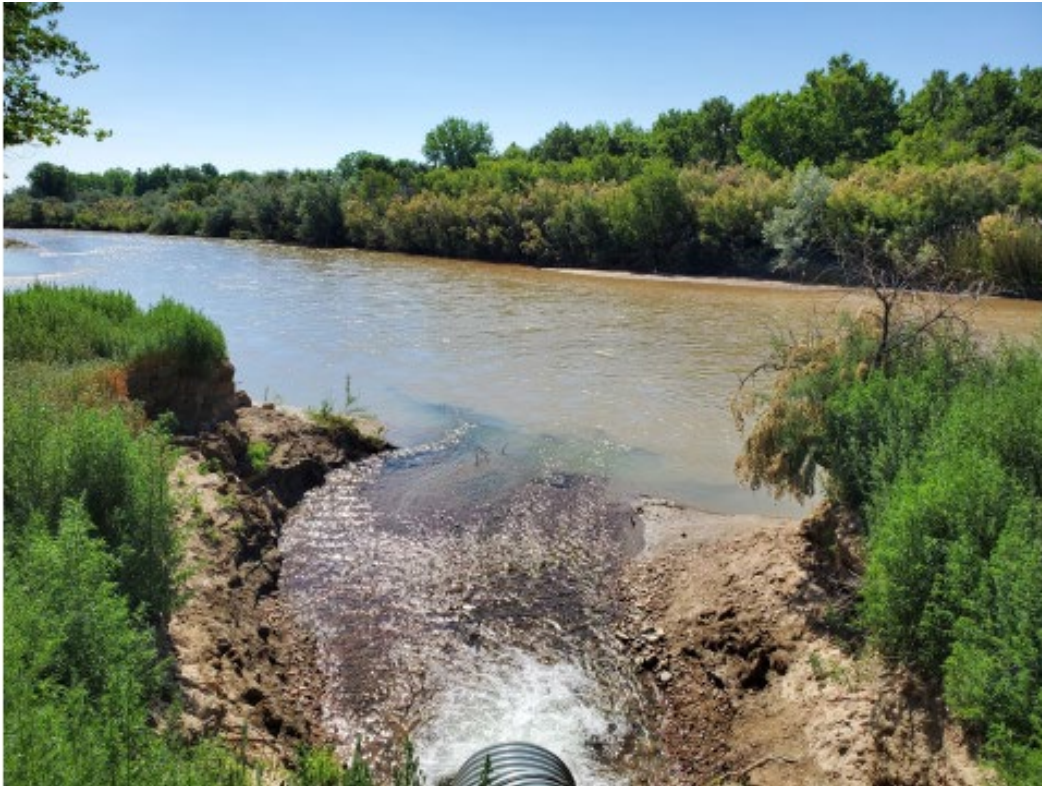
Photo 13: Looking west at the discharge point for Lake #2 into the Arkansas River.

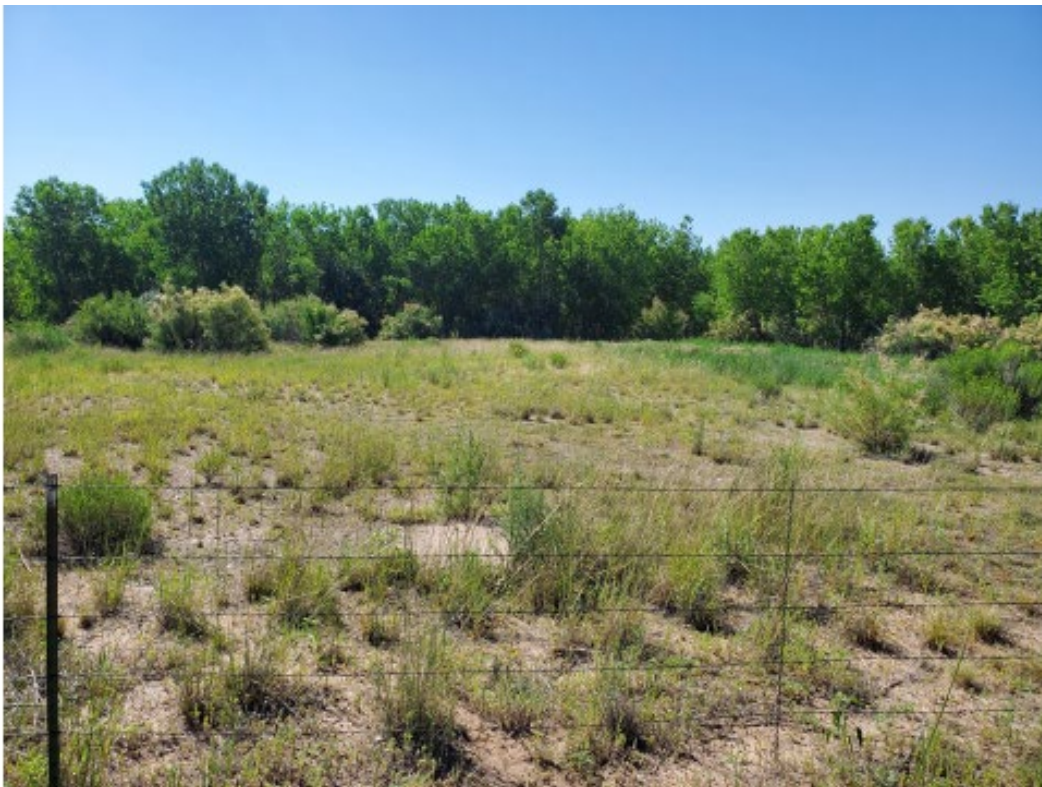
When the Arkansas River re-aligned in the late 1990s, the area proposed to remain as Lake #1 was washed out, and has since self-reclaimed with a variety of grasses and trees (Photo 14; Map 1; Figure 1). This area remains within the permit boundary, however the October 2004 SWSP deemed this area to no longer be contributing to stream depletions. No other areas on site have been reclaimed or revegetated at this time.

Photo 14: Looking west into the area that was proposed to be reclaimed as Lake #1. Fence is a remnant of an old grazing area agreement.

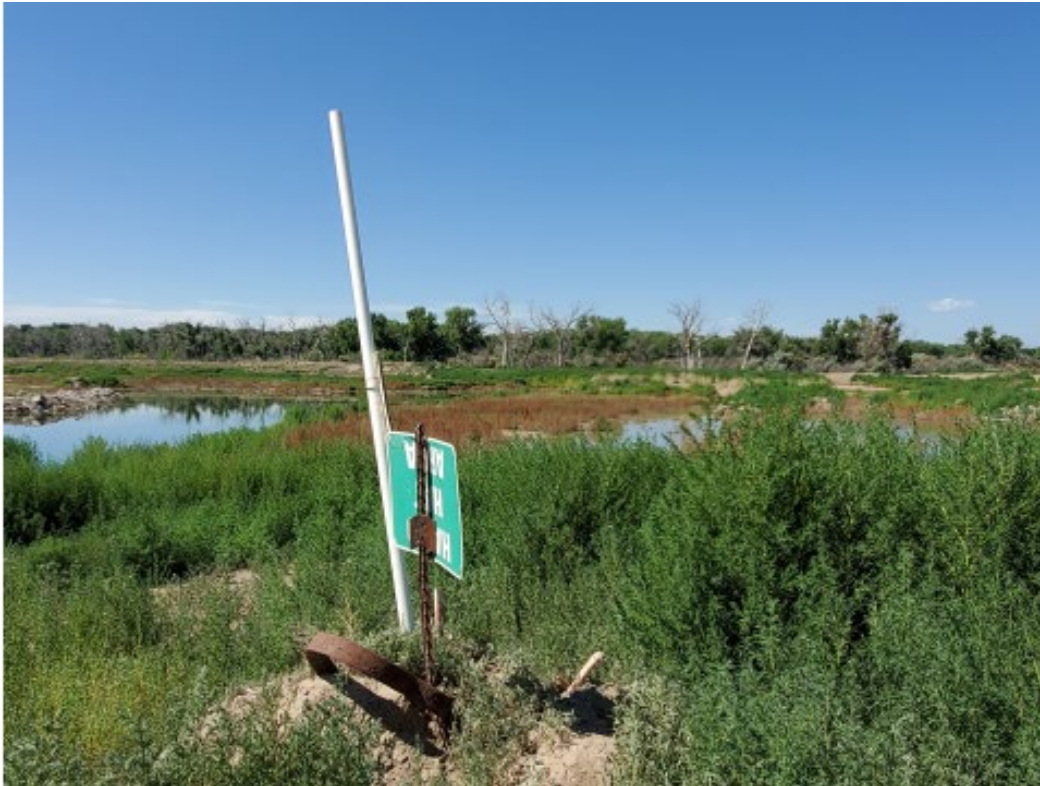
Photo 15: Looking west at a boundary marker marking the north-eastern most corner of the permit boundary.

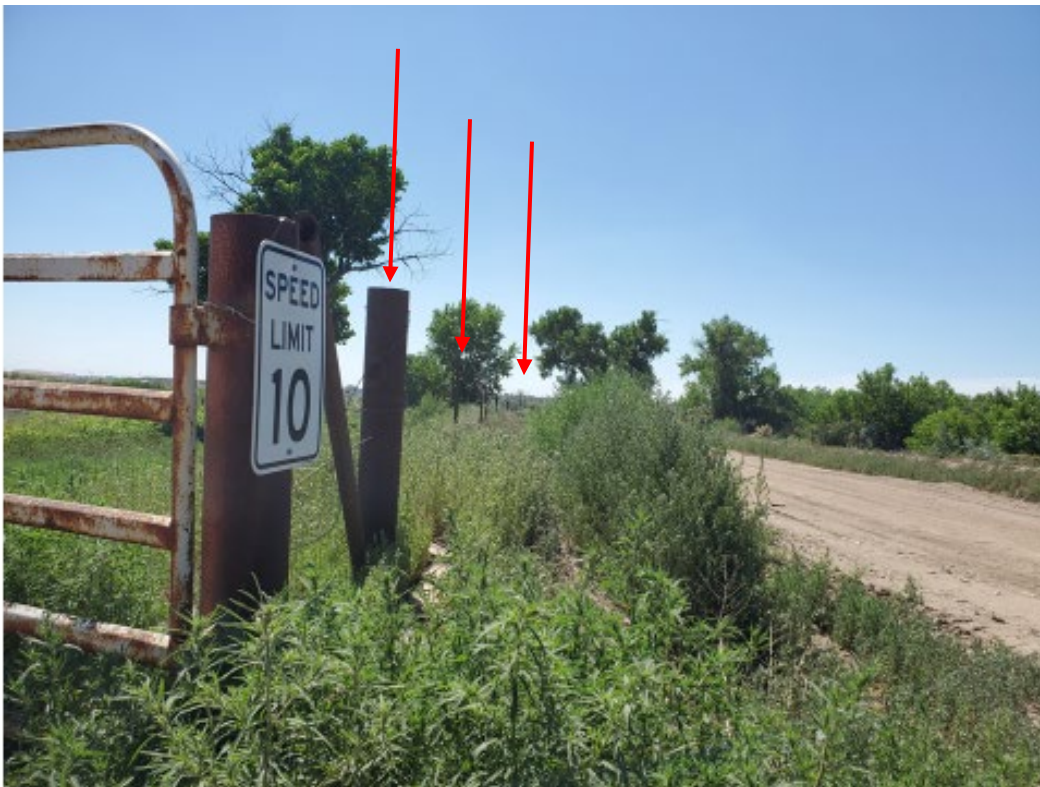
Photo 16: Looking south along a fence line recognized as the east northern boundary.

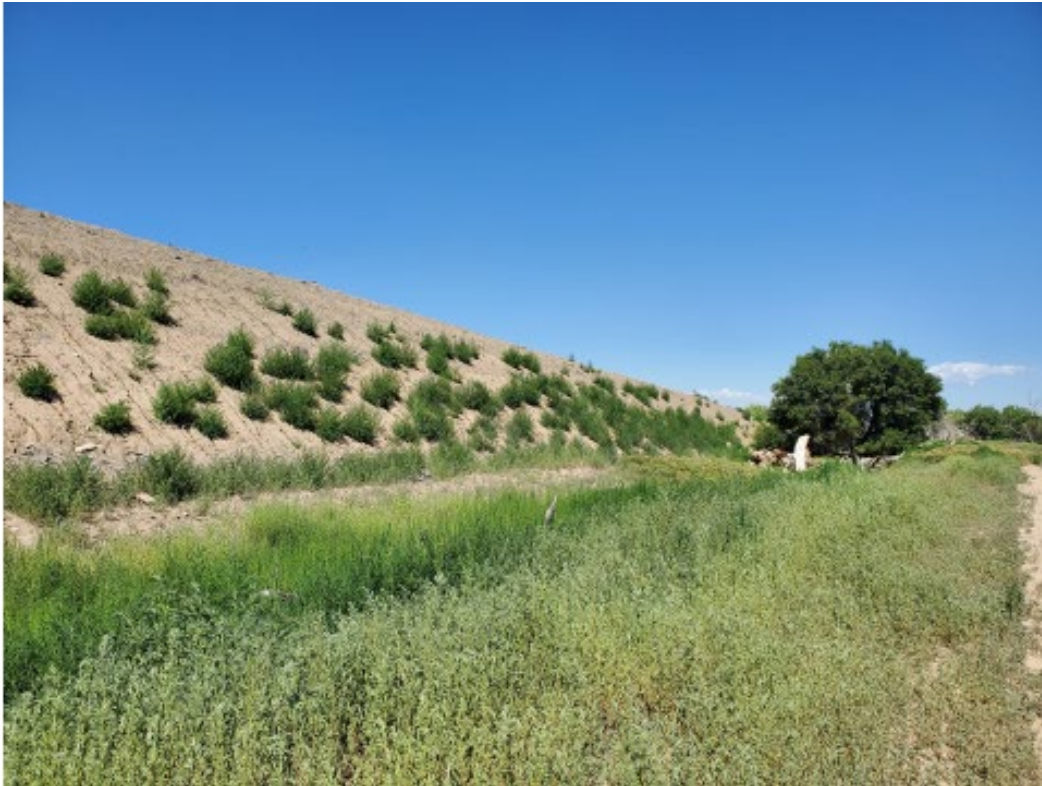
A topsoil pile was observed onsite (Photo 17; Map 1). The topsoil pile appears relatively stable with some vegetation growing on it. However, some rills have formed due to the high precipitation in the area. If the pile is to remain unused in reclamation for greater than 180 days, the Operators must address the erosion or ensure that the pile is stabilized by creating a vegetative cover using the approved seed mix in accordance with Rule 3.1.9(1).

Photo 17: Looking north at the stockpile located to the west.

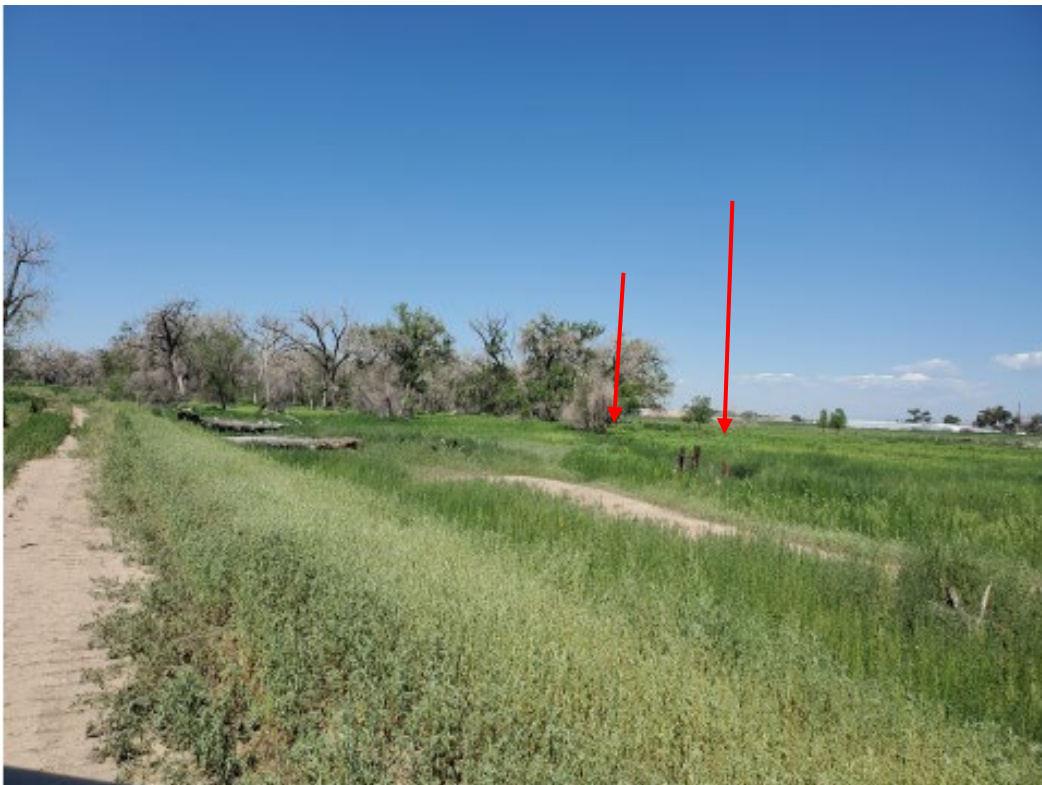
Photo 18: Looking north at a fence treated as the boundary.

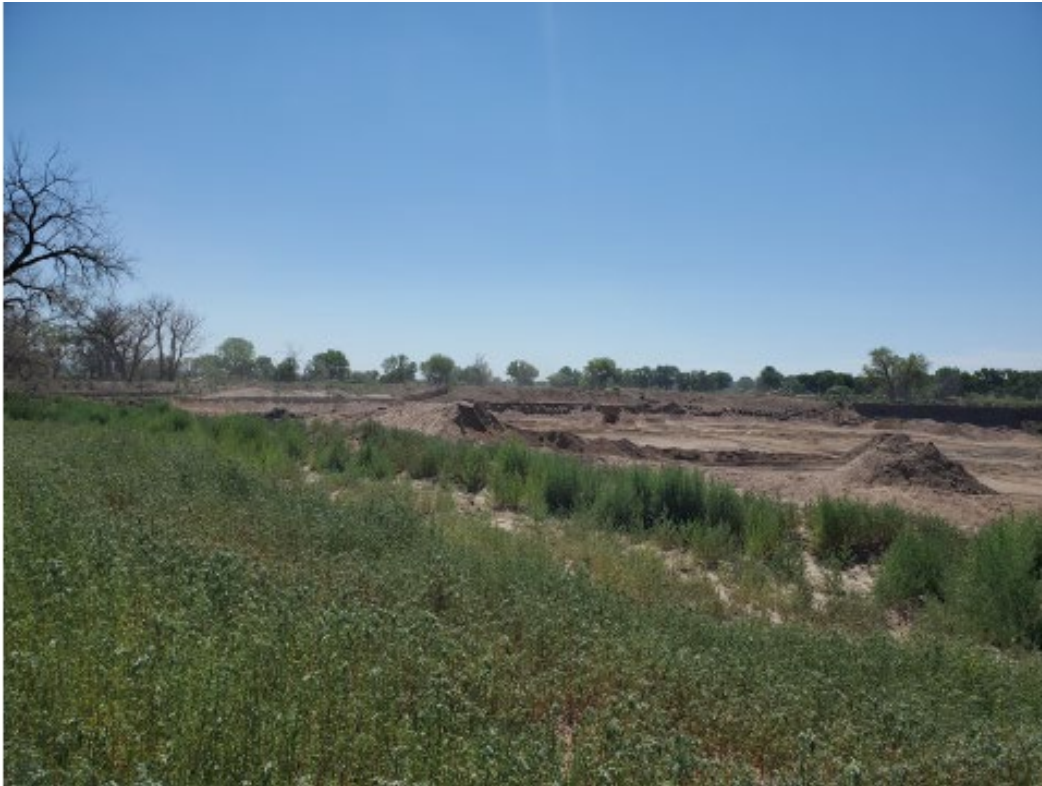
POSSIBLE VIOLATION: The Operator has failed to comply with the conditions of an order, permit, or regulation pursuant to C.R.S. 34-32.5-124. Specifically, the Operator has failed to comply with the mining plan approved in the permit by excavating a new pit in an area not previously approved for excavation. Therefore, the reclamation plan does not account for this new excavation.

Photo 19: Looking across the active pit at its at the south border.

CORRECTIVE ACTIONS: This possible violation will require a hearing before the Mined Land Reclamation Board. The schedule and other details for the MLRB hearing will be provided under a separate document to be sent via certified mail to the Operator.

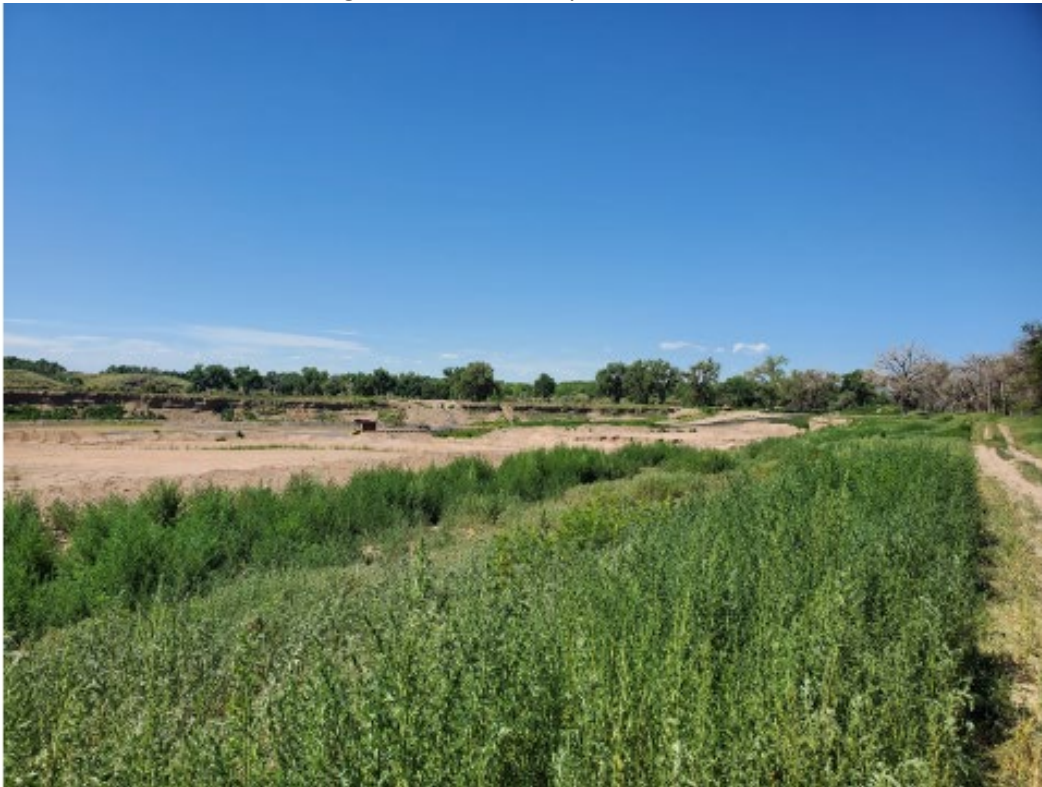
Photo 20: Looking across the pit at the pit's northern border.

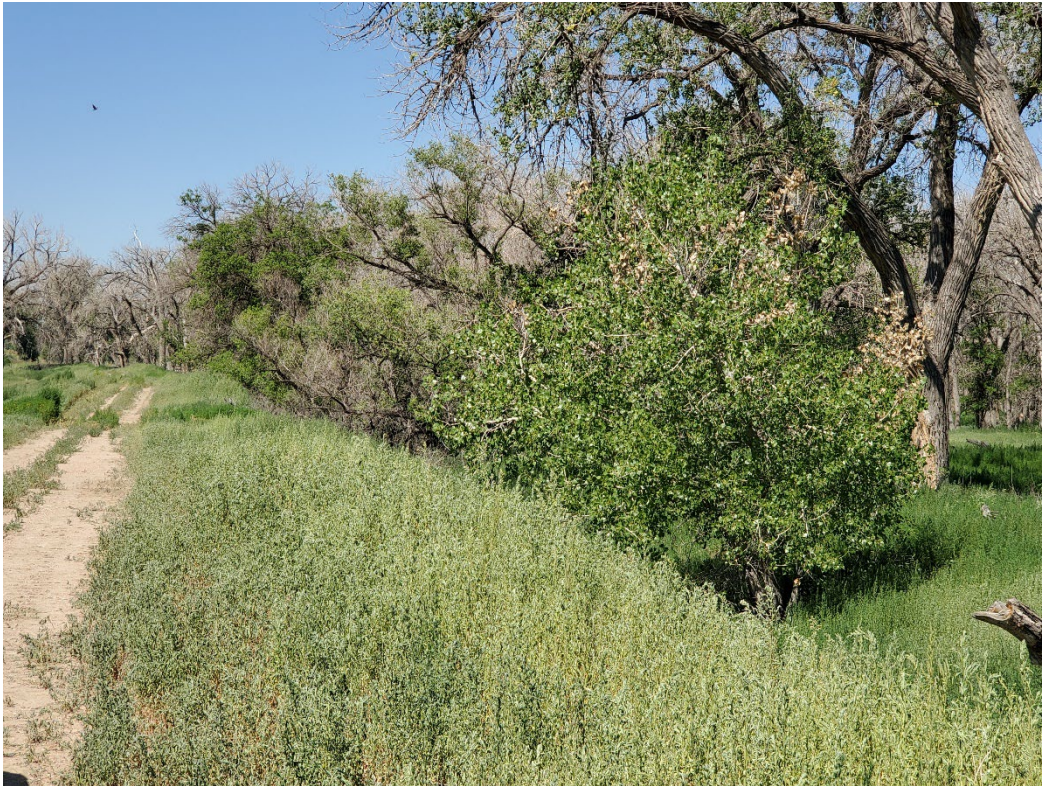
Photo 21: Looking north-east at the trees lining the access road north of the pit. Trees have been dying since dewatering has taken place.

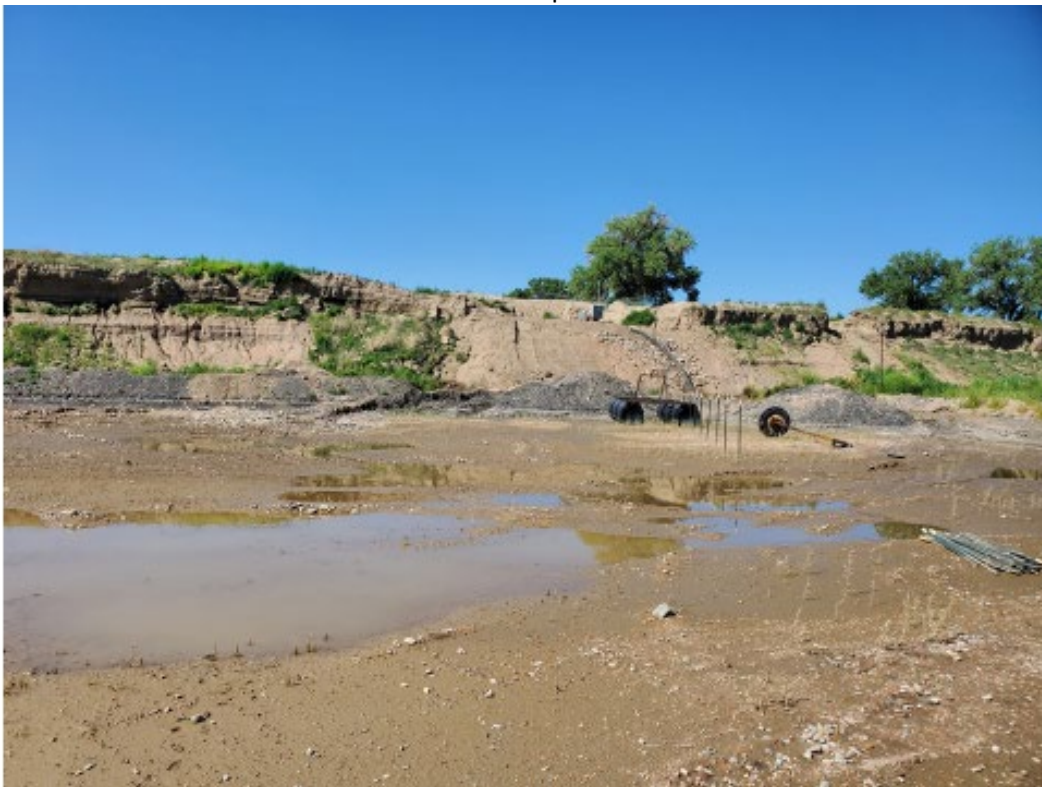
Photo 22: Standing within the pit, looking at the western pit wall.

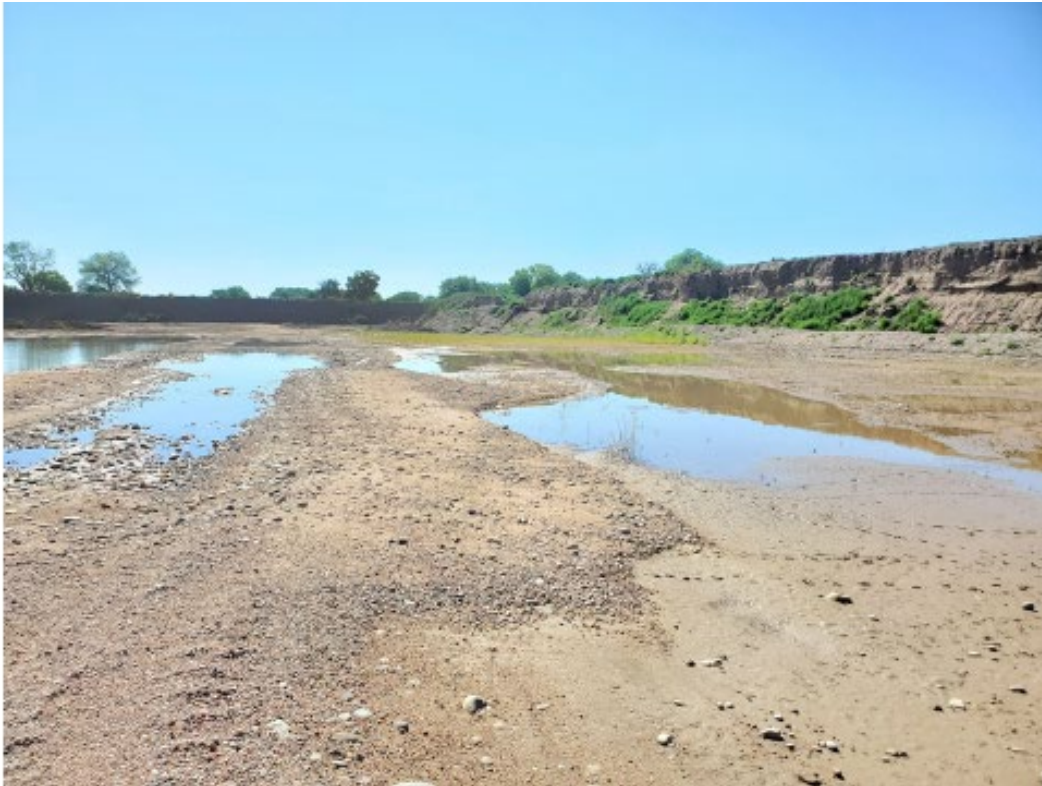
Photo 23: Standing in the pit, looking south at the intersection of the south and west borders. Drill logs provided by the Operator indicate the maximum depth of the pit to be 35 feet.

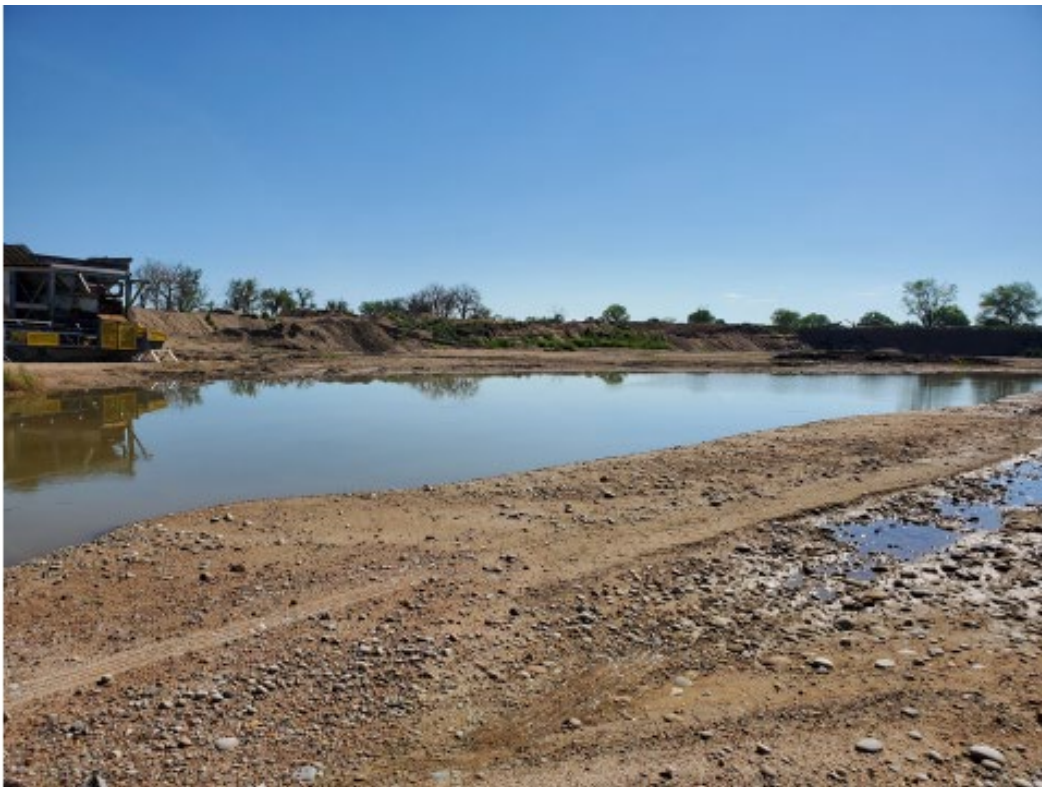
Photo 24: Standing in the pit, looking at the northern wall. Some standing water present in the pit.

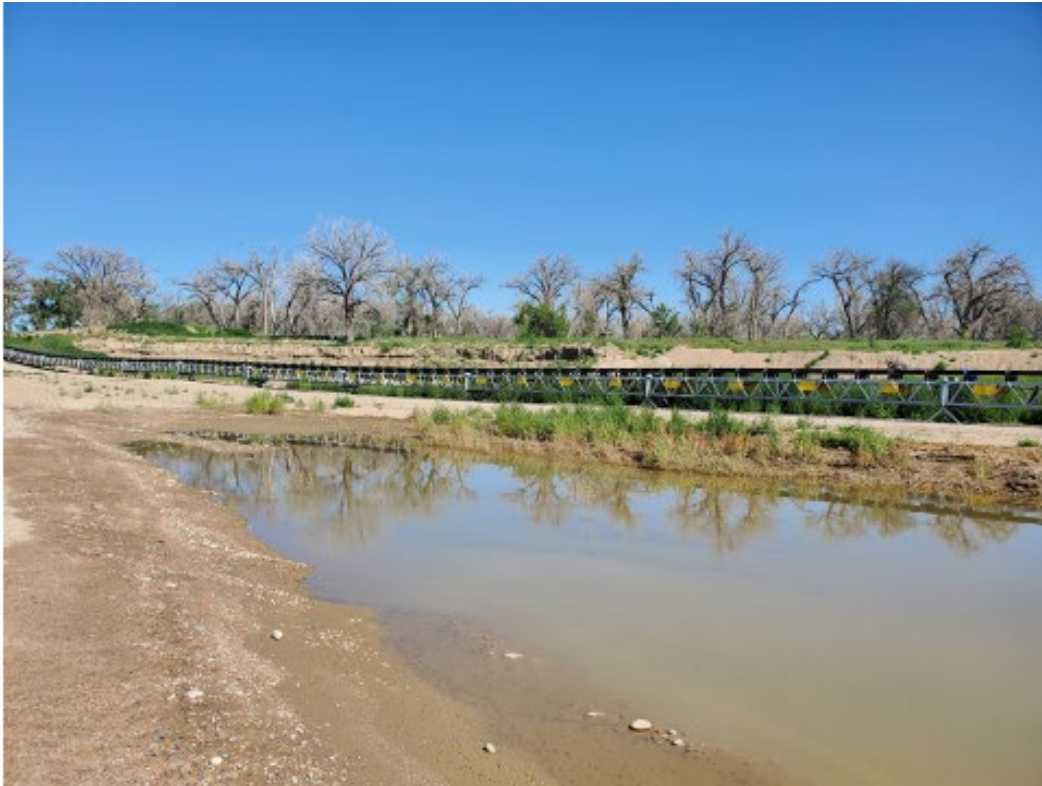
Photo 25: Standing in the pit, looking north-east at the conveyor belt being installed.
