MINERALS PROGRAM INSPECTION REPORT
PHONE: (303) 866-3567

MINE NAME: Rich Pit	MINE/PROSPECTING ID#: M-1985-218	MINERAL: Sand and gravel	COUNTY: Pueblo
INSPECTION TYPE: Monitoring	WEATHER: Clear	INSP. DATE: July 13, 2023	INSP. TIME: 08:30
OPERATOR: Martin Marietta Materials, Inc.	OPERATOR REPRESENTATIVE: Phillip Courtney and Rusty Cochran	TYPE OF OPERATION: 112c - Construction Regular Operation	
REASON FOR INSPECTION: Normal I&E Program	BOND CALCULATION TYPE: Complete Bond	BOND AMOUNT: \$344,500.00	
DATE OF COMPLAINT: NA	POST INSP. CONTACTS: None	JOINT INSP. AGENCY: None	
INSPECTOR(S): Amber Michels	INSPECTOR'S SIGNATURE:

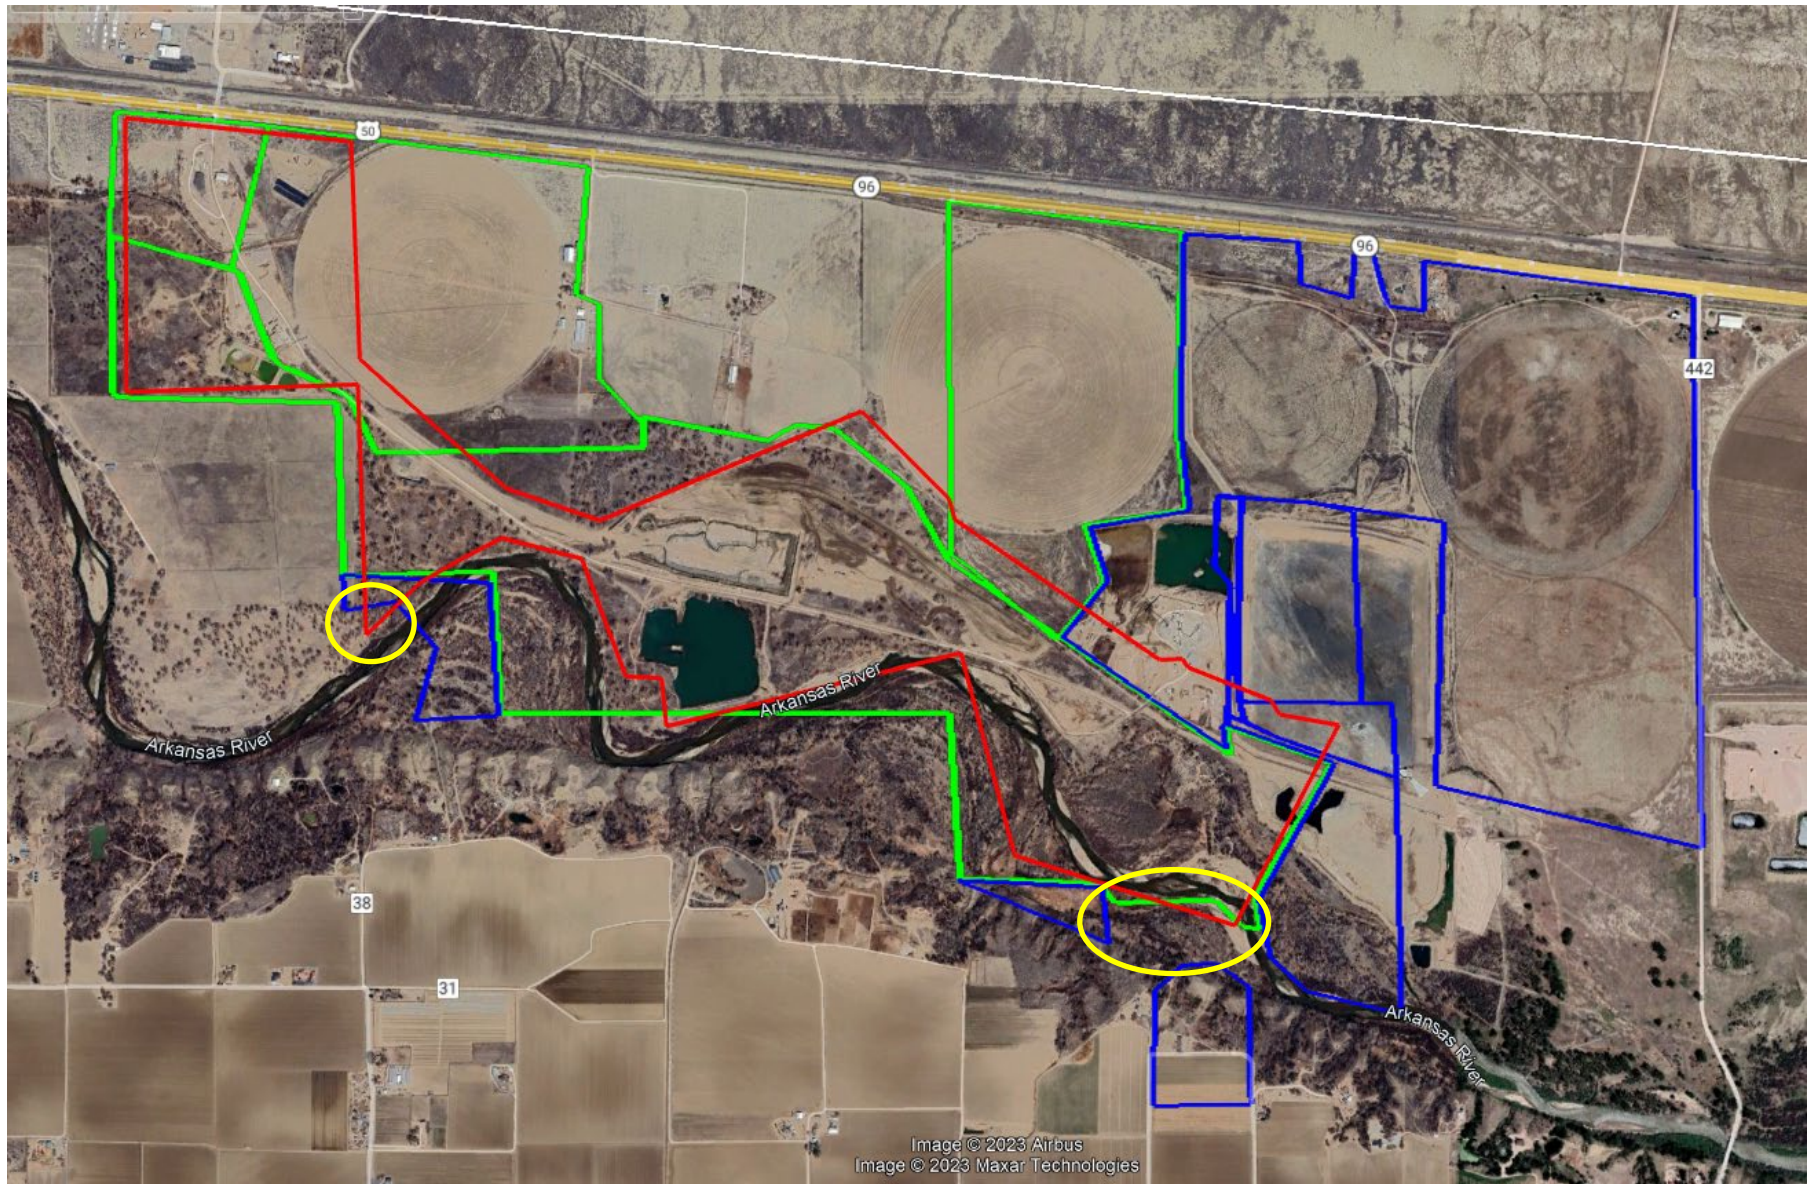
delineated by fencing in the area. The fences do not appear to follow the approved map precisely (Figure 3), however, they do seem to follow land boundaries owned by the Operator.

Figure 3: An extrapolation of the approved permit boundary into Google Earth using Google Earth Pro. The red polygon represents the approximate approved permit boundary. The green polygon represents the parcels owned by the Operator according the County Assessor site. The blue polygons represent parcels that the boundary appears to cross that are not owned by the operator. The areas circled in yellow indicate where the permit boundary crosses areas with no ownership information provided on the Pueblo County Assessor's site.
