MINERALS PROGRAM INSPECTION REPORT
PHONE: (303) 866-3567

MINE NAME: Stone City Mine	MINE/PROSPECTING ID#: M-1990-143	MINERAL: Clay (general)	COUNTY: Pueblo
INSPECTION TYPE: Monitoring	WEATHER: Clear	INSP. DATE: July 21, 2023	INSP. TIME: 08:30
OPERATOR: General Shale Brick, Inc.	OPERATOR REPRESENTATIVE: Jason McGraw	TYPE OF OPERATION: 110c - Construction Limited Impact	
REASON FOR INSPECTION: Normal I&E Program	BOND CALCULATION TYPE:	BOND AMOUNT: \$5,000.00	
DATE OF COMPLAINT: NA	POST INSP. CONTACTS: None	JOINT INSP. AGENCY: None	
INSPECTOR(S): Amber Michels	INSPECTOR'S SIGNATURE:

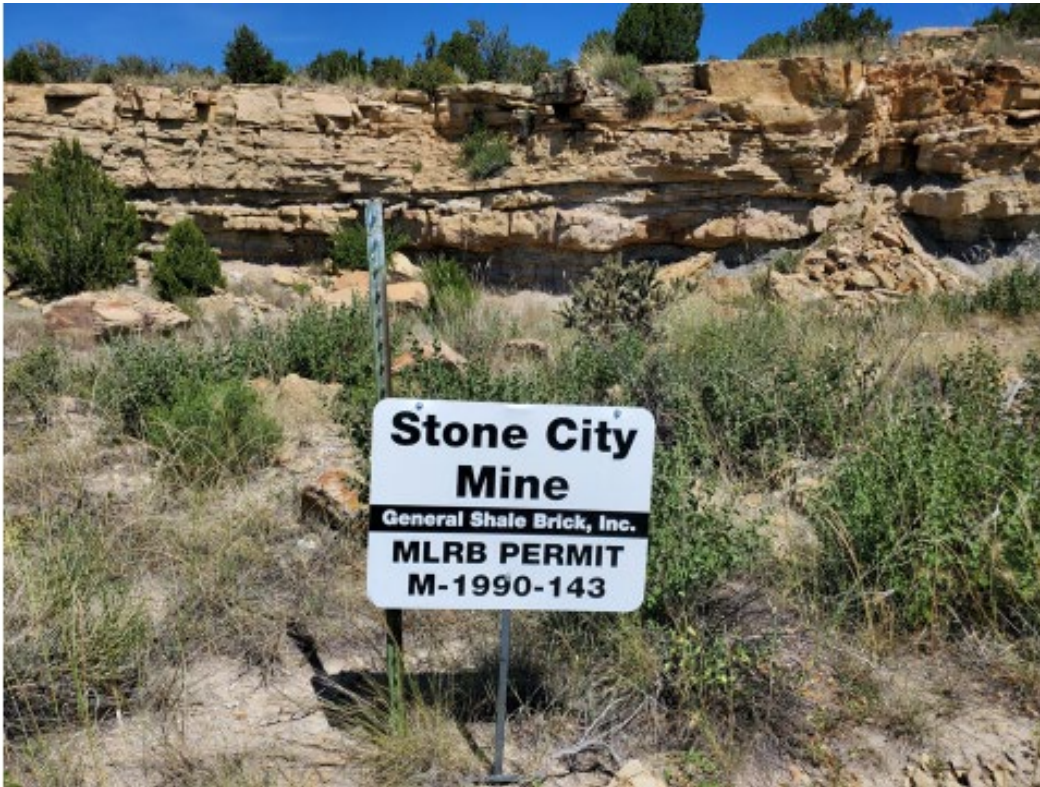
Photo 1: Looking west at mine sign and permit boundary marker.

A mine sign posted in compliance with Rule 3.1.12(1) was posted near the entrance to the site (Photo 1: Map 1). A few boundary markers were observed onsite as well (Photos 1, 4, and 7; Map 1). The boundary markers installed more accurately reflect the boundary where historically mining abuts the permitted site within the permit boundaries (see Maps 1 and 2). The Division's December 8, 1999 inspection indicates that these markers were placed here to be out of the way of military maneuvers throughout the area. The markers appear to encompass the outcrop that is to be mined.

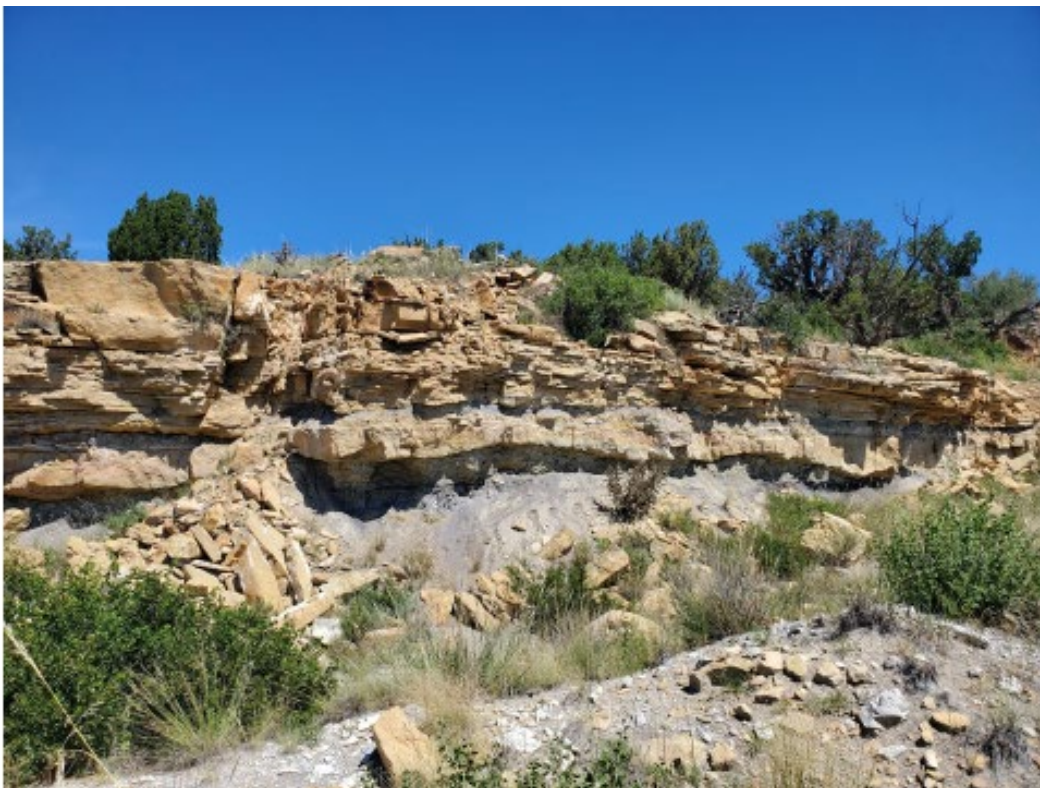
Photo 2: Looking west at minor mining disturbance along the eastern boundary of the permit.

Mining at this site consists of breaking up an 18 foot or less lens of sandstone caprock to reach a variety of clay layers (Photos 2 and 8; Map 1). The clays salvaged on site are categorized as flint, bone, and plastic clays. The dimensions of the clay lenses vary, and not all lenses are present throughout the entire site. Much of the flint clay was mined out in the south portion of the site via underground pre-law historic mining (Photos 5, 6, and 9; Maps 1 and 2), and plastic clays were left as waste (Photo 10; Map 1). The Operator intends to salvage the plastic clay piles once mining resumes. When the site was being actively mined by the previous Permittee, the overburden was broken up, clay was salvaged, and hauled off-site.

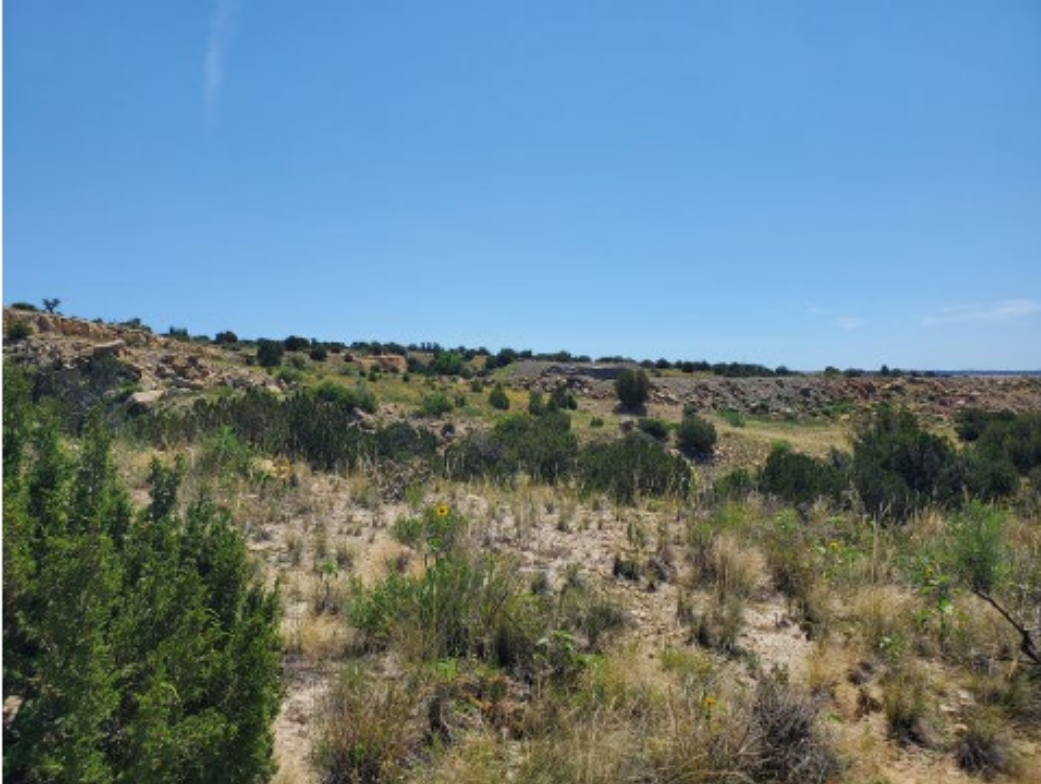
Photo 3: Standing at the permit sign, looking East at the adjacent Tomahawk Mine (M-1991-003).

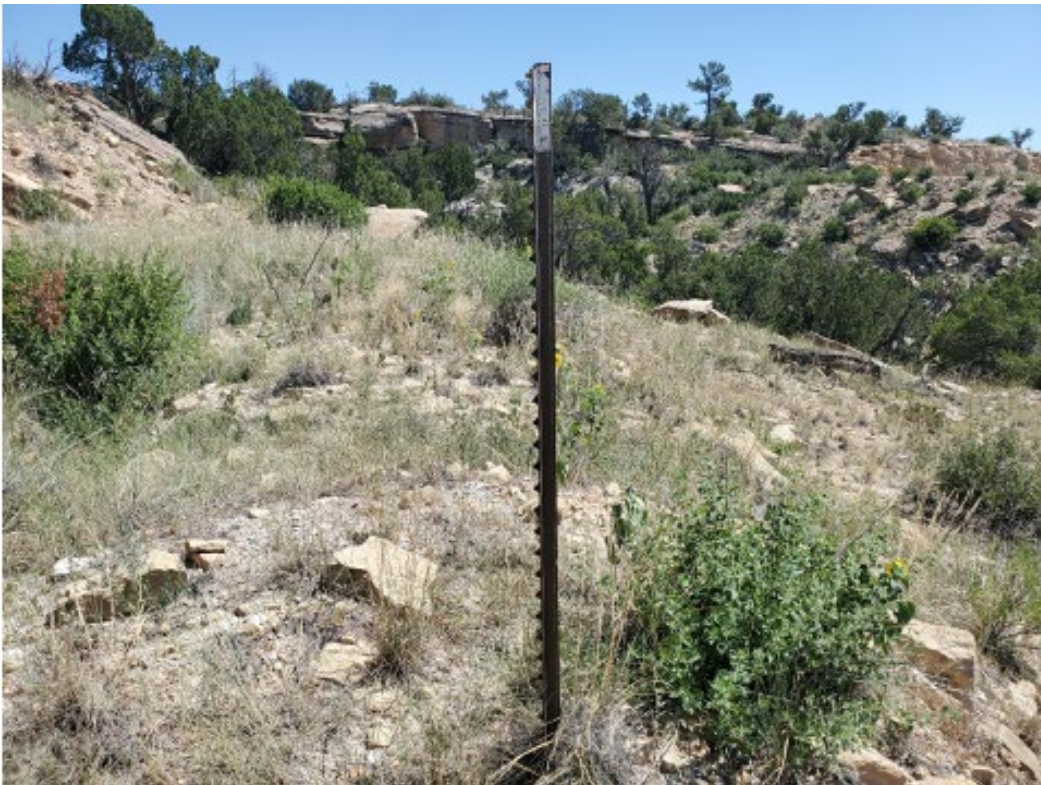
Photo 4: Looking north at a permit boundary marker.

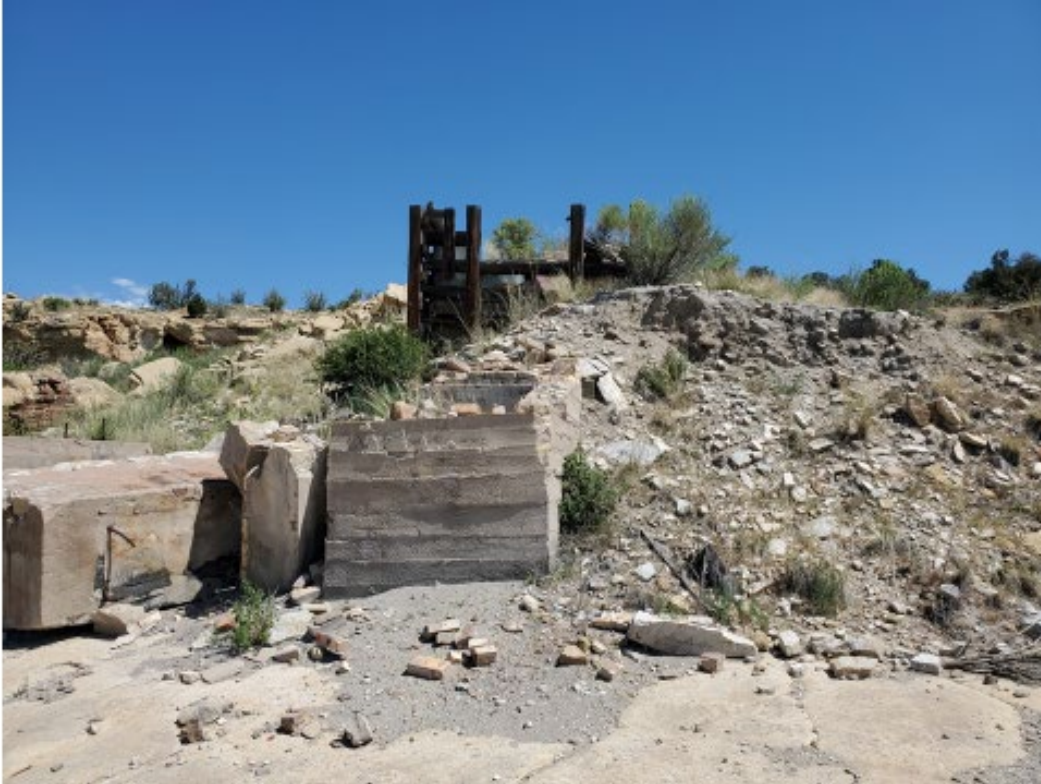
Photo 5: Looking north at some historic mining disturbance located to the south of the Stone City permit boundary.

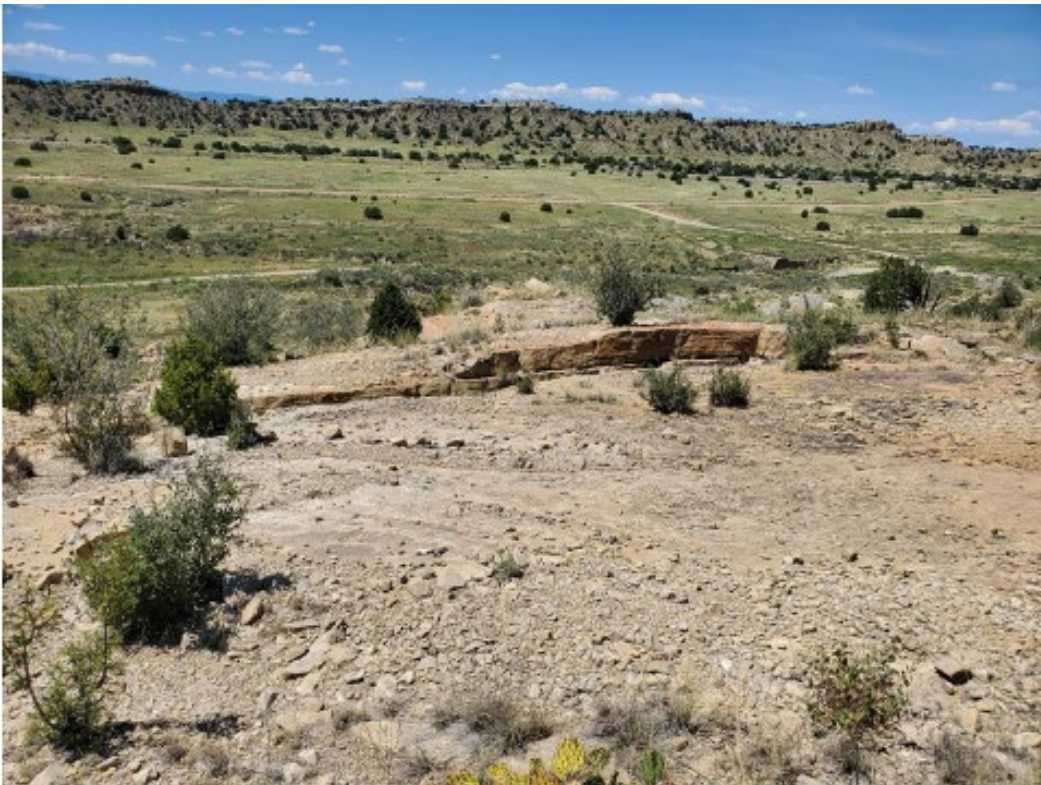
Photo 6: Standing on-top of an outcrop within the permit boundary, looking south at old mining disturbance from historic underground mines in the area.

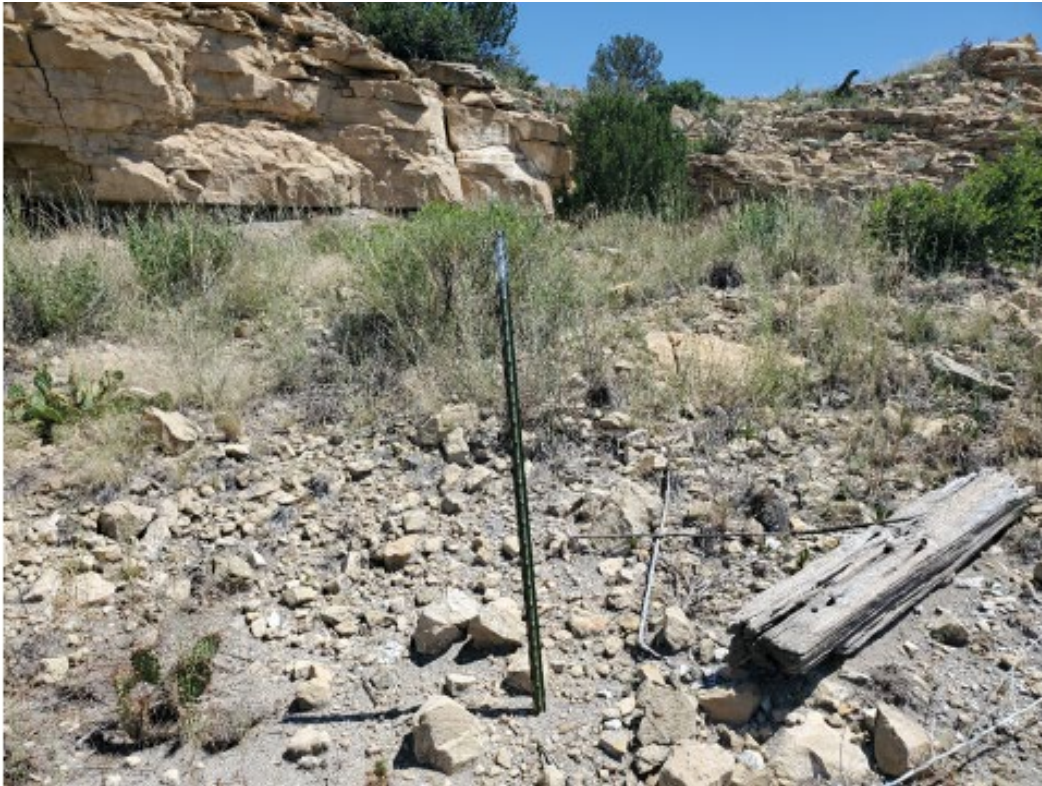
Photo 7: Looking north at a boundary marker.

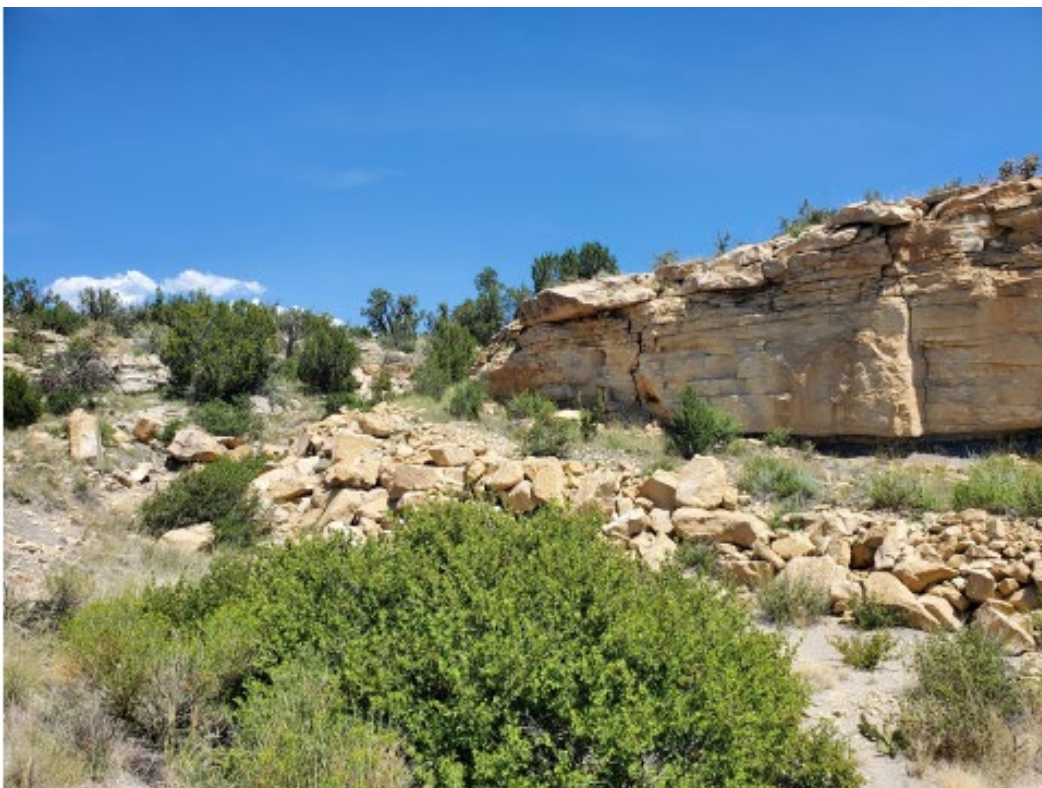
Photo 8: Looking north along the mine's southern boundary. Rubble stockpiles remain from historic mining.

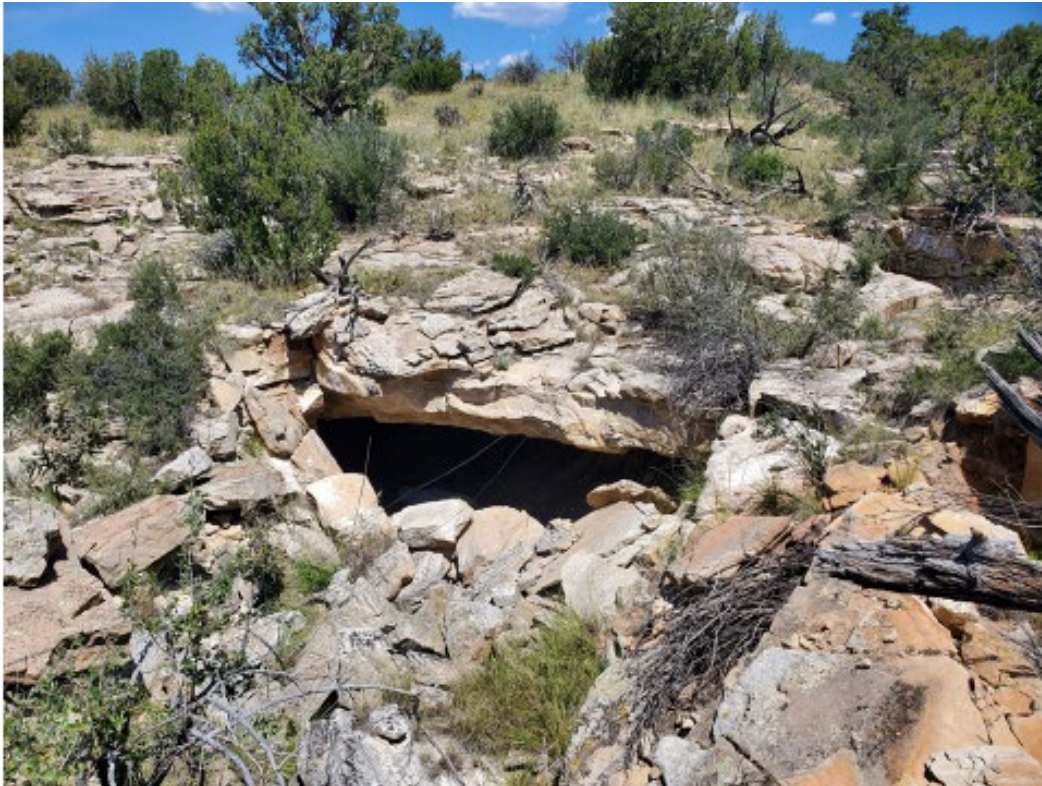
Photo 9: Looking north from on top of the outcrop at a cave left from historic underground mining.

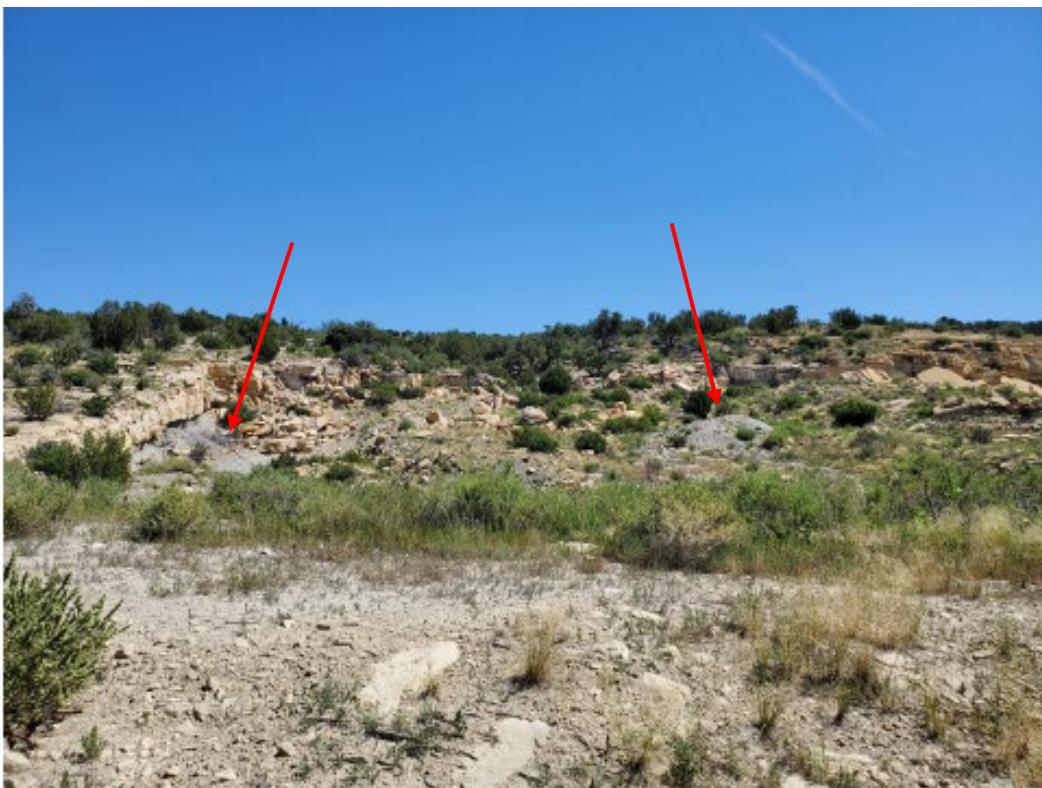
Photo 10: Looking north at the south-western border of the permit. Some gray clay material discarded by historic mining will be salvaged by the Operator when mining resumes.
