Kirtright CT-1 Response Letter

Re: Response to Citizen Complaint, CT-1, Kirtright Pit M-1986-123

KIRTRIGHT PIT M-1986-123 LARIMER COUNTY, CO	
PREPARED FOR:	COULSON EXCAVATING CO., INC.

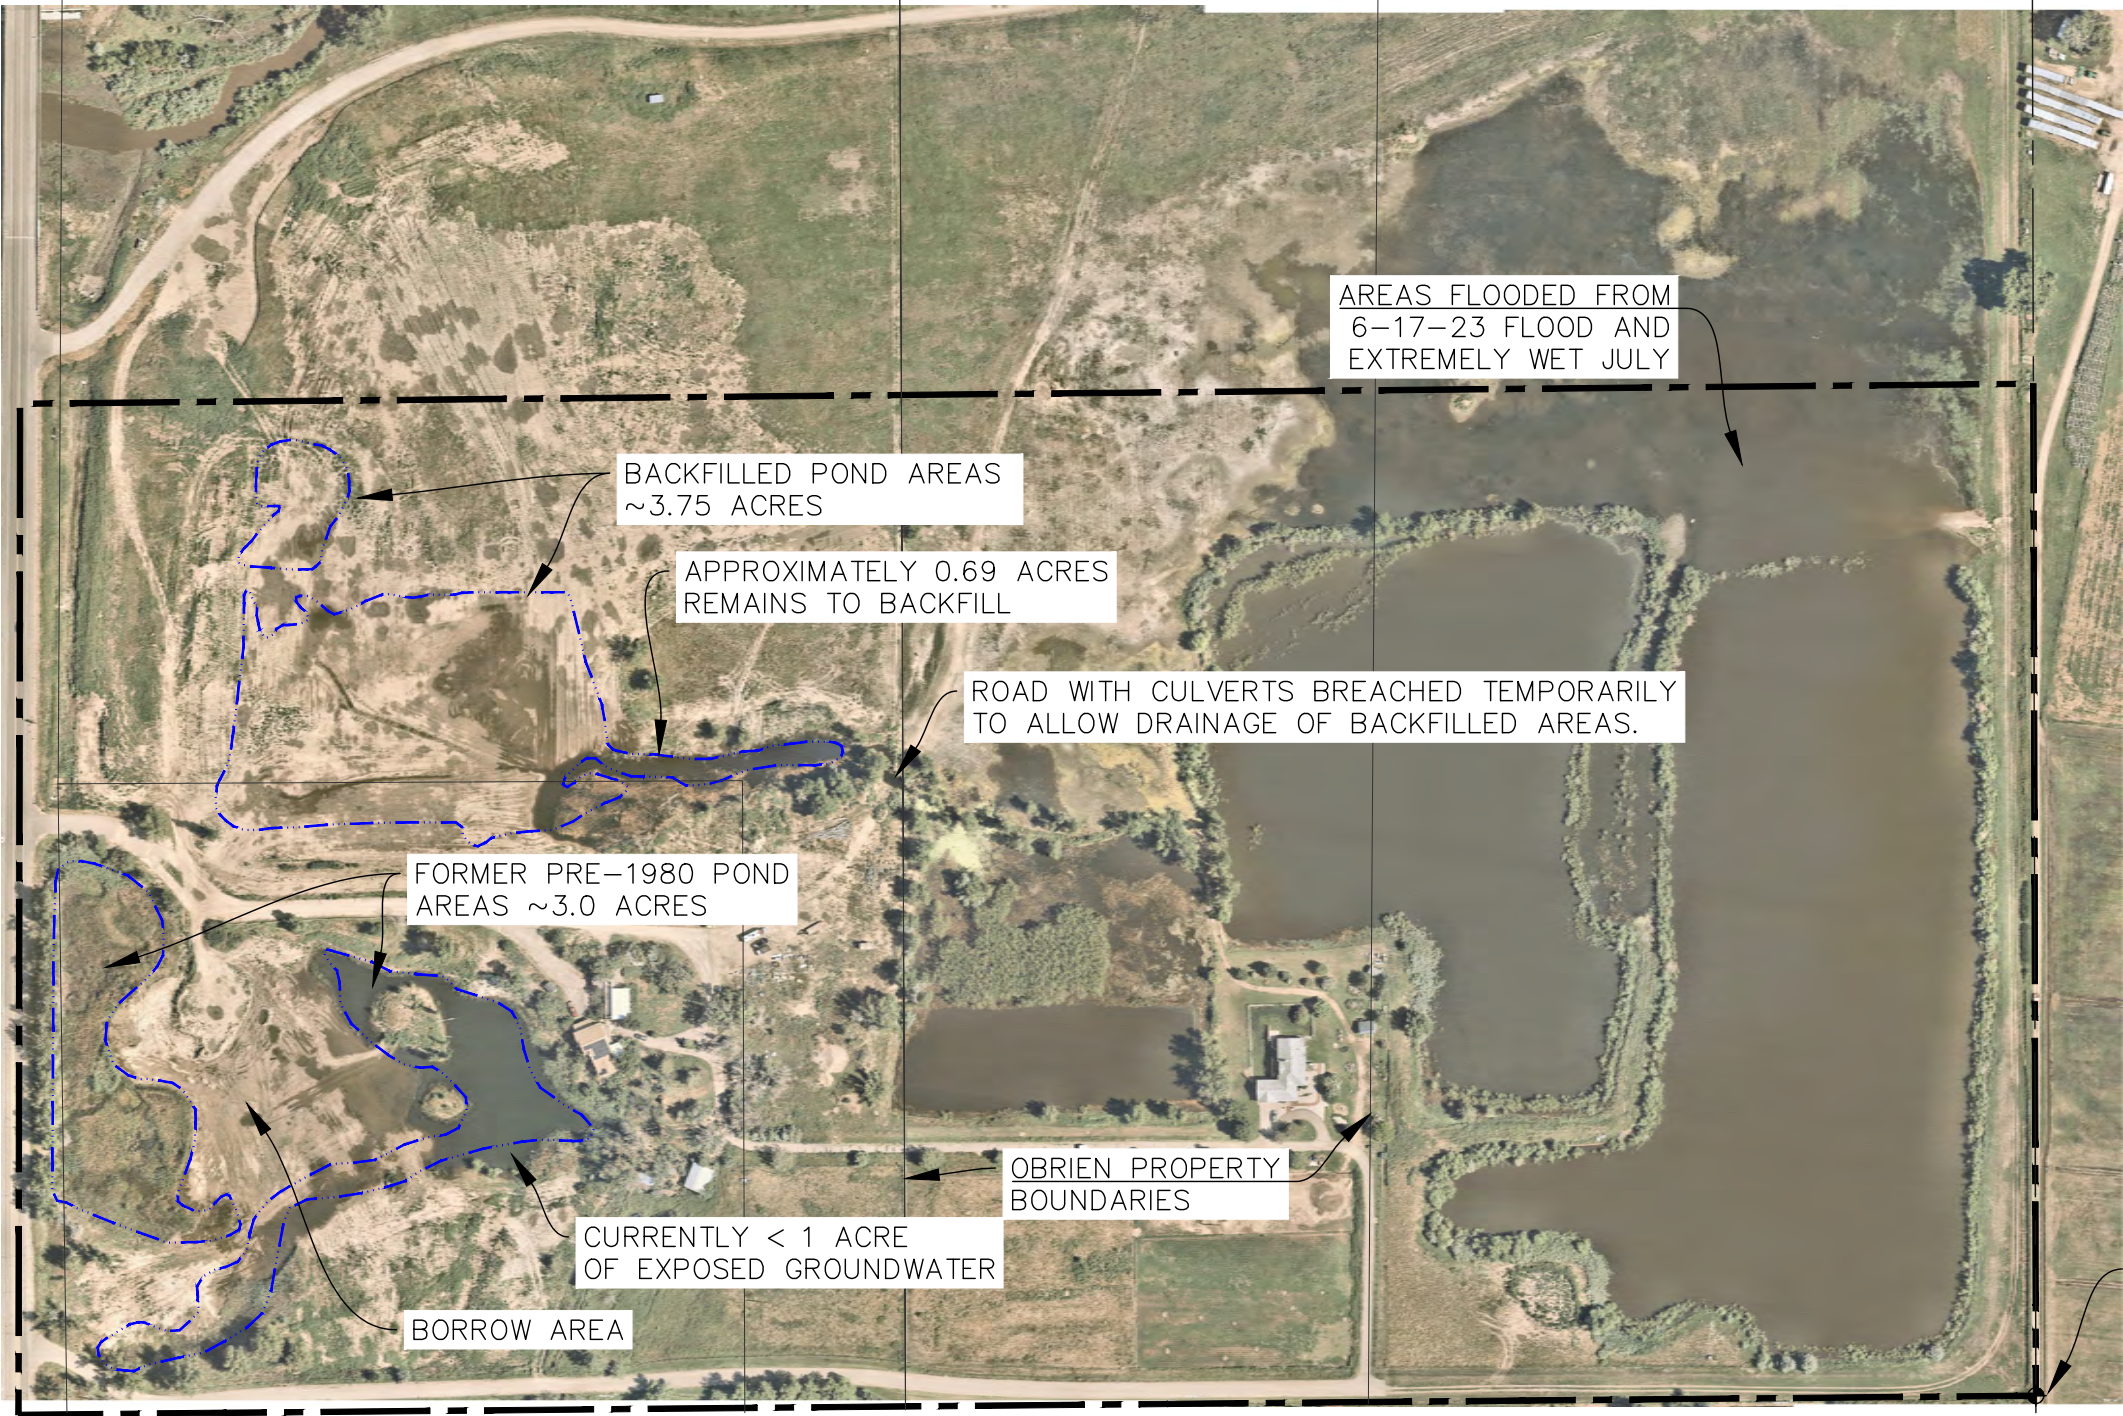
FIGURE 1			
AERIAL PHOTO 8-4-2023			
SCALE 1"=250'	DWG NO. FIGURE 1.DWG	REV. REV	
DRAWN BY: CTW	CHECKED BY: PFW	DATE: 9/14/2023	SHEET 1 OF 1

CEC has made an application to water court for the permanent augmentation of exposed groundwater at the Kirtright Pit (Case # 19CW3157). At the advise of their water attorney, CEC began backfilling a shallow pond in the northwest of the permit area with an aerial extent of approximately 3.75 acres (see Figure 1) for the purpose of reducing the area of exposed groundwater. This activity is consistent with the MLRB rules and regulations regarding restoring hydrologic balance. CEC had ceased working on the site in June due to the Big Thompson River flooding in the area. There is approximately 0.69 acres of pond left to backfill and their plan is to continue backfilling pending the approval of DRMS. The borrow area for material used to backfill the pond area is shown in Figure 1. Previously, that borrow area had approximately 3 acres of exposed groundwater (Pre 1980). Currently, there is less than 1 acre of groundwater exposed in that area. The earthwork activity in late August, I believe was Randy Kirtright is likely restoring the Pre-1980 ponds in that area.

It is known that a flooding event did occur on the Big Thompson River with the following flows observed at the Loveland stream gage 6/16/2023 1210 c.f.s. , 6/17/2023 1600 c.f.s. , 6/18/2023 1350 c.f.s. 6/19/2023 1130 c.f.s. 6//20 1060 c.f.s. and 6/21 975 c.f.s. This event did flood part of the Kirtright property and the backfilling area as well as the borrow area. The aerial photo from 8/4/2023 still shows ponding of floodwaters in the eastern ponds.

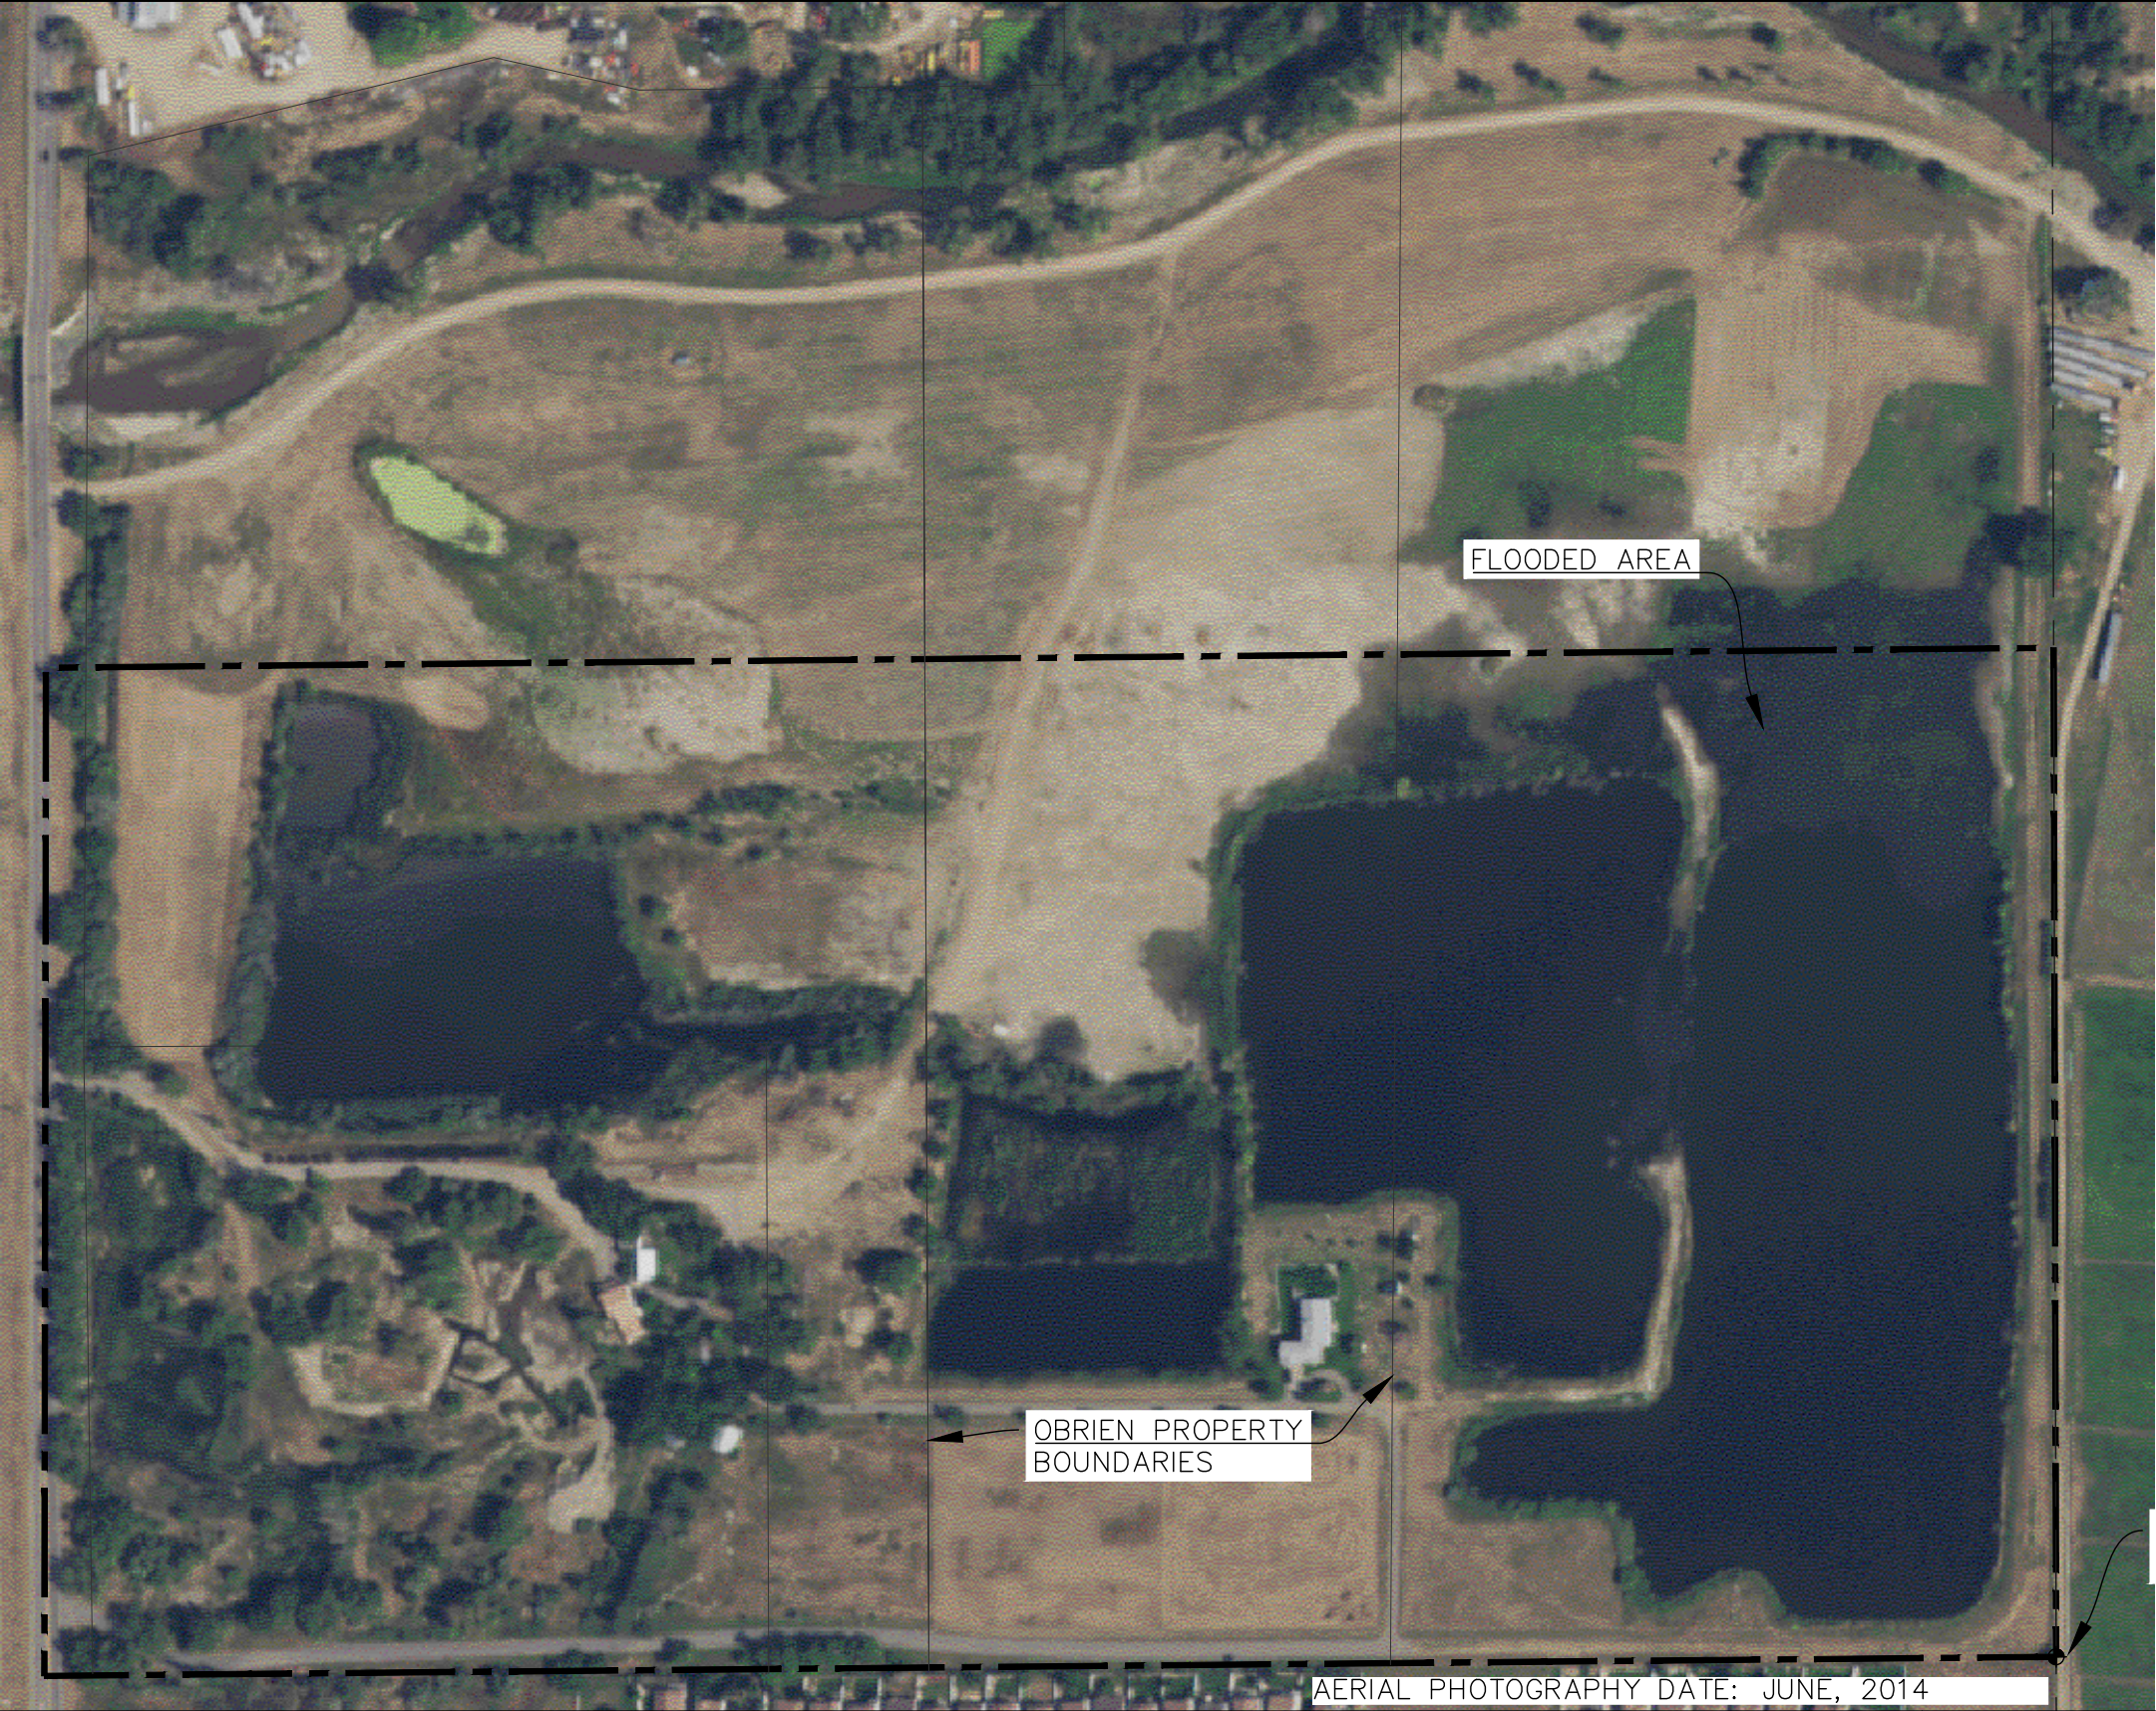
FIGURE 2
AERIAL PHOTO JUNE 2014

This area has taken an unusually long period to drain or evaporate is due to the very wet preceding month of July 2023 and the fact there is not an overflow drain for those ponds. Historically, the ponds to the west (backfill area) and the ponds to the east including ponds on Linda O'Brien's property have always been hydraulically connected with culverts running under a road between the ponds (See Figure 2). To demonstrate this, refer to Figure 2, which shows similar flooding as seen in the 2023 aerial occurring in June of 2014. That road was temporarily breached to allow more rapid dewatering of the backfill areas. Once the area is completely backfilled, there will be no water from the west flowing onto Linda O'Brien's property and the northern most pond area on her land is expected to completely dry up. In general, the backfilled pond area would not be expected to create a rise to floodwaters since ponds are typically modeled as ineffective flow areas. It should be noted that CEC will be required to submit a LOMR to FEMA following final grading of the adjoining Stroh Pit as well as Kirtright Pit via Larimer County and will update floodplain maps at that time.
