MINERALS PROGRAM INSPECTION REPORT
PHONE: (303) 866-3567

MINE NAME: Lemoine Gravel Pit	MINE/PROSPECTING ID#: M-1979-140	MINERAL: Sand and gravel	COUNTY: Delta
INSPECTION TYPE: Surety Release Inspection	WEATHER: Clear	INSP. DATE: October 4, 2023	INSP. TIME: 13:45
OPERATOR: Delta County	OPERATOR REPRESENTATIVE: Tim McCracken and others	TYPE OF OPERATION: 112c - Construction Regular Operation	
REASON FOR INSPECTION: Surety Release Requested	BOND CALCULATION TYPE: None	BOND AMOUNT: \$0.00	
DATE OF COMPLAINT: NA	POST INSP. CONTACTS: None	JOINT INSP. AGENCY: None	
INSPECTOR(S): Robert Zuber, P.E.	INSPECTOR'S SIGNATURE:

On October 4, 2023, Rob Zuber of the Division conducted an inspection related to Surety Release No. 2 (SL-02) for the Lemoine Gravel Pit (M-1979-140). Tim McCracken, Delta County Engineer, and three other County employees (John Allen, Tim Hunter, and Scott Sheetz) represented the operator. The weather during the inspection was partly cloudy and warm. Much of the site was muddy from irrigation.

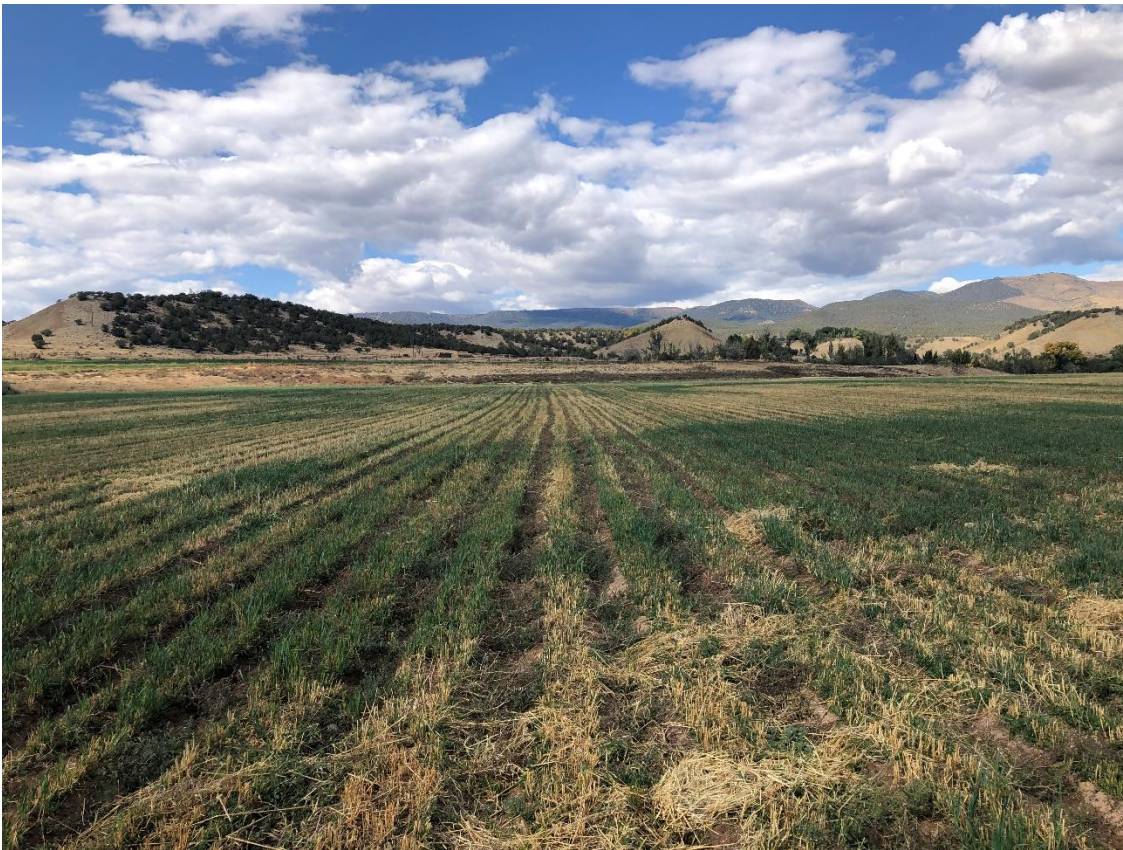
The northwestern portion of the permit is a reclaimed 3:1 slope extending from the original elevation of the site down to the reclaimed pasture. This slope was observed to be stable with no erosional features, and the vegetation cover appears to be much better than in 2022. A significant portion of the vegetation on this northwest slope is Russian thistle, which is not a listed noxious weed but is not a desirable species.

Looking west with pasture in foreground and hillside with Russian thistle in middle of photo

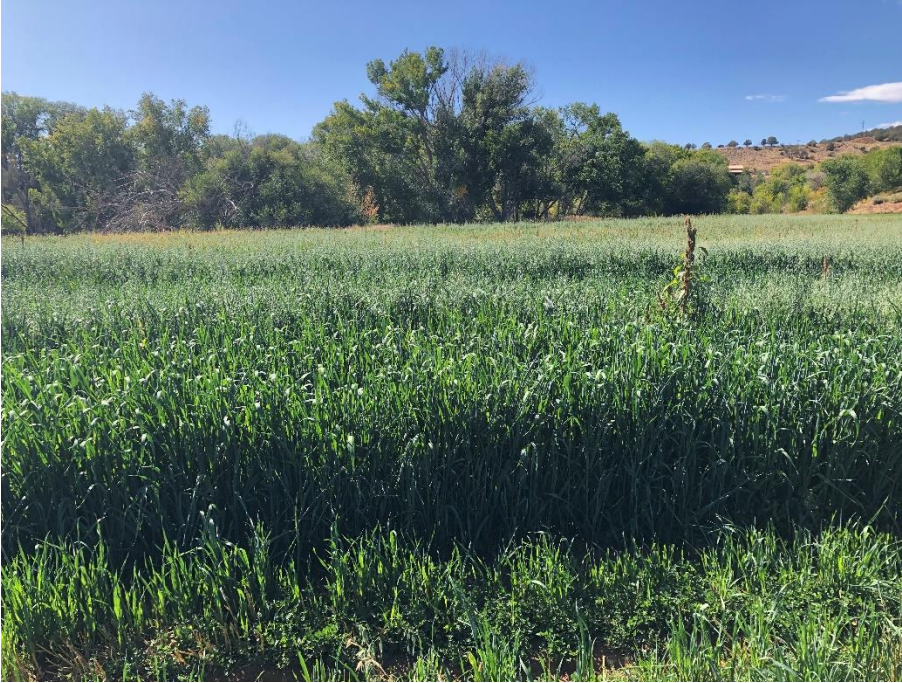
The grass and alfalfa in the pasture had been harvested, and the remaining vegetation was still short. Per County staff, the harvesting took place approximately a month before the inspection. In some areas, tall stands of grass or oats had not been harvested at the time of the inspection.

South side of pasture with uncut grass

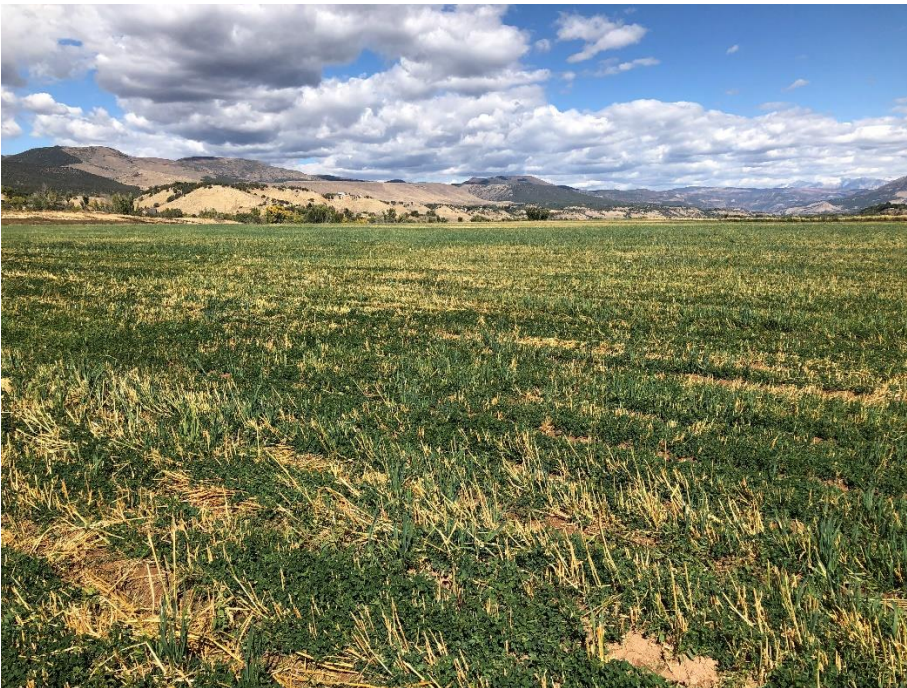
Middle of pasture with cut grass

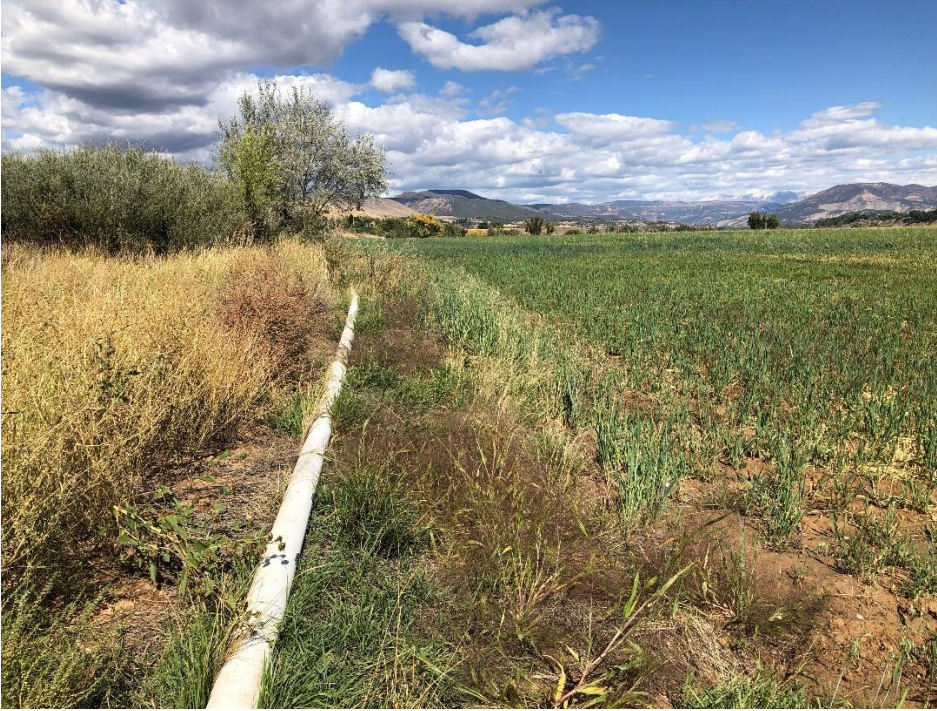
During the inspection, it appeared that all three of the tasks from TR-02 have been accomplished. There was no sign of low spots that would impede farming. The pasture area, which encompasses over 90 percent of the site, was well-covered with alfalfa and grasses. Irrigation pipes (10-inch PVC) were installed along the northwest side of the pasture, and all the pasture area was muddy. Per County staff, the installation of the irrigation system and the seeding were completed in the summer of 2023.

Irrigation pipe on west side of pasture

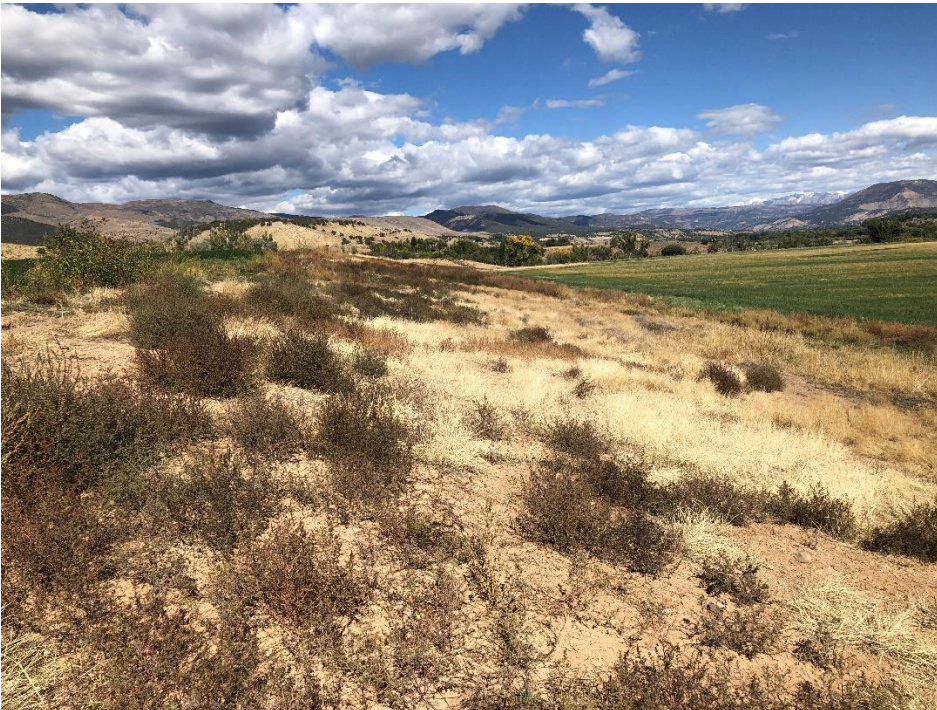
Slope on west side with Russian thistle plants
