MINE SITE INSPECTION NARRATIVE

COMPANY: Colowyo Coal Company L.P.

MINE: Colowyo Mine

DATE OF INSPECTION: September 12, 2023

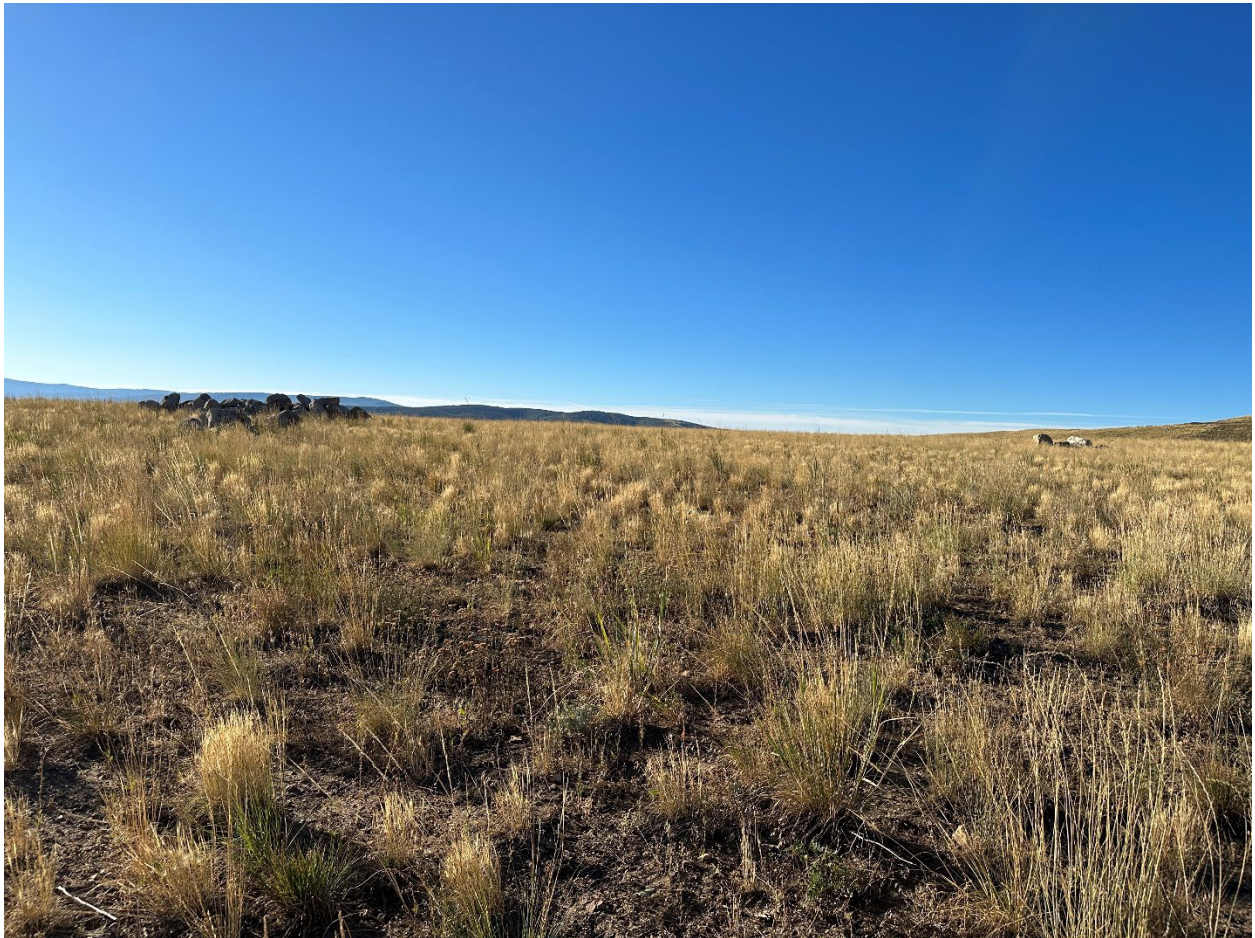
EP061. Stable, no issues noted other than some thistle present. Vegetation included perennial grasses (e.g. wild rye), yarrow, and sage (Figure 1).

Figure 1 - A sample of the reclamation of parcel EP061. The small features in the background are animal habitat structures made of natural stone.

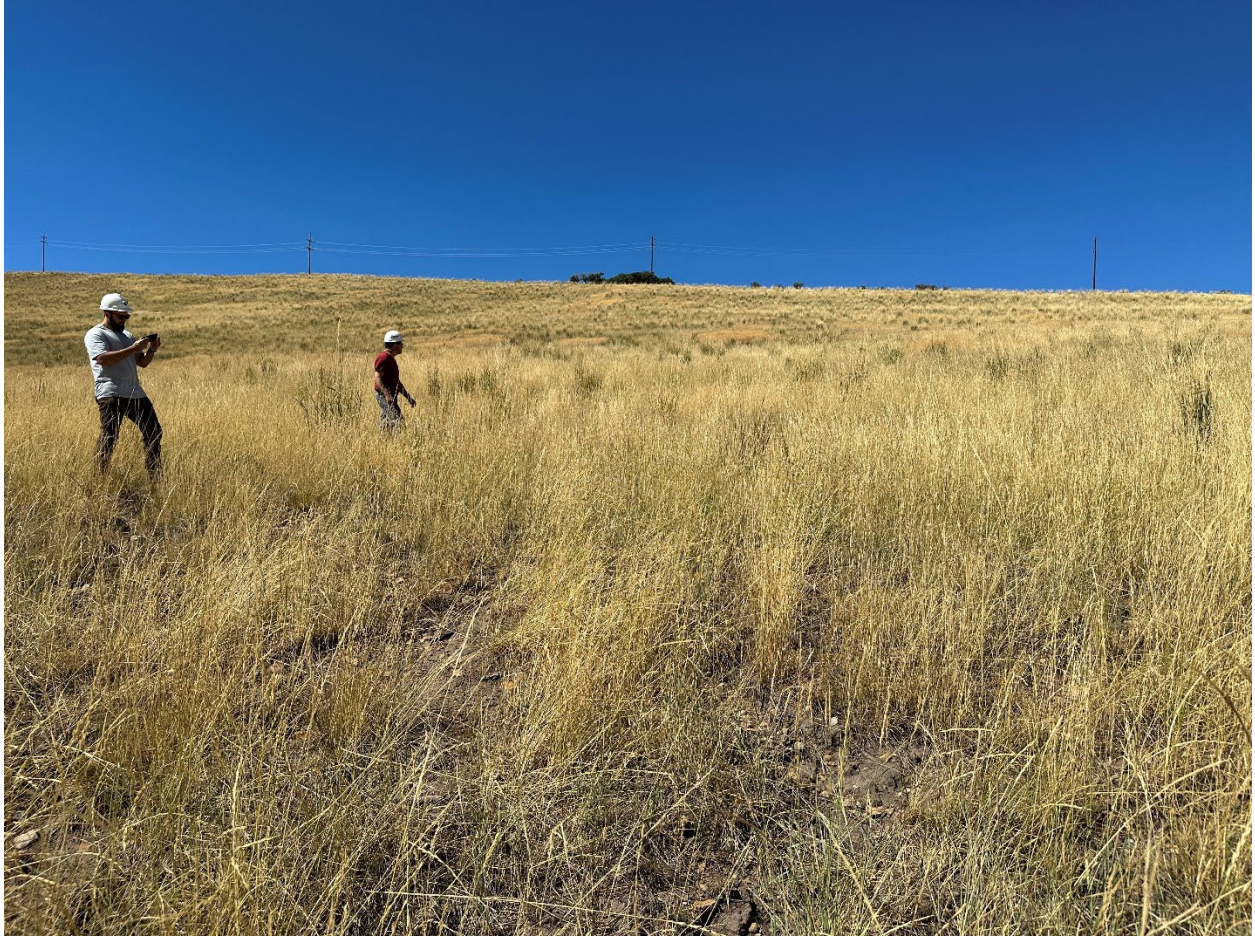
WP026, WP027, WP028, and WP032. Stable with the majority of vegetation present consisting of annual and perennial grasses; however, this inspection occurred later in the growing season when forbs may be harder to observe (Figure 2). There was a significant number of patchy populations of cheatgrass present at these sites. We discussed how the operator is treating the cheatgrass and they described a preemergent herbicide, sprayed in late August / early September, to kill seeds. We toured a few small sites where this has recently been found effective; OSMRE will follow up with the operator for more specifics on the formulation and long-term effectiveness of this herbicide.

Figure 2 - A sample of the vegetation within parcel WP032. Grasses were abundant and healthy.

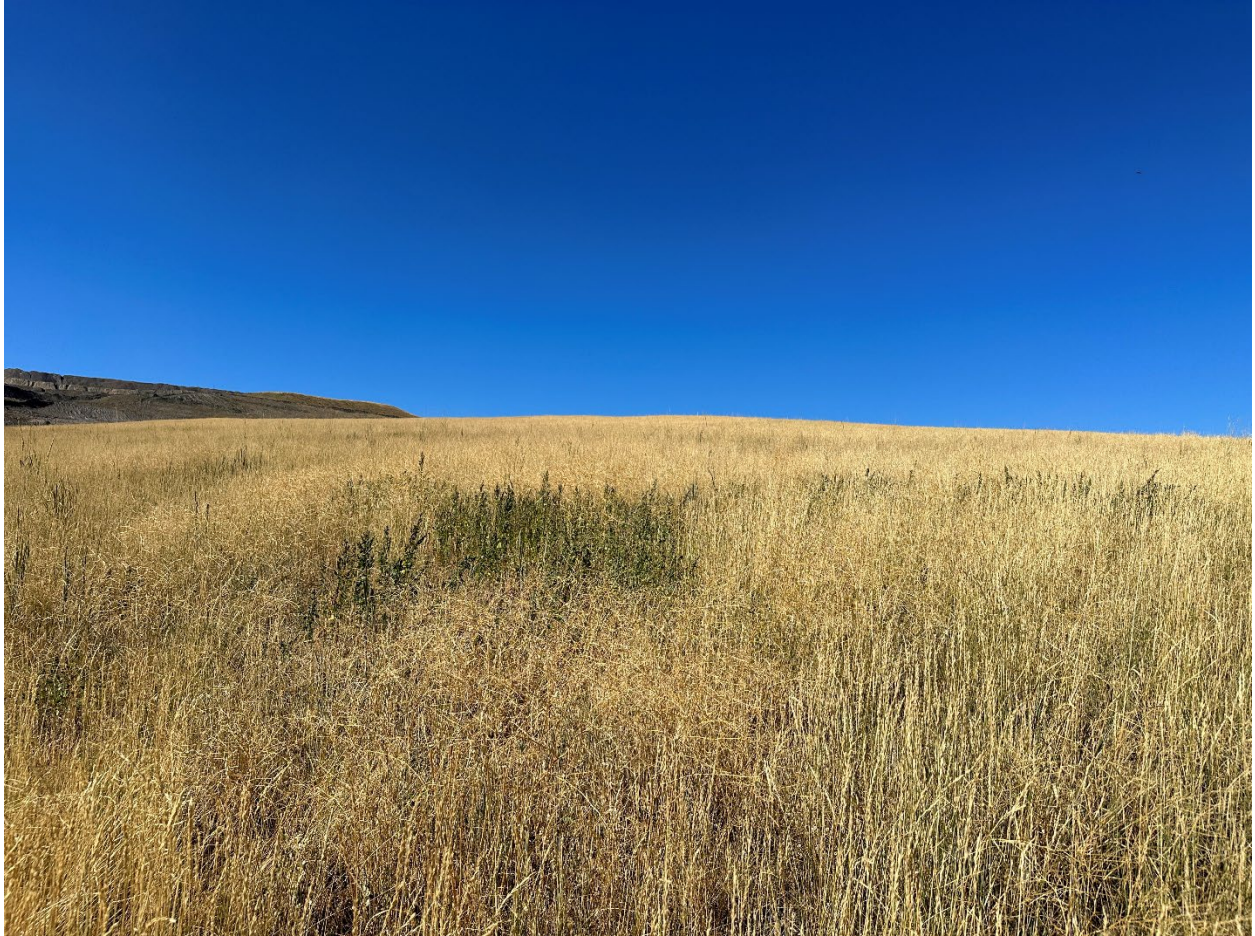
WP029. Stable with the majority of vegetation present consisting of annual and perennial grasses (Figure 3). This parcel appeared to have much less cheatgrass than those described above.

Figure 3 - Sample reclamation from parcel WP029. Overall, this parcel was well-vegetated with a relatively small population of cheatgrass.
