Job Number: 99-3983

Subject: Quarterly Observation Report, Refuse Pile,
Foidel Creek Mine, Routt County, Colorado.

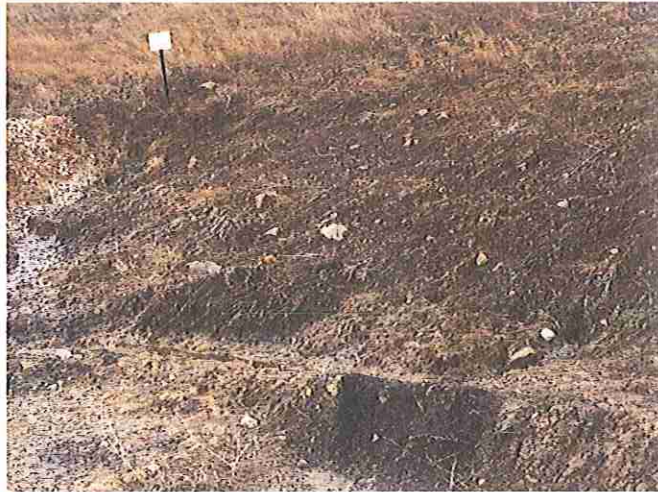
March 30, 2017-Underdrain Outlet/Seepage Area

A seepage area at the toe of the northeast end of the refuse pile expansion area, approximately 30 feet northwest of the outlet of the underdrain, developed in fall 2014. At the time of our observations, the seepage was surfacing at the toe of the slope and flowing into the drainage from the undrain outlet then into the existing pond east of the Refuse Pile Expansion Area. The discharge was clear, with no evidence of sediment. No signs of washout, slumps or slope instability were observed at this time. The seepage area will be monitored during future inspections and noted in our inspection reports. Photographs of the seepage area taken at the time of our inspection on March 30, 2017 are attached.

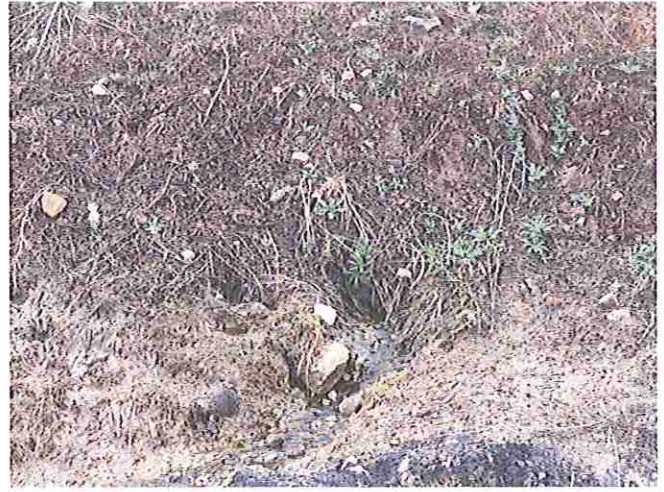
March 30, 2017-Seepage Area

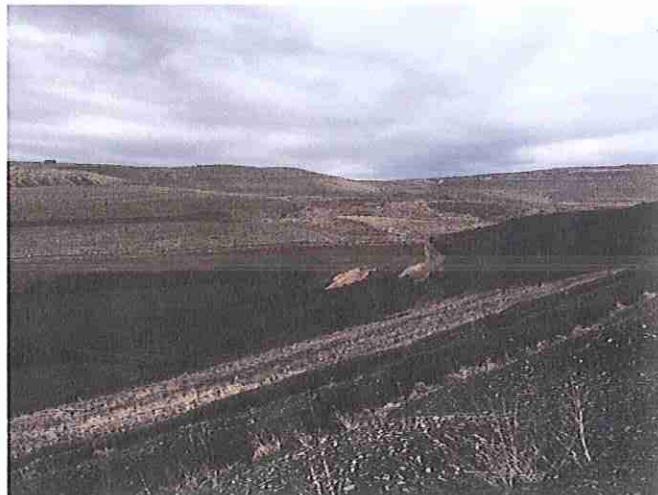
March 30, 2017- Southwest End of Underdrain

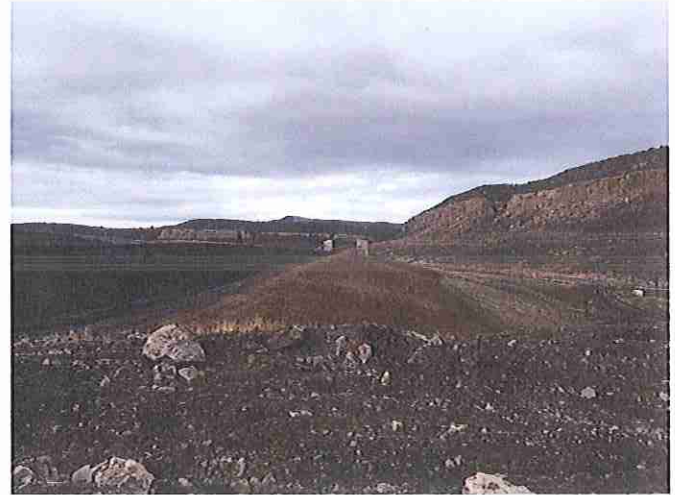
March 30, 2017-Second Bench Cover & Topsoil

At the time of our site visit on March 30, 2017, NWCC completed a cursory site inspection of the existing refuse pile. Based on our observations made during this visit, it appeared that the contractor was presently stockpiling and compacting refuse coal in the new Expansion Area. At the time of our site visit the refuse coal had been placed and compacted to an elevation above the second bench situated along the east side of the stockpile. It appeared the contractor had placed the cover materials and topsoil for the second bench.

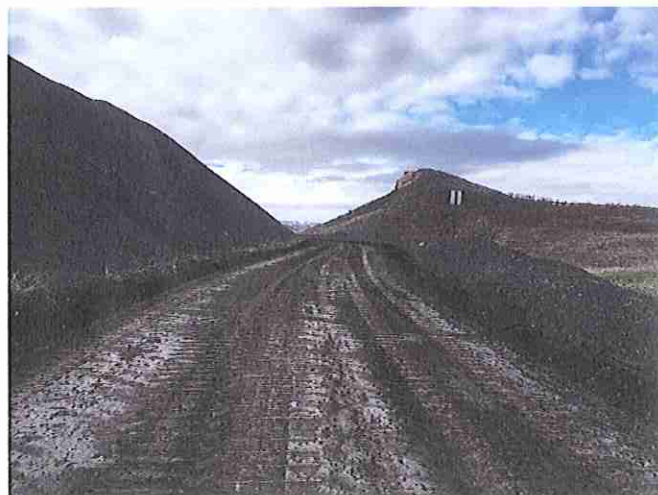
March 30, 2017-Haul Road to Areas 2, 3, 4

The internal roadways in the new expansion area of the pile are in good condition. The upper haul road to Areas 2, 3 and 4 of the refuse pile was accessible at the time of our site visit. The grading and compacting of the stockpiles completed in 2015 appear to have improved the overall drainage in these areas and no areas of concentrated drainage or slope instability were observed in this area during our site visit. Additional refuse materials had been placed in Areas 2, 3 and 4 and the contractor was in the process of grading and compacting these materials.

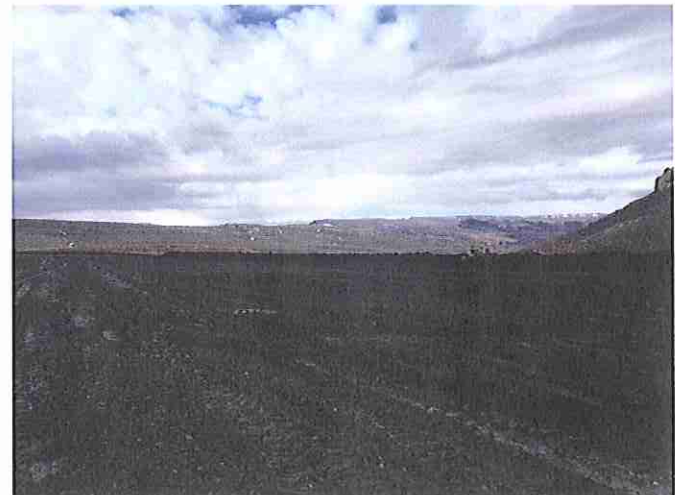
March 30, 2017-Grading Areas 2, 3, 4
