October 9, 2017

Job Number: 99-3983

Subject: Quarterly Observation Report, Refuse Pile,
Foidel Creek Mine, Routt County, Colorado.

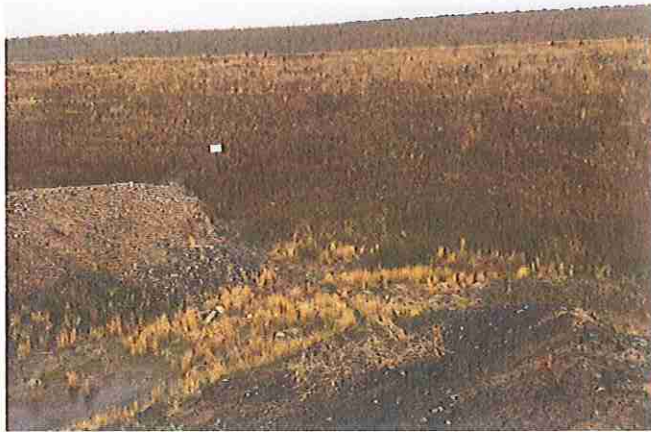
A seepage area at the toe of the northeast end of the refuse pile expansion area, approximately 30 feet northwest of the outlet of the underdrain, developed in fall 2014. At the time of our observations, the seepage was surfacing at the toe of the slope and flowing into the drainage from the undrain outlet then into the existing pond east of the Refuse Pile Expansion Area. The discharge was clear, with no evidence of sediment. No signs of washout, slumps or slope instability were observed at this time. The seepage area will be monitored during future inspections and noted in our inspection reports. Photographs of the seepage area taken at the time of our inspection on September 30, 2017 are attached.

September 29, 2017-Underdain Outlet/Seepage Area

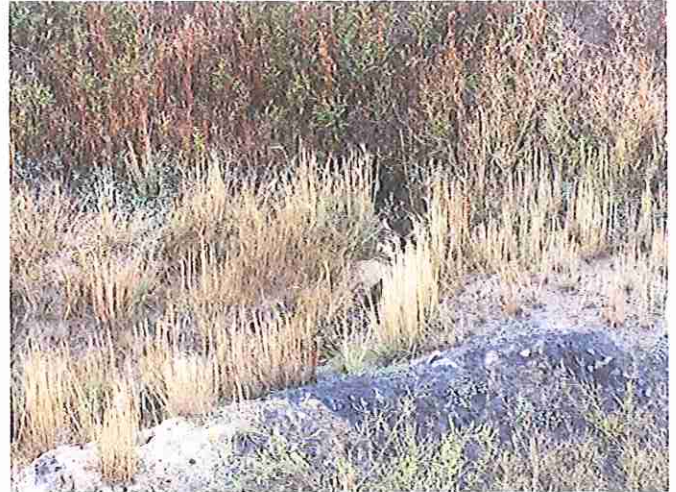
September 29, 2017-Seepage Area

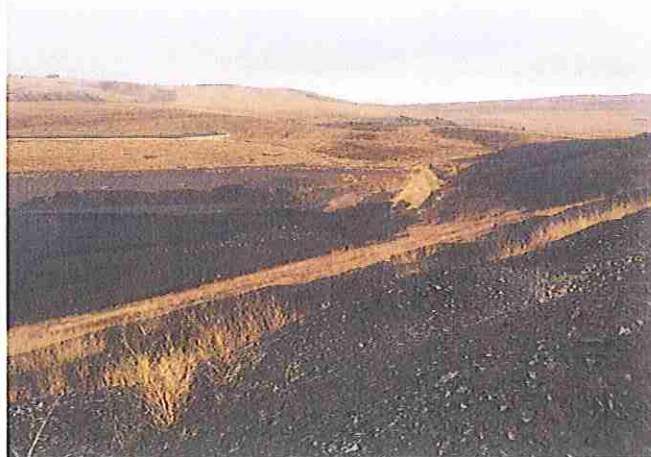
September 29, 2017- Southwest End of Underdrain

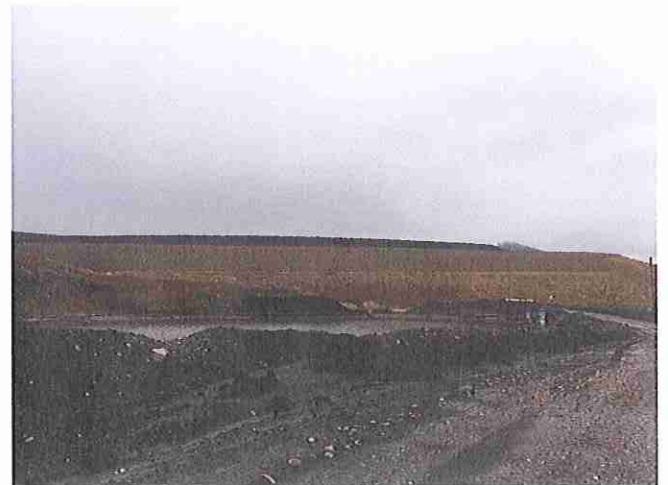
September 29, 2017-Lower & Second Bench Vegetation

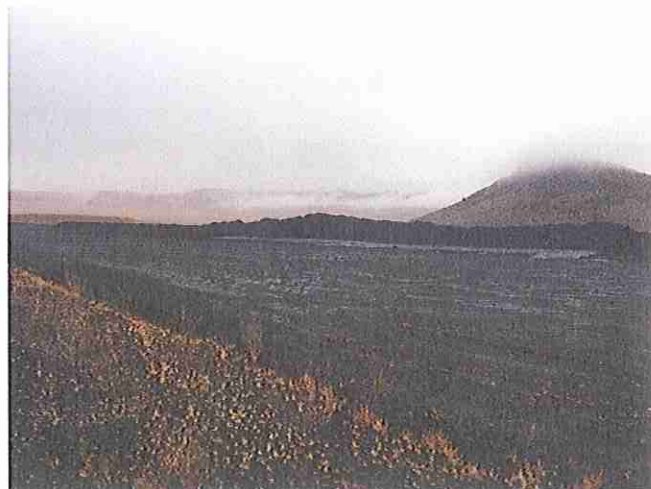
The internal roadways in the new expansion area of the pile are in good condition. The upper haul road to Areas 2, 3 and 4 of the refuse pile was accessible at the time of our site visit. The grading and compacting of the stockpiles completed in 2015 appear to have improved the overall drainage in these areas and no areas of concentrated drainage or slope instability were observed in this area during our site visit. The contractor did not appear to be stockpiling materials in this area at the time of our site visit.

September 29, 2017-Areas 2, 3, 4 Stockpile

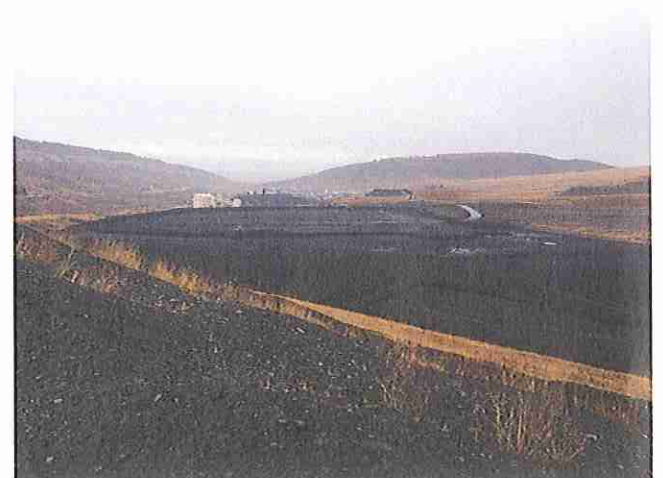
At the time of our site visit on September 29, 2017, NWCC completed a cursory site inspection of the existing refuse pile. Based on our observations made during this visit, it appeared that the contractor was presently stockpiling and compacting refuse coal in the new Expansion Area. At the time of our site visit the refuse coal had been placed and compacted below the third bench situated along the east side of the stockpile.

September 29, 2017-Expansion Ares from Areas 2, 3, 4
