January 9, 2018

Job Number: 99-3983

Subject: Quarterly Observation Report, Refuse Pile,  
Foidel Creek Mine, Routt County, Colorado.

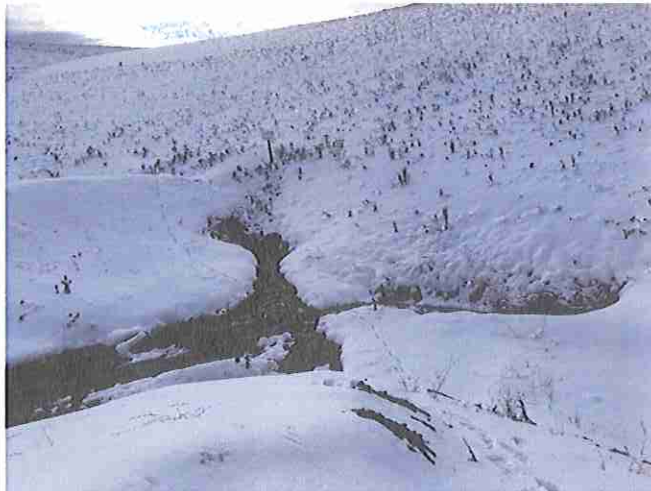
A seepage area at the toe of the northeast end of the refuse pile expansion area, approximately 30 feet northwest of the outlet of the underdrain, developed in the fall of 2014. At the time of our observations, the seepage was still surfacing at the toe of the slope and flowing into the drainage from the undrain outlet then into the existing pond east of the Refuse Pile Expansion Area. The discharge remains clear, with no evidence of sediment. No signs of washout, slumps or slope instability were observed at this time. The seepage area will be monitored during future inspections and noted in our inspection reports. Photographs of the seepage area taken at the time of our inspection on December 29, 2017 are attached.

December 29, 2017-Underdrain Outlet/Seepage Area

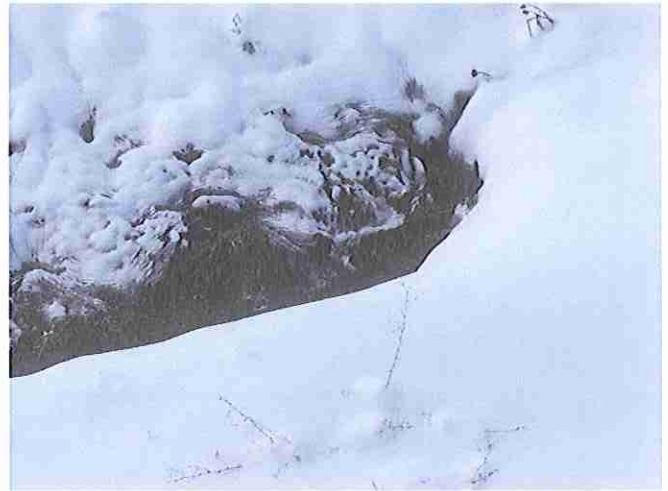
December 29, 2017-Seepage Area

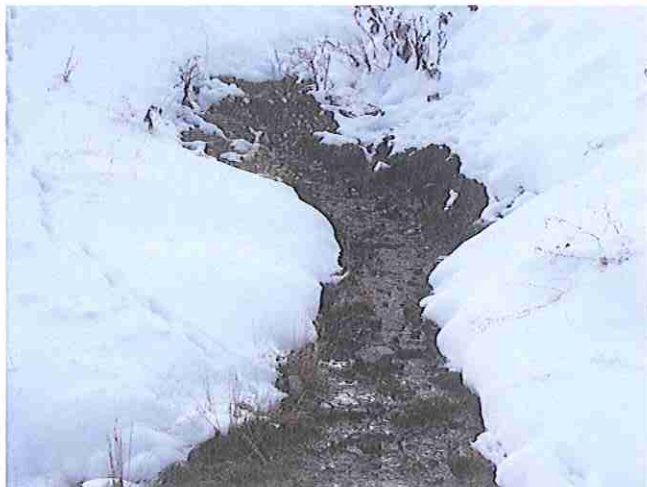
December 29, 2017- Underdrain Outlet

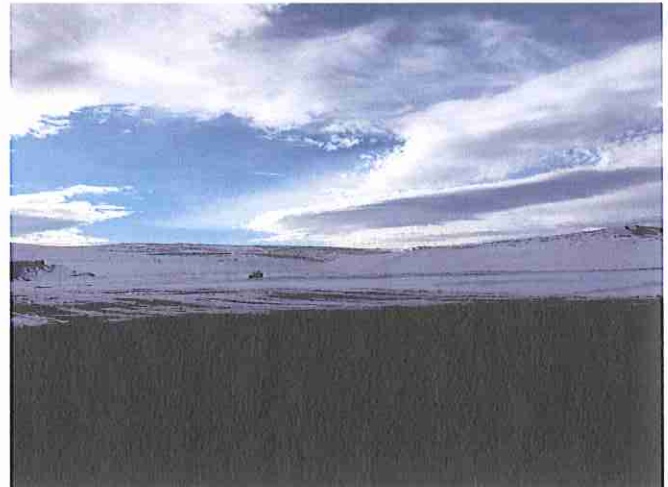
The internal roadways in the new expansion area of the pile were in good condition. The upper haul road to Areas 2, 3 and 4 of the refuse pile was not accessible at the time of our site visit, due to snow cover. The surface drainage conditions generally appeared to be adequate across the top and sides of the pile; however, our observations were limited due to snow cover.

December 29, 2017-Areas 2, 3, 4 from Expansion Area

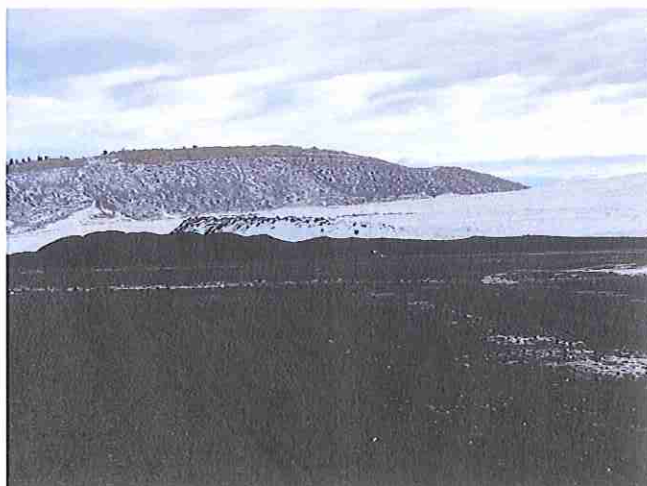
At the time of our site visit on December 29, 2017, NWCC completed a cursory site inspection of the existing refuse pile. Based on our observations made during this visit, it appeared that the contractor was presently stockpiling the refuse coal in the north-northeast portion of the new Expansion Area. At the time of our site visit the refuse coal had been placed and compacted above the second bench along the northeast side of the stockpile.

December 29, 2017-Stockpile in Expansion Area

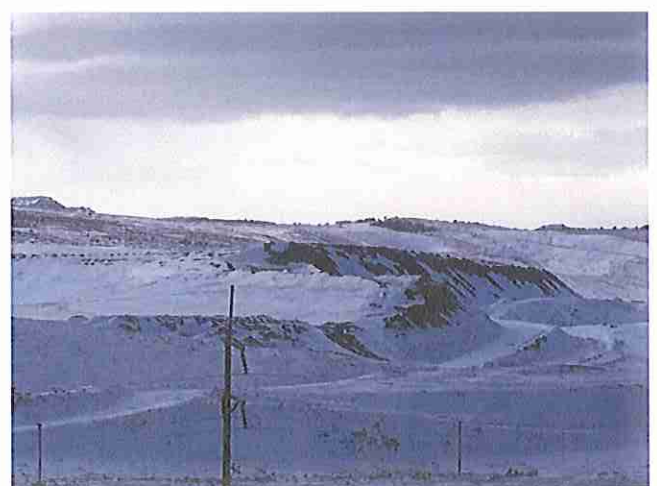
December 29, 2017-Haul Road to Areas 2, 3, 4
