July 9, 2018

Job Number: 99-3983

Subject: Quarterly Observation Report, Refuse Pile,
Foidel Creek Mine, Routt County, Colorado.

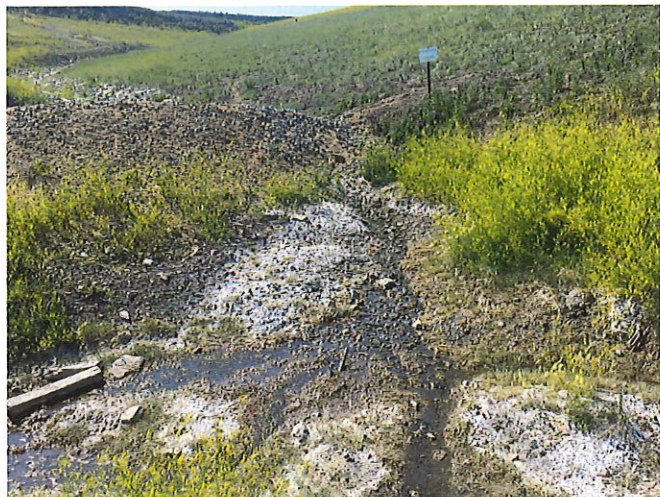
A seepage area at the toe of the northeast end of the refuse pile expansion area, approximately 30 feet northwest of the outlet of the underdrain, developed in fall 2014. At the time of our observations, the seepage was surfacing at the toe of the slope and flowing into the drainage from the undrain outlet then into the existing pond east of the Refuse Pile Expansion Area. The discharge was clear, with no evidence of sediment. No signs of washout, slumps or slope instability were observed at this time. The seepage area will be monitored during future inspections and noted in our inspection reports. Photographs of the seepage area taken at the time of our inspection on June 29, 2018 are attached.

June 29, 2018-Underdrain Outlet/Seepage Area

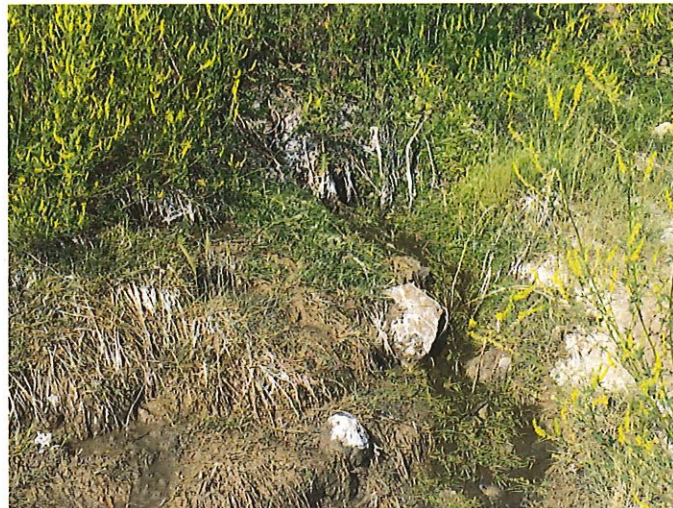
June 29, 2018-Seepage Area

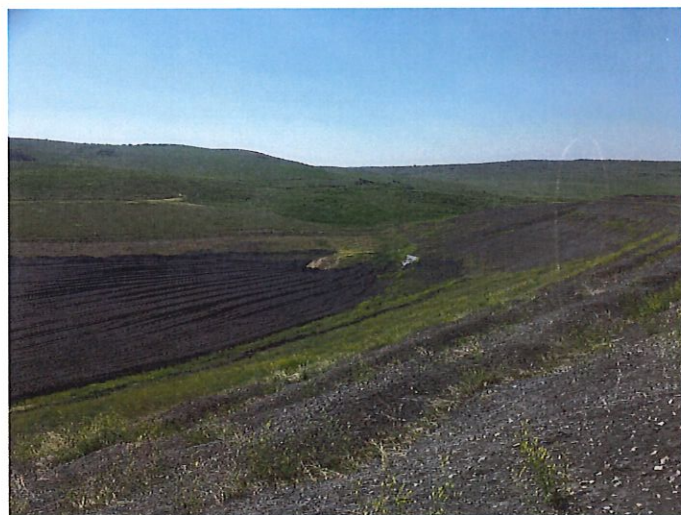
June 29, 2018- Southwest End of Underdrain

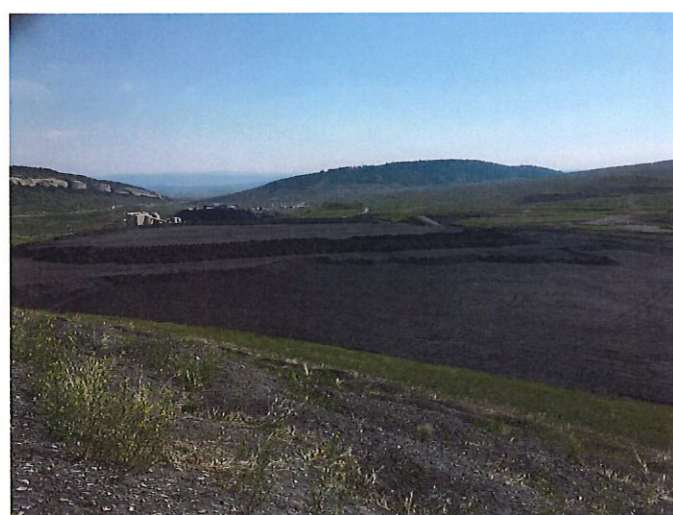
At the time of our site visit on June 29, 2018, NWCC completed a cursory site inspection of the existing refuse pile. Based on our observations made during this visit, it appeared that the contractor was presently stockpiling and compacting refuse coal in the new Expansion Area. At the time of our site visit the refuse coal had been placed and compacted to an elevation above the second bench situated along the east side of the stockpile.

June 30, 2018-Expansion Area from Areas 2, 3, 4

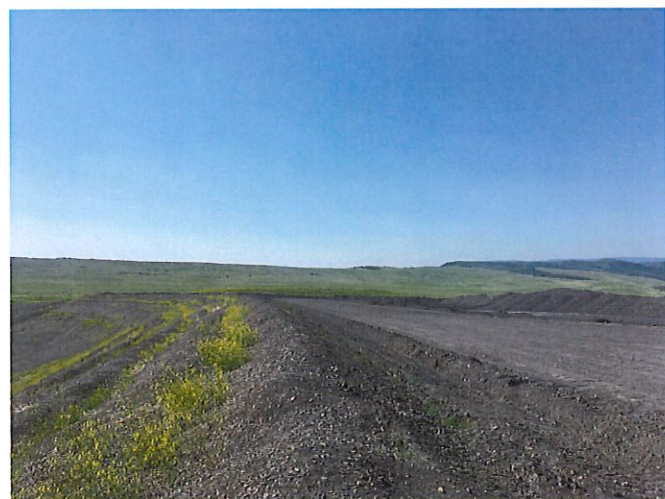
The internal roadways in the new expansion area of the pile are in good condition. The upper haul road to Areas 2, 3 and 4 of the refuse pile was accessible at the time of our site visit and in good condition.

June 29, 2018-Areas 2, 3, 4

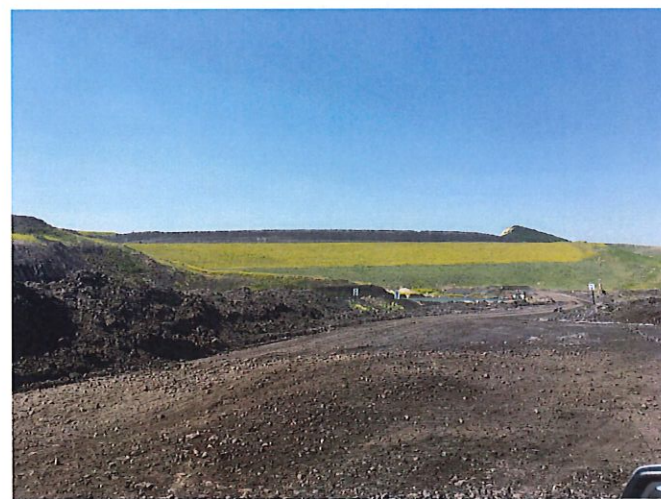
June 29, 2018-Revegetaion Expansion Area
