Job Number: 99-3983

Subject: Quarterly Observation Report, Refuse Pile,
Foidel Creek Mine, Routt County, Colorado.

TCC Refuse Pile-Quarterly Inspection

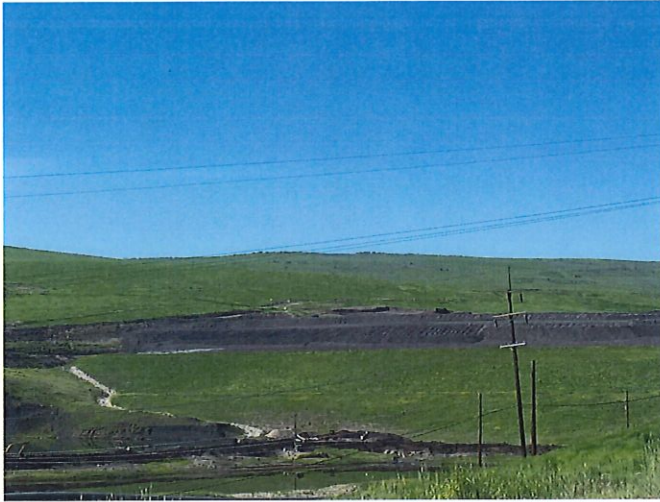
A seepage area at the toe of the northeast end of the refuse pile expansion area, approximately 30 feet northwest of the outlet of the underdrain, developed in fall 2014. At the time of our site visit, the seepage area was not accessible due to construction activity for the wash plant thickener tank. The seepage area will be observed during our next quarterly inspection.

June 28, 2019-Seepage Area (Construction Activity)

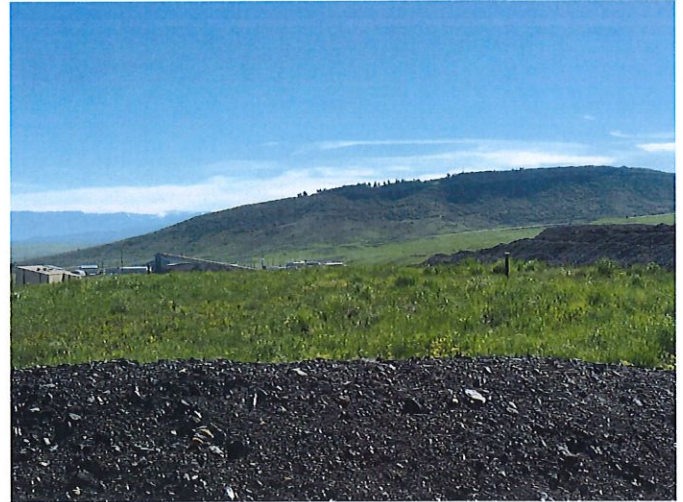
We were previously informed by Brian Watterson of Peabody that all of the original monitor wells installed in the Refuse Pile were destroyed in July 2012. Two new monitor wells were constructed in Area 1 of the Refuse Pile in December 2013. NWCC was provided monthly monitor well readings for this quarter by Miller Water Monitor Service, Inc. The water level in the western monitor well (RW#1) was measured at 57.46 feet below the existing ground surface (bgs) on April 23rd, at 57.34 feet bgs on May 6th and at 57.12 feet bgs on June 27th of 2019. The water level in the eastern monitor well (RW#2) was measured at 56.45 feet bgs on April 23rd, at 56.53 feet bgs on May 6th and at 56.16 feet bgs on June 27th of 2019. An additional monitor well (RW#3) was constructed at the southeast end of the 1st bench in new Expansion Area in June of 2014. The water level in the expansion area monitor well (RW#3) was dry when checked on April 23rd, May 6th and June 27th of 2019.

June 28, 2019-Monitor Wells RW1 & RW2

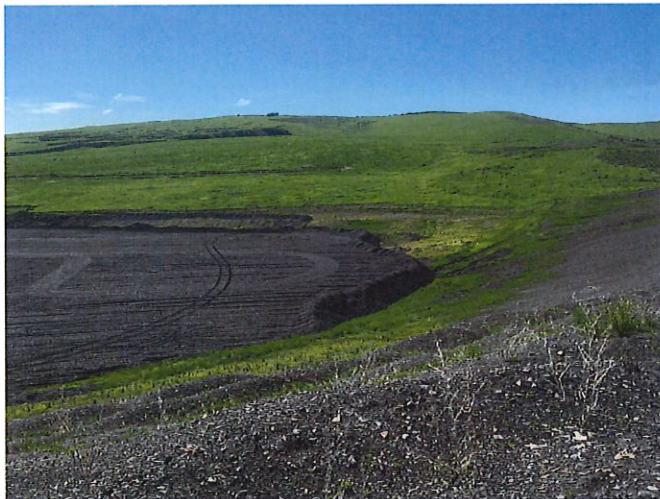
June 28, 2019- Southwest End of Underdrain

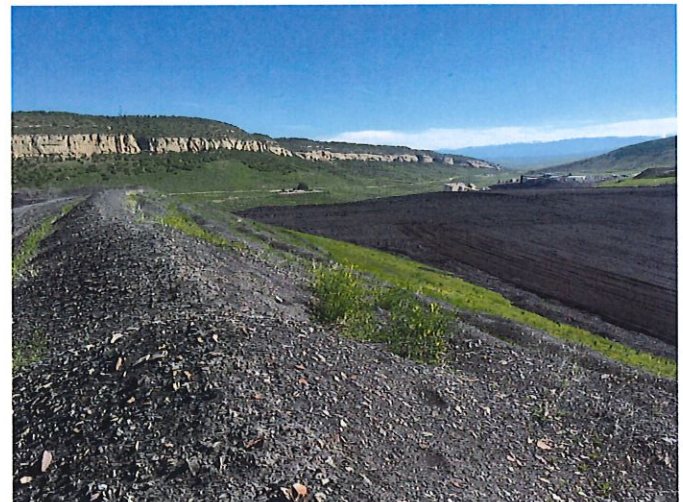
At the time of our site visit on June 28, 2019, NWCC completed a site inspection of the existing refuse pile. Based on our observations made during this visit, it appeared that the contractor was presently stockpiling and compacting refuse coal in the new Expansion Area. At the time of our site visit the refuse coal had been placed and compacted to an elevation above the second bench situated along the east side of the stockpile.

June 28, 2019-Expansion Area from Areas 2, 3, 4

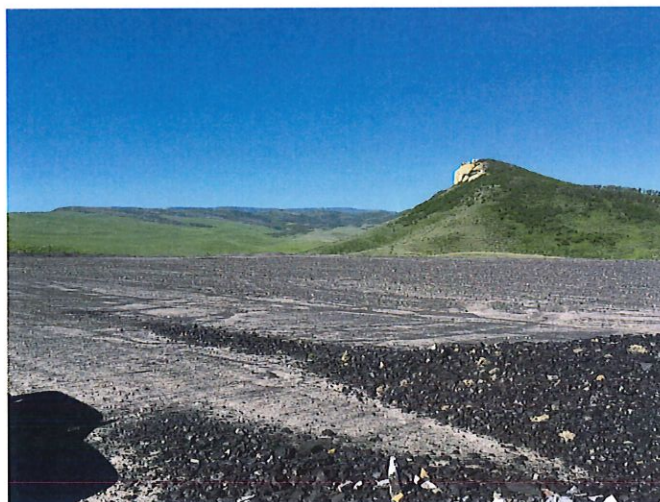
The internal roadways in the new expansion area of the pile are in good condition. The upper haul road to Areas 2, 3 and 4 of the refuse pile was accessible at the time of our site visit and in good condition.

June 28, 2019-Areas 2, 3, 4

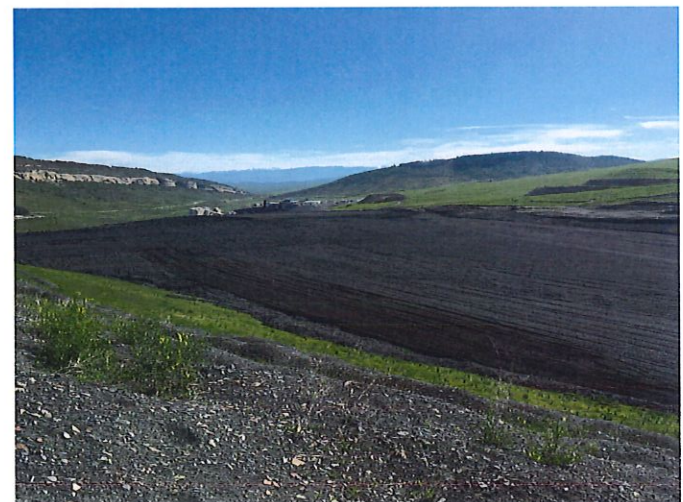
June 28, 2019- Expansion Area
