Job Number: 99-3983

Subject: Quarterly Observation Report, Refuse
Pile, Foidel Creek Mine, Routt County, Colorado.

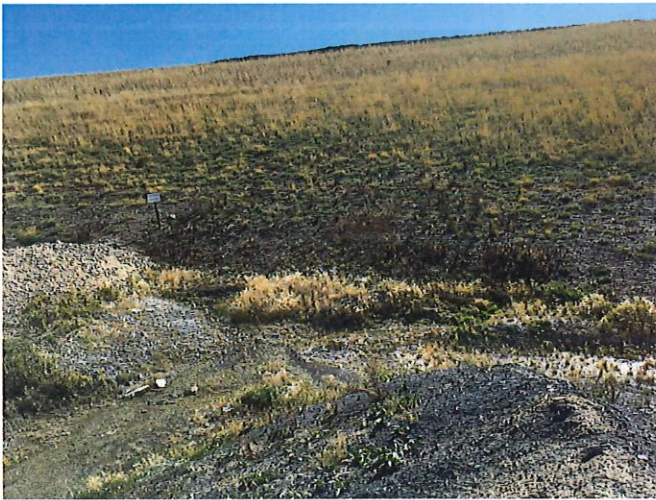
A seepage area at the toe of the northeast end of the refuse pile expansion area, approximately 30 feet northwest of the outlet of the underdrain, developed in fall 2014. At the time of our observations, the seepage was surfacing at the toe of the slope and flowing into the drainage from the undrain outlet then into the existing pond east of the Refuse Pile Expansion Area. The discharge was clear, with no evidence of

sediment. No signs of washout, slumps or slope instability were observed at this time. The seepage area will be monitored during future inspections and noted in our inspection reports. Photographs of the seepage area taken at the time of our inspection on September 30, 2019 are attached.

September 30, 2019-Drain Outlet/Seepage Area

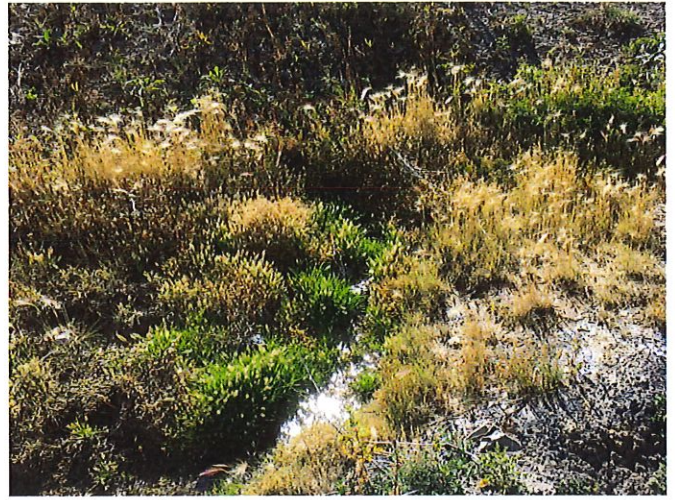
September 30, 2019-Seepage Area

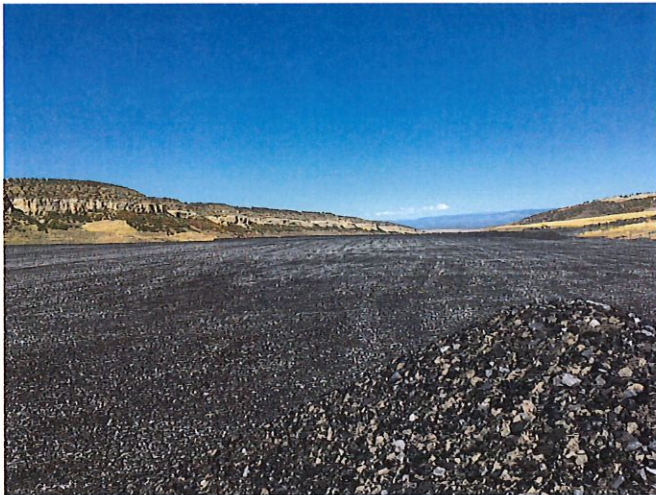
At the time of our site visit on September 30, 2019, NWCC completed a site inspection of the existing refuse pile. Based on our observations made during this visit, it appeared that the contractor was presently stockpiling and compacting refuse coal in the new Expansion Area. At the time of our site visit, the refuse coal had been placed and compacted to an elevation near the third bench situated along the east side of the stockpile.

September 30, 2019- Expansion Area

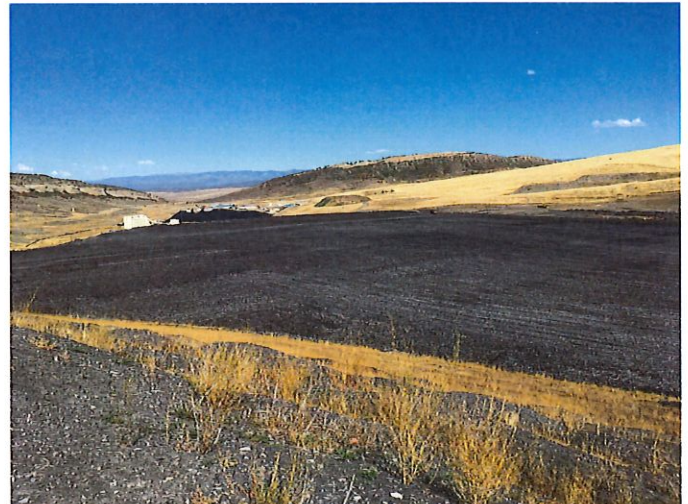
September 30, 2019-Expansion Area from Areas 2, 3, 4

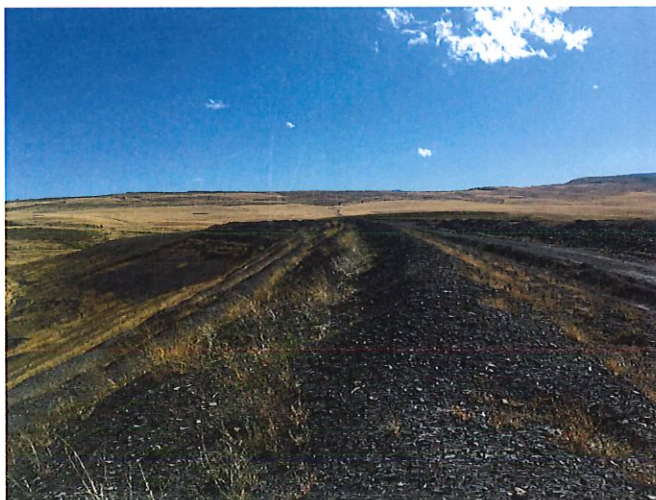
The internal roadways in the new expansion area of the pile are in good condition. The upper haul road to Areas 2, 3 and 4 of the refuse pile was accessible at the time of our site visit and in good condition.

September 30, 2019-Areas 2, 3, 4

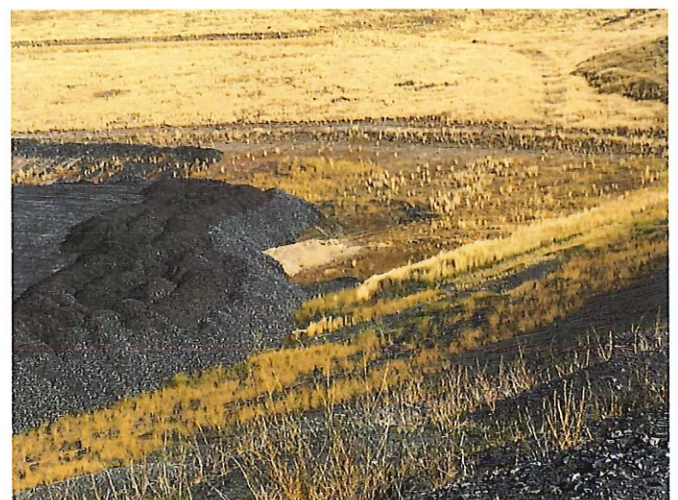
September 30, 2019- Southwest End of Drain
