Twentymile Coal Company
29515 RCR #27
Oak Creek, CO 80467

Job Number: 99-3983

Subject: Quarterly Observation Report, Refuse
Pile, Foidel Creek Mine, Routt County, Colorado.

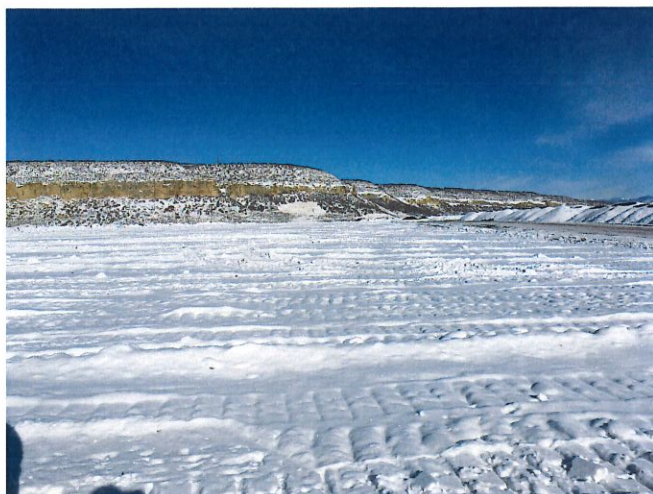
December 31, 2019-Expansion Area

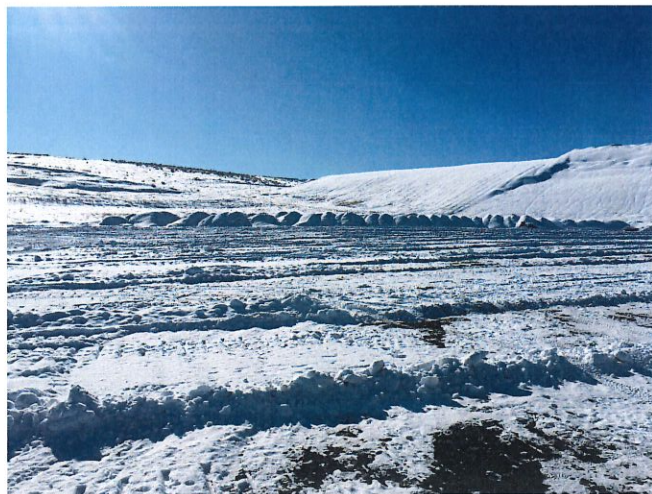
December 31, 2019-Expansion Area

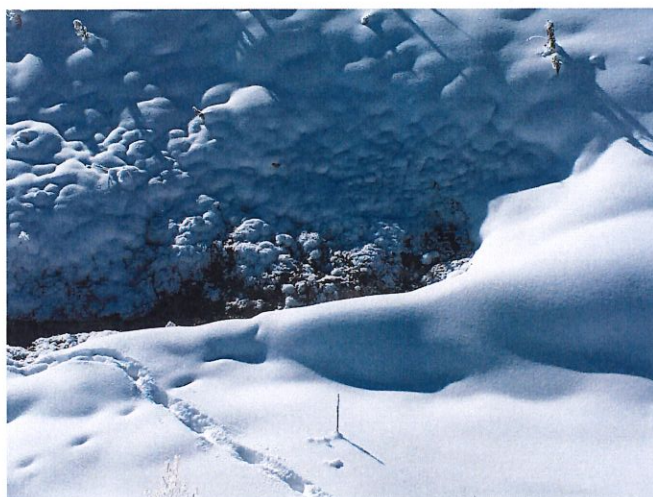
A seepage area at the toe of the northeast end of the refuse pile expansion area, approximately 30 feet northwest of the outlet of the underdrain, developed in fall 2014. At the time of our observations, the seepage was surfacing at the toe of the slope and flowing into the drainage from the undrain outlet then into the existing pond east of the Refuse Pile Expansion Area. The discharge was clear, with no evidence of sediment. No signs of washout, slumps or slope instability were observed at this time. The seepage area

will be monitored during future inspections and noted in our inspection reports. Photographs of the seepage area taken at the time of our inspection on December 31, 2019 are attached.

December 31, 2019- Seepage Area

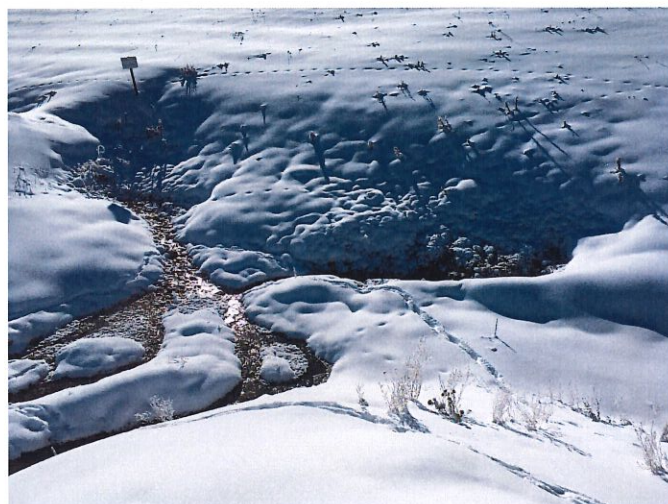
December 31, 2019-Seepage Area and Drain Outlet

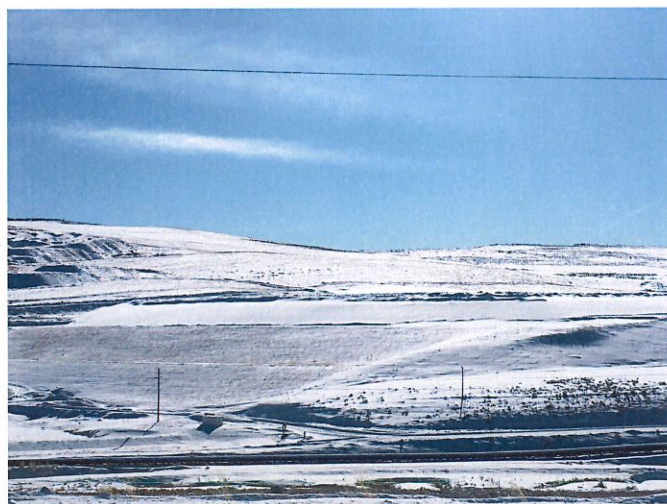
At the time of our site visit on December 31, 2019, NWCC completed a site inspection of the existing refuse pile. Based on our observations made during this visit, it appeared that the contractor was presently stockpiling and compacting refuse coal in the new Expansion Area. At the time of our site visit, the refuse coal had been placed and compacted to an elevation near the third bench situated along the east side of the stockpile.

December 31, 2019-Benches on East Side of Refuse Pile

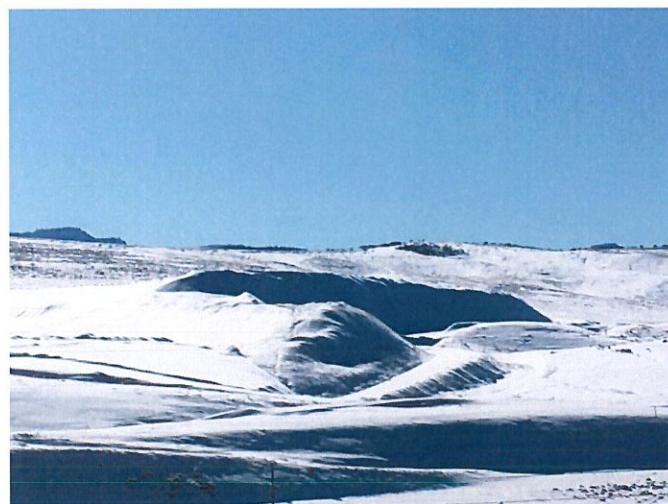
The internal roadways in the new expansion area of the pile are in good condition; however, our observations were limited by snow cover. The upper haul road to Areas 2, 3 and 4 of the refuse pile was not accessible at the time of our site visit due to snow.

December 31, 2019- Area 2, 3, 4
