Job Number: 99-3983

Subject: Quarterly Observation Report, Refuse  
Pile, Foidel Creek Mine, Routt County, Colorado.

## TCC Refuse Pile-Quarterly Inspection

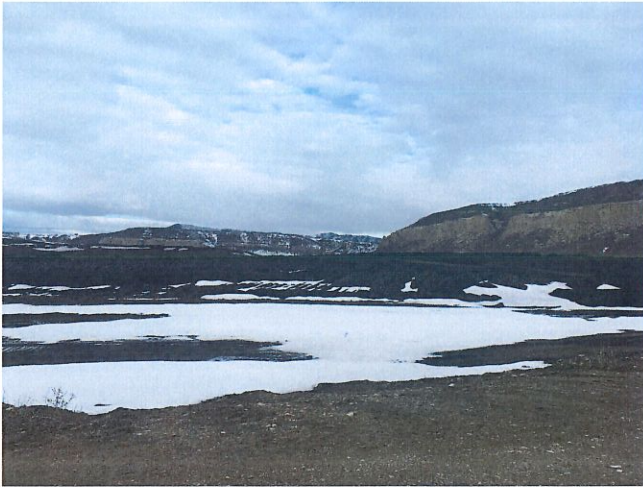
At the time of our site visit on March 31, 2020, NWCC completed a site inspection of the existing refuse pile. Based on our observations made during this visit, it appeared that the contractor was presently stockpiling and compacting refuse coal in the new Expansion Area. At the time of our site visit, the refuse coal had been placed and compacted to an elevation near the third bench situated along the east side of the stockpile.

March 31, 2020-Expansion Area

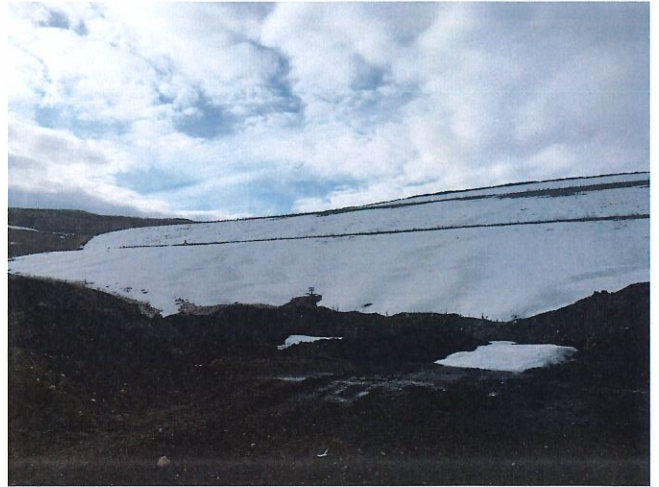
March 31, 2020-Expansion Area Lower Benches

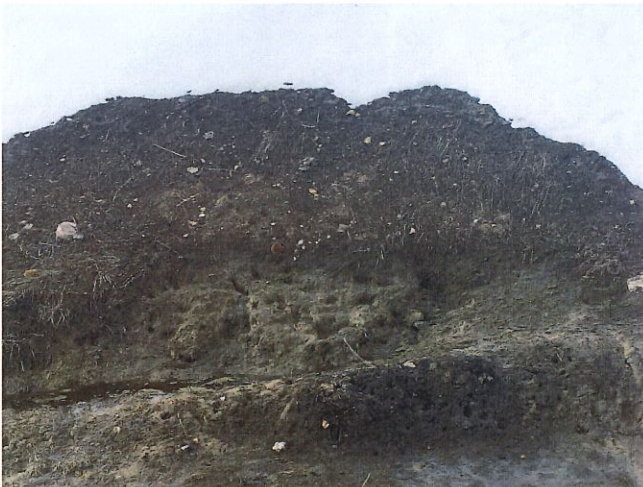
A seepage area at the toe of the northeast end of the refuse pile expansion area, approximately 30 feet northwest of the outlet of the underdrain, developed in fall 2014. At the time of our observations, the seepage was surfacing at the toe of the slope and flowing into the drainage from the undrain outlet then into the existing pond east of the Refuse Pile Expansion Area. The discharge was clear, with no evidence of sediment. No signs of washout, slumps or slope instability were observed at this time. The seepage area

March 31, 2020- Seepage Area

will be monitored during future inspections and noted in our inspection reports. Photographs of the seepage area taken at the time of our inspection on March 31, 2020 are attached.

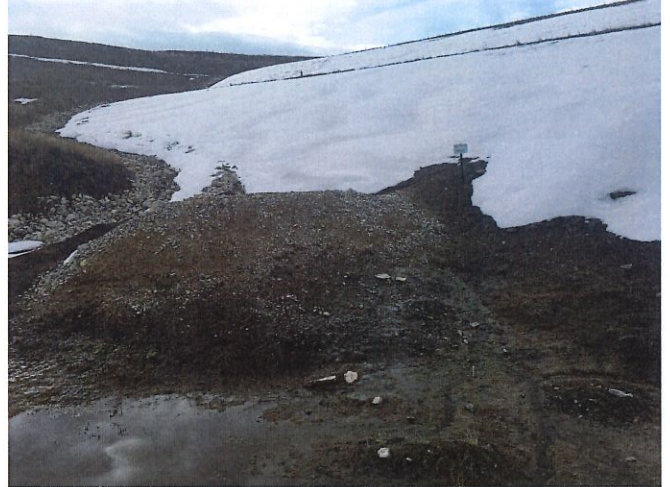
March 31, 2020-Seepage Area and Drain Outlet

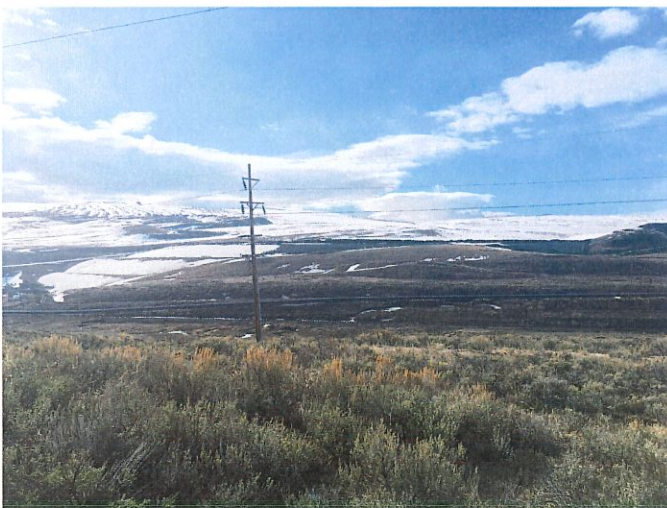
March 31, 2020-Benches on East Side of Refuse Pile

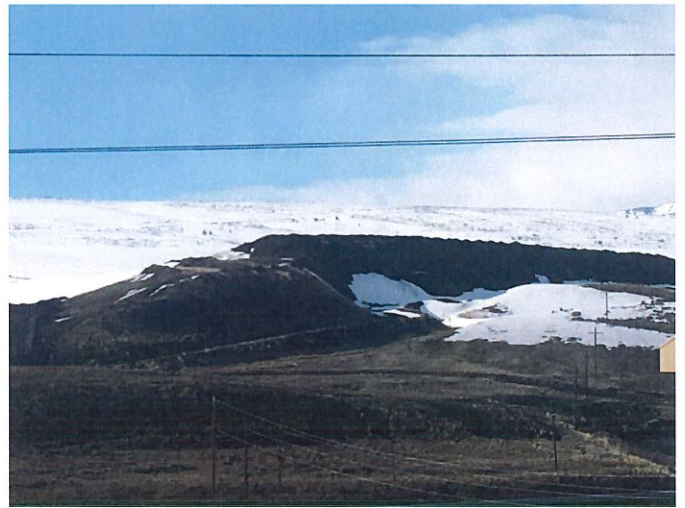
The internal roadways in the new expansion area of the pile are in good condition; however, our observations were limited by snow cover. The upper haul road to Areas 2, 3 and 4 of the refuse pile was not accessible at the time of our site visit due to snow.

March 31, 2020- Area 2, 3, 4
