April 8, 2021

Job Number: 99-3983

Subject: Quarterly Observation Report, Refuse  
Pile, Foidel Creek Mine, Routt County, Colorado.

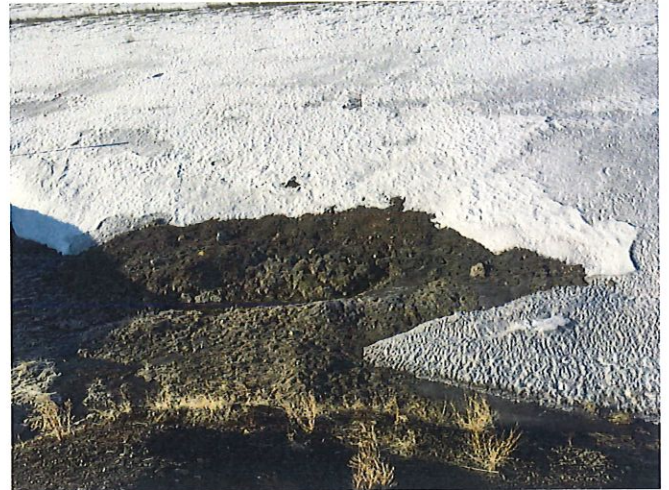
A seepage area at the toe of the northeast end of the refuse pile expansion area, approximately 30 feet northwest of the outlet of the underdrain, developed in fall 2014. At the time of our observations, the seepage was surfacing at the toe of the slope and flowing into the drainage from the undrain outlet then into the existing pond east of the Refuse Pile Expansion Area. The discharge was clear, with no evidence of sediment. No signs of washout, slumps or slope instability were observed at this time. The seepage area

March 31, 2021-Seepage Area

will be monitored during future inspections and noted in our inspection reports. Photographs of the seepage area taken at the time of our inspection on March 31, 2021 are attached.

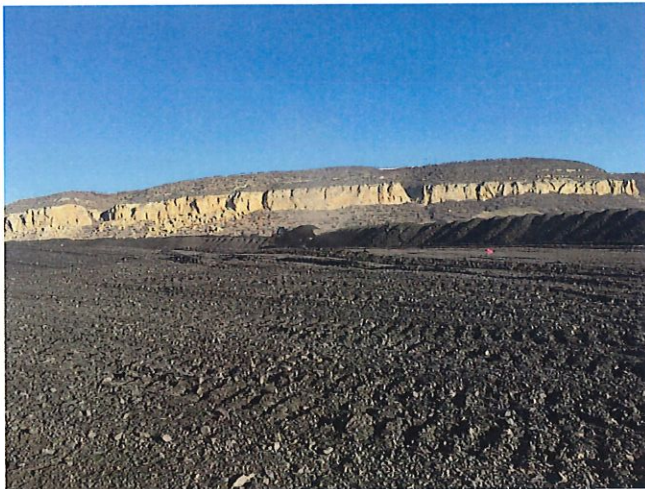
At the time of our site visit on March 31, 2021, NWCC completed a site inspection of the existing refuse pile. Based on our observations made during this visit, it appeared that the contractor was presently stockpiling and compacting refuse coal in the new Expansion Area. At the time of our site visit, the refuse coal had been placed and compacted to an elevation near the top of the third bench situated along the east side of the stockpile.

March 31, 2021- Expansion Area Stockpiles

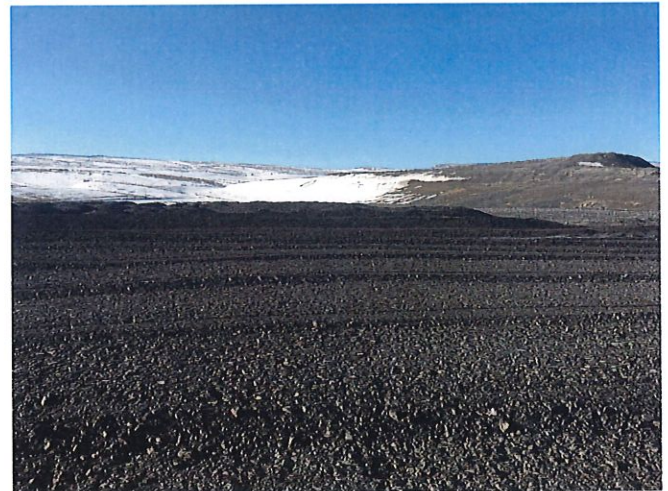
The internal roadways in the new expansion area of the pile are in good condition; however, our observations were limited by snow cover. The upper haul road to Areas 2, 3 and 4 of the refuse pile was not accessible at the time of our site visit due to snow.

March 31, 2021-Area 2,3 4 from Expansion Area

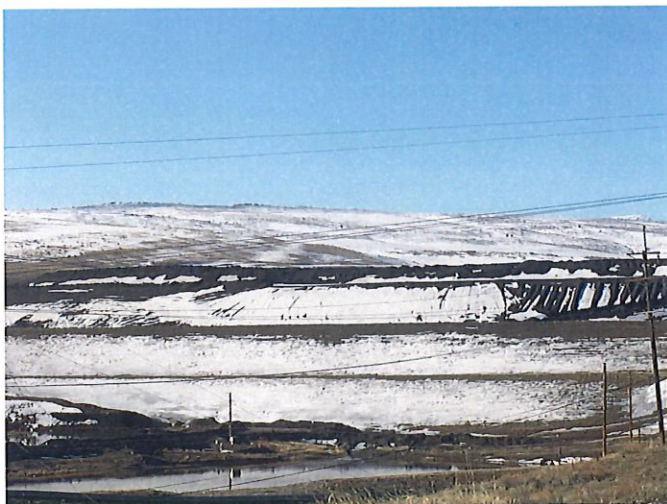
March 31, 2021-Benches on East Side of Refuse Pile

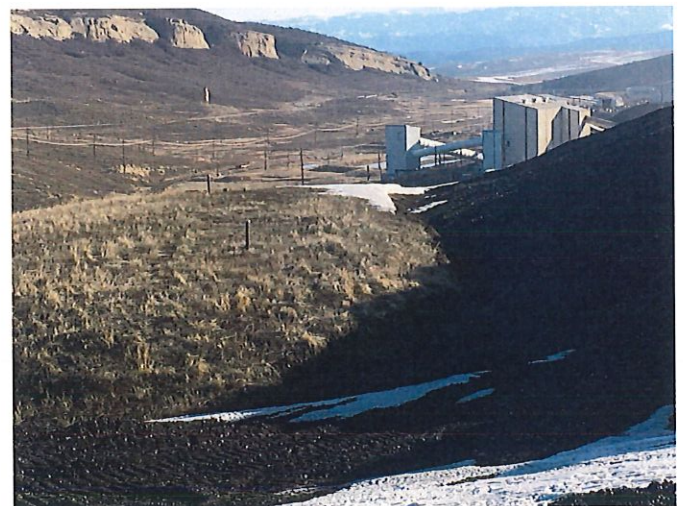
March 31, 2021- RW#1 and RW#2, North of Expansion Area
