Job Number: 99-3983

Subject: Quarterly Observation Report, Refuse
Pile, Foidel Creek Mine, Routt County, Colorado.

TCC Refuse Pile-Quarterly Inspection

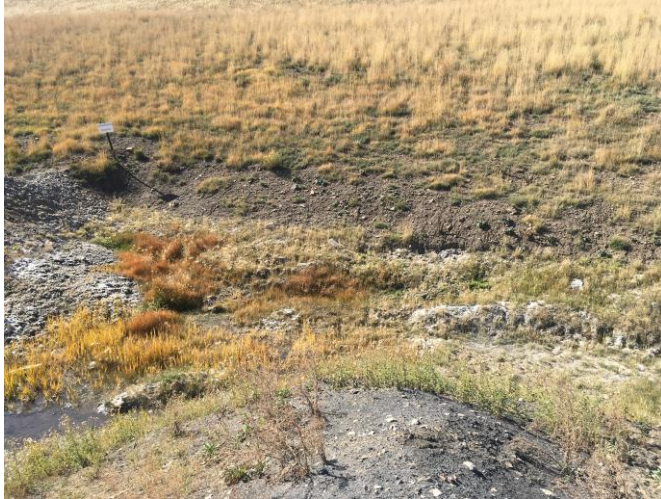
A seepage area at the toe of the northeast end of the refuse pile expansion area, approximately 30 feet northwest of the outlet of the underdrain, developed in fall 2014. At the time of our observations, the seepage was surfacing at the toe of the slope and flowing into the drainage from the undrain outlet then into the existing pond east of the Refuse Pile Expansion Area. The discharge was clear, with no evidence of sediment. No signs of washout, slumps or slope instability were observed at this time. The seepage area

September 29, 2023-Drain Outlet and Seepage Area

will be monitored during future inspections and noted in our inspection reports. Photographs of the seepage area taken at the time of our inspection on September 29, 2023 are attached.

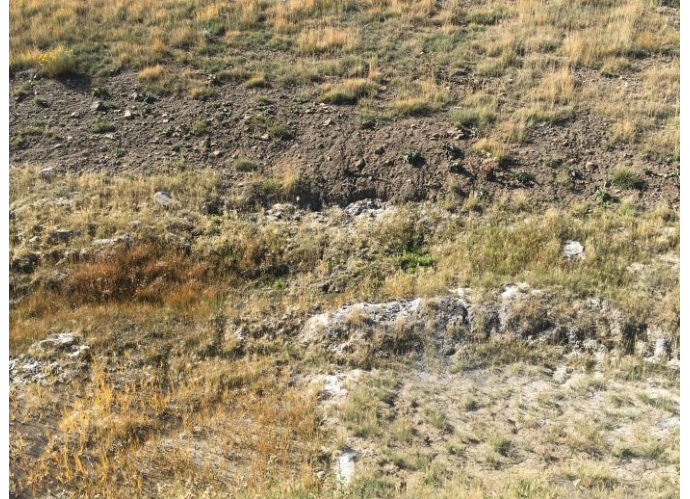
September 29, 2023-Seepage Area

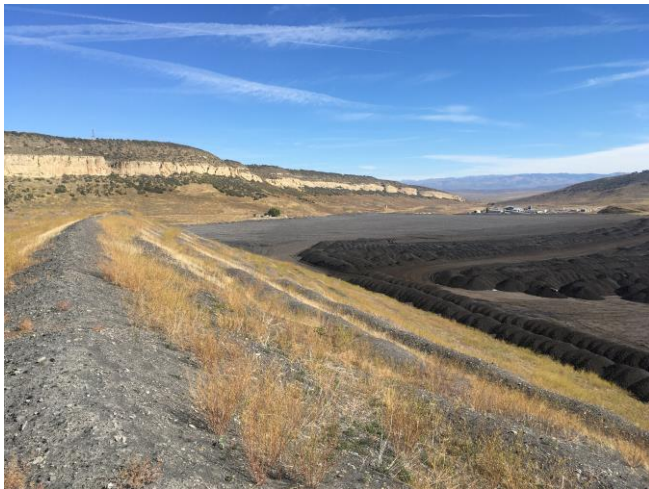
At the time of our site visit on September 29, 2023, NWCC completed a site inspection of the existing refuse pile. Based on our observations made during this visit, it appeared that the contractor was presently stockpiling, grading and compacting refuse coal in the new Expansion Area. At the time of our site visit, the refuse coal had been placed and compacted to an elevation above the third bench situated along the east side of the stockpile.

September 29, 2023- Expansion Area from Areas 2, 3 and 4

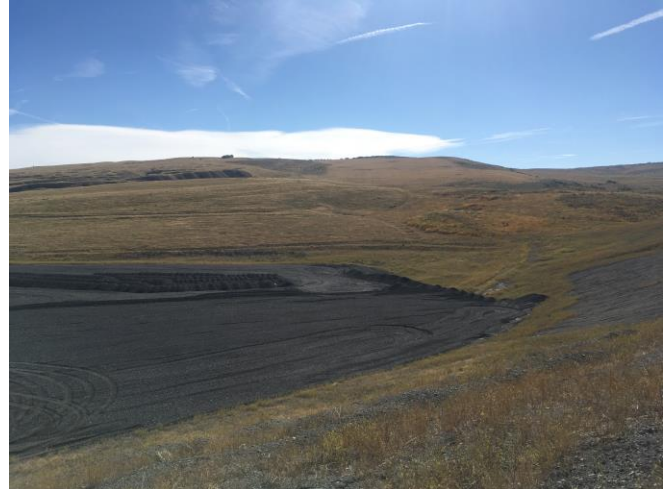
September 29, 2023- SW End of Drain in Expansion Area

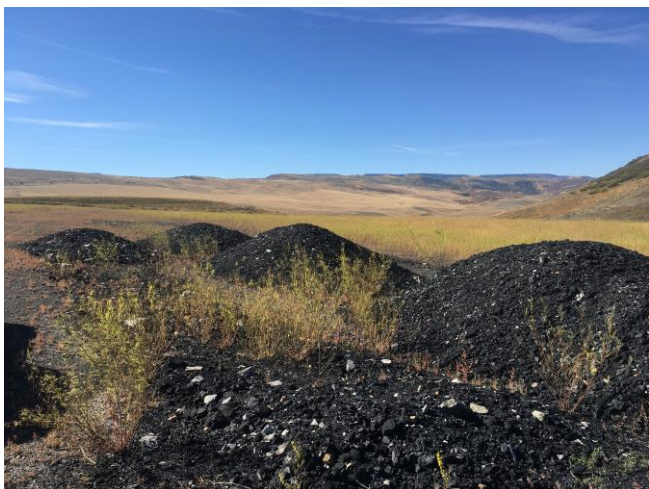
The internal roadways in the new expansion area of the pile are in good condition. The upper haul road to Areas 2, 3 and 4 of the refuse pile was accessible at the time of our site visit and in good condition.

September 29, 2023- Areas 2, 3 and 4

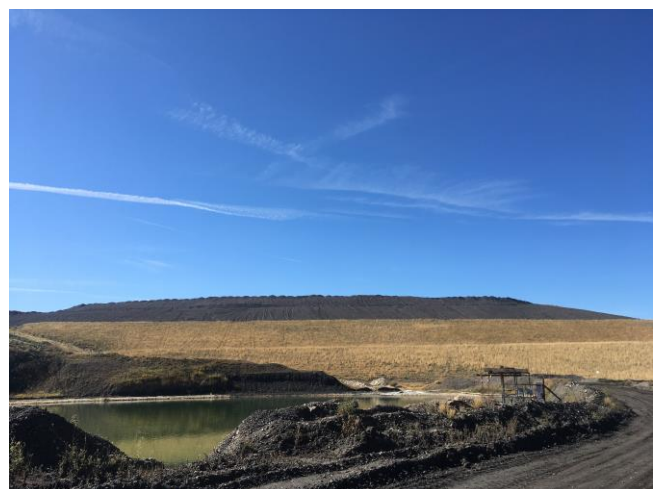
September 29, 2023- Benches on East Side of Refuse Pile
