## Keenesburg Mine Site Inspection Report

3rd Quarter

9/22/2023

# COORS ENERGY KEENESBURG MINE

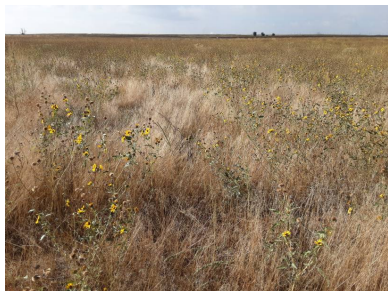
Dense and widely spread Cheatgrass. No mow or reseed fall 2023 to avoid disturbing ground and spreading seed. Manage by mowing prior to seed set 2024 and reseed fall 2024, if appropriate (Photo 1).

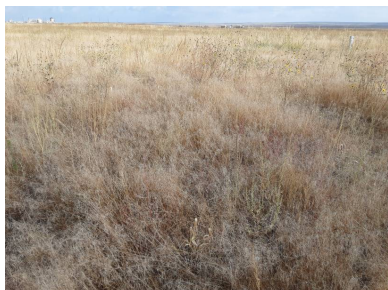
Dense cheatgrass in Area. Minimal desirable vegetation noticeable. No mow or reseed fall 2023 to avoid disturbing ground and spreading seed. Manage by mowing prior to seed set 2024 and reseed fall 2024, if appropriate (Photo 3).

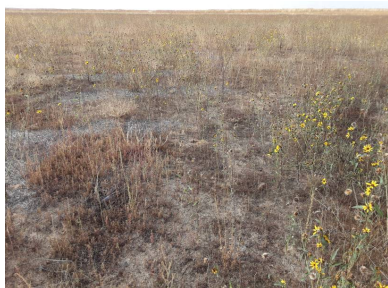
Mow area in preparation for fall seeding. Noted Russian thistle stunted, check for soil compaction or soil fertility issues prior to overseeding (Photo 4).

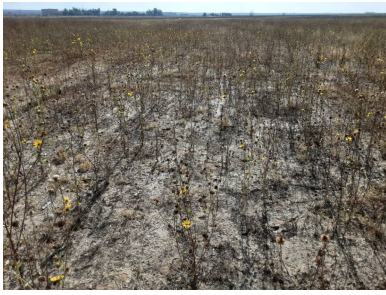
No sheet flows observed in areas where erosion was recorded prior to revegetation. Likely a result from deep ripping in a north to south direction during spring 2022 revegetation work (Photo 5).

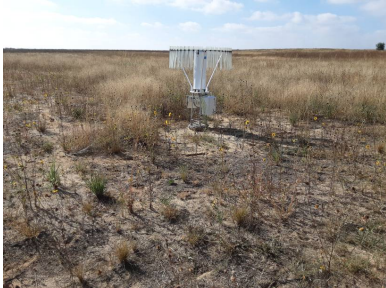
Weather station appears functional (Photo 6)

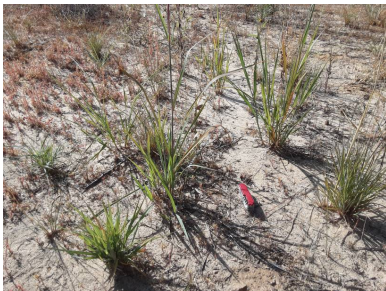
Warm season grasses starting to establish and become more predominant in revegetation areas (Photo 7).

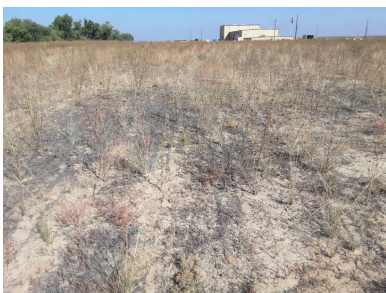
Area marketed for fall reseeding may not be necessary with warm season grasses starting to establish. Continue to monitor spring 2024. No mow fall 2023 to allow warm season grasses to set seed and preserve old vegetation cover to help soil surface from drying out over wintering months (Photo 8).

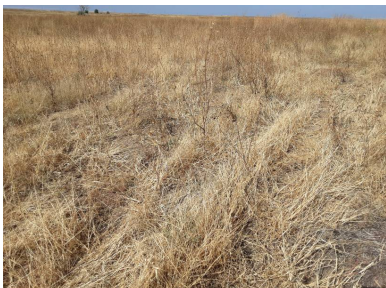
Dense sandbar grass in area. Though native, avoid dispersal during mowing and other fall revegetation activities (Photo 9).

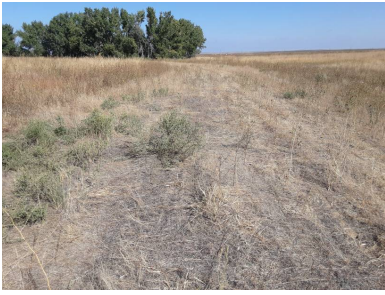
Dense cheatgrass on old haul road and revegetation area. No mow or reseed fall 2023 to avoid disturbing ground and spreading seed. Manage by mowing prior to seed set 2024 and reseed fall 2024, if appropriate. Buffalograss also dispersed amongst cheatgrass (Photo 10).
