Denver Field Branch Inspection Narrative

Permittee: Twentymile Coal, LLC Facility: Foidel Creek Mine

Permit No: C-82-056
Date of Inspection: May 2, 2023
Inspection Type: Partial Oversight

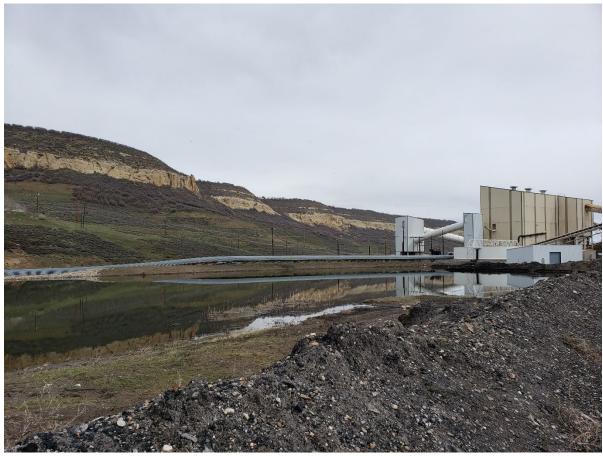
This was a partial oversight inspection focused on ponds and facilities (Figure 1). Although snow melt had commenced for the year, we were still not able to access some areas due to flooding and soft ground conditions.

Figure 1 - An overview picture of a section of the facilities: overall, the site was stable at the time of inspection

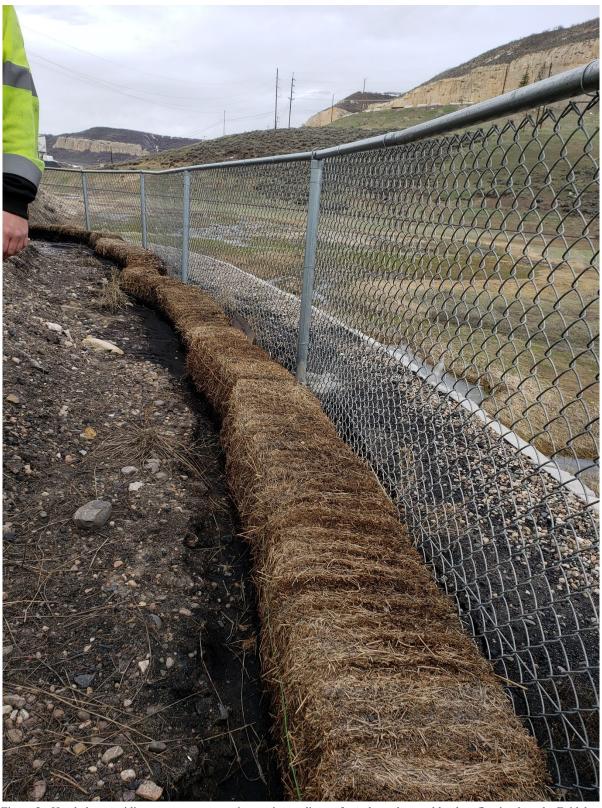
An issue with proper sediment control and drainage, first recorded by DRMS in their June 16, 2022, inspection report, still exists. The June 16, 2022 inspection report describes the issue in general terms, showing two pictures of the sediment jumping a retaining wall that separates the loadout from the Foidel Creek drainage as; "...runoff that is not adequately being captured from disturbed areas." The subsequent July 27, 2022, DRMS inspection report repeats this determination and requires the operator to provide the site with adequate temporary sediment control. DRMS found the site to be unimproved according to the August 17, 2022, inspection report and required the operator to inform the Division how the grading/sediment control issue will be corrected by September 30, 2022. DRMS's September 17, 2022 confirmed the operator had taken steps to correct the problem, and subsequent inspection reports have provided more detail and photographs to support this determination.

At the time of inspection control measures were installed and providing some protection against sediment reaching the Foidel Creek including:

- hay bales (Figure 2),
- silt fencing (Figure 3), and
- an open ditch leading to a drainpipe that directs flow to a pump house that sends it into Pond E.

Figure 2 - Hay bales providing temporary protection against sediment from the stoker coal loadout flowing into the Foidel Creek drainage.

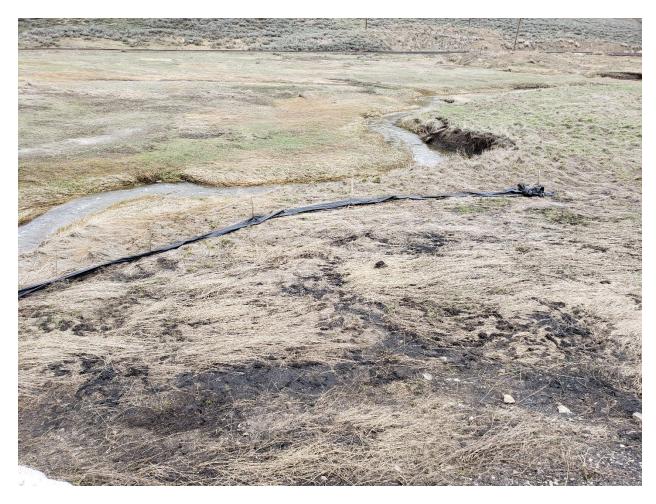
Figure 3 - Silt fence installed to prevent sediment from the stoker coal loadout from reaching Foidel Creek. This fence is in need of repair or removal, and the sediment requires removal.

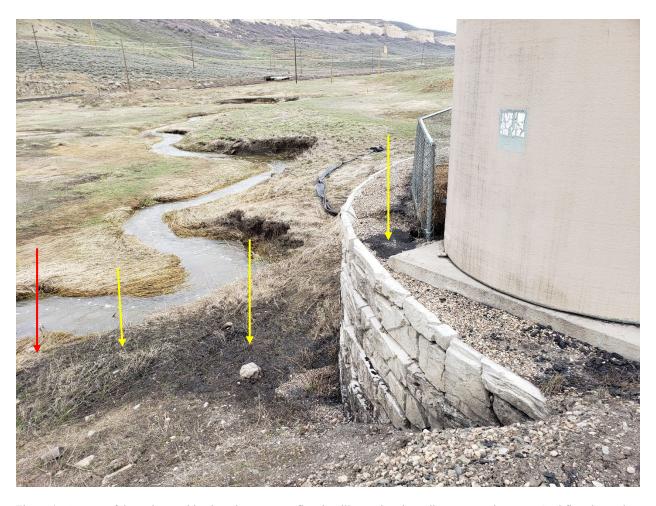
Figure 4 - An area of the stoker coal loadout that suggests flow is still escaping the sediment control system. Coal fines located beyond the hay bales at a location of significant erosion behind the retaining wall (yellow arrows) are also not currently sequestered behind any sediment control (red arrow).

With the current system there is evidence that flow continues to reach the stream buffer zone, as it does not appear that sediment control measures are placed around the entre disturbance (Figure 4). The operator plans to improve this system by coating the inside of the loadout with a spray-on lining and connecting a drainpipe directly to the pumphouse to prevent uncontrolled leaks of wash water and sediment from exiting the loadout building. Upon further analysis OSMRE recommends that the operator ensure any additional flow from this area be directed to ponds designed to accept this flow and to ensure that any existing coal and non-coal waste and sediment controls (e.g. the silt fence in Figure 3, in need of repair or removal) be safely removed from the Foidel Creek drainage. OSMRE will follow up with DRMS to ensure the full function of this system as described in the permit.

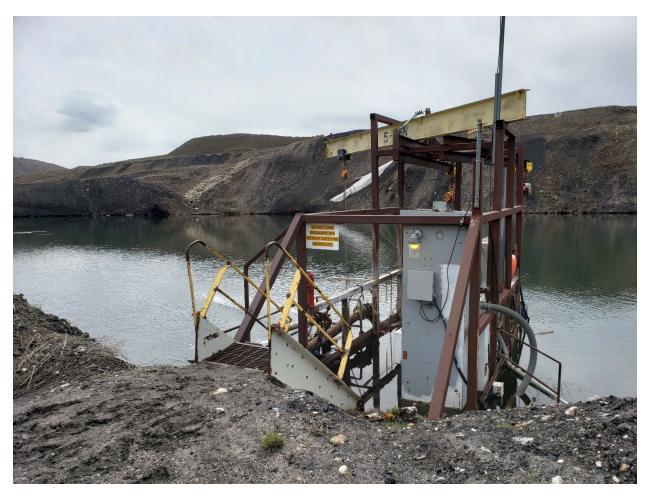
The following ponds were stable, holding water, and functional at the time of inspection: 6MN, Pit (Figure 5), D, and G. All but Pond 6MN were discharging during the inspection.

Figure 5 - Pit Pond: stable, holding water, draining, and fully functional at the time of inspection.
