MINE SITE INSPECTION NARRATIVE

COMPANY: Hayden Gulch Terminal, Inc.

MINE: Hayden Gulch Loadout

PERMIT NO: C-1992-081 (C-081-92 in the OSMRE I and E database)

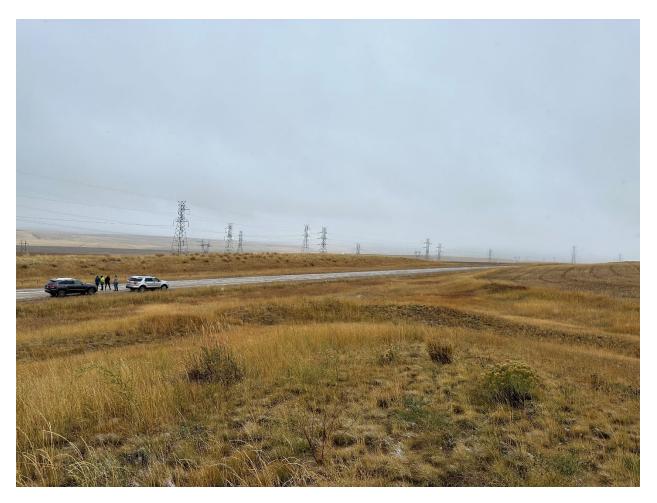
We drove the entire length of the road and walked the permit boundary behind each topsoil storage pile. The road was well-maintained and safe (Figure 1) and the adjacent vegetation (including on the topsoil storage piles and within ditches) was established and self-sustaining (Figure 2). No significant erosional or stability issues were observed. No enforcement actions were taken in response to this inspection.

Figure 1 - A section of the road as seen from the top of a topsoil storage pile. The entire length of the road was well maintained and safe.

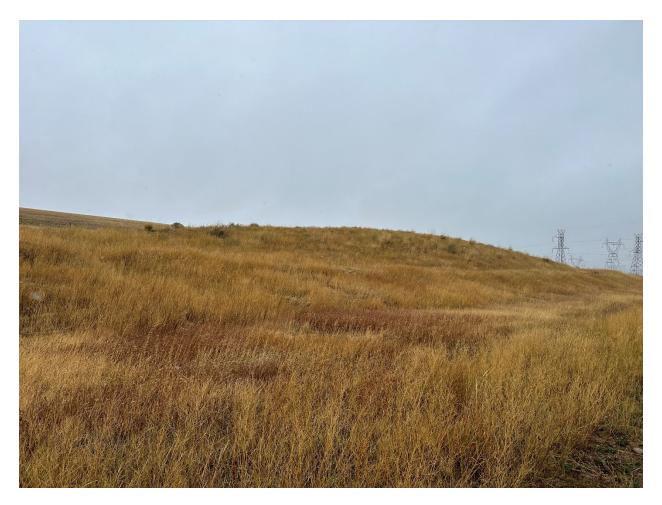
Figure 2 – An example of the well established and self-sustaining vegetation on the permitted lands adjacent to the road.
