## Bernhardt inspection report

**MINERALS PROGRAM INSPECTION REPORT**  
**PHONE: (303) 866-3567**

<b>MINE NAME:</b> Bernhardt Sand and Gravel Pit	<b>MINE/PROSPECTING ID#:</b> M-2023-025	<b>MINERAL:</b> Sand and gravel	<b>COUNTY:</b> Weld
<b>INSPECTION TYPE:</b> Preoperation Inspection	<b>WEATHER:</b> Clear	<b>INSP. DATE:</b> November 9, 2023	<b>INSP. TIME:</b> 08:45
<b>OPERATOR:</b> IHC Scott, Inc.	<b>OPERATOR REPRESENTATIVE:</b> Andy Carpenter, JC York	<b>TYPE OF OPERATION:</b> 112c - Construction Regular Operation	
<b>REASON FOR INSPECTION:</b> Preoperation Inspection	<b>BOND CALCULATION TYPE:</b> None	<b>BOND AMOUNT:</b> NA	
<b>DATE OF COMPLAINT:</b> NA	<b>POST INSP. CONTACTS:</b> None	<b>JOINT INSP. AGENCY:</b> None	
<b>INSPECTOR(S):</b> Robert Zuber, P.E.	<b>INSPECTOR'S SIGNATURE:</b>

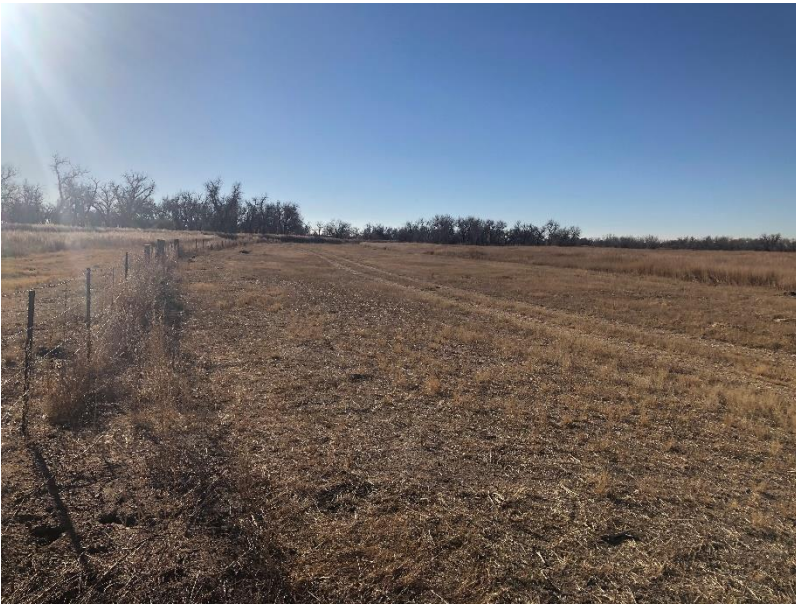
Along the east side, between the site and the South Platte River, there are extensive stands of trees. No wetland areas were observed within the proposed permit boundary. No weed patches were observed. Coyote scat was seen on the west side of the site.

**Looking at east side of site toward river, from NE entrance**

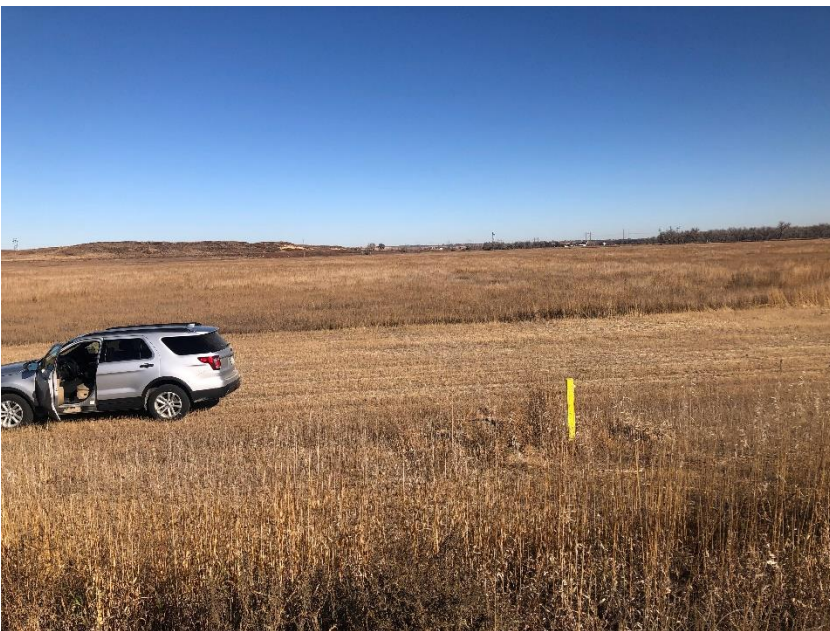
The site is predominantly fallow agricultural land with large amounts of kochia and grasses. It has not been irrigated for two seasons, per Mr. Carpenter. No equipment was onsite. The perimeter has been mowed for access, approximately 20 feet wide.

**Looking north at site from levee on south side of site**

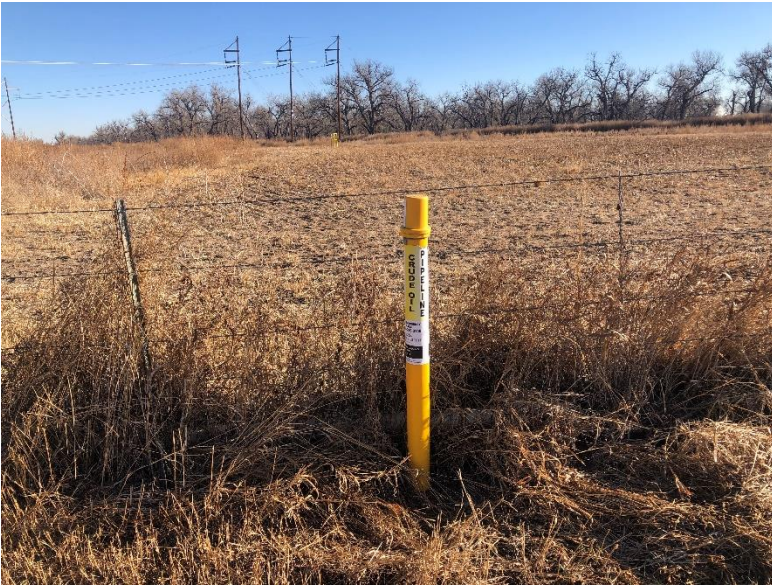
Permanent man-made structures within 200 feet of the proposed permit area are shown on a map in the application (Map C-1). These include the fence, a power line, railroad tracks and a trestle, dirt roads, water pumps (owned by IHC Scott), monitoring wells (owned by IHC Scott), abandoned oil/gas wells, and oil/gas lines. Several markers were seen indicating underground oil/gas lines. No ponds or irrigation ditches were seen in the vicinity of the proposed permit area. The map appears to be accurate with one exception: the power line to the pumps is not shown. However, this line is owned by IHC Scott, and this is not a concern of the Division. The adjacent landowners do not have permanent structures such as houses or barns within 200 feet of the site. The adjacent properties do contain tanks, dirt piles, wood piles, and old equipment.

**Oil line marker near NE entrance**

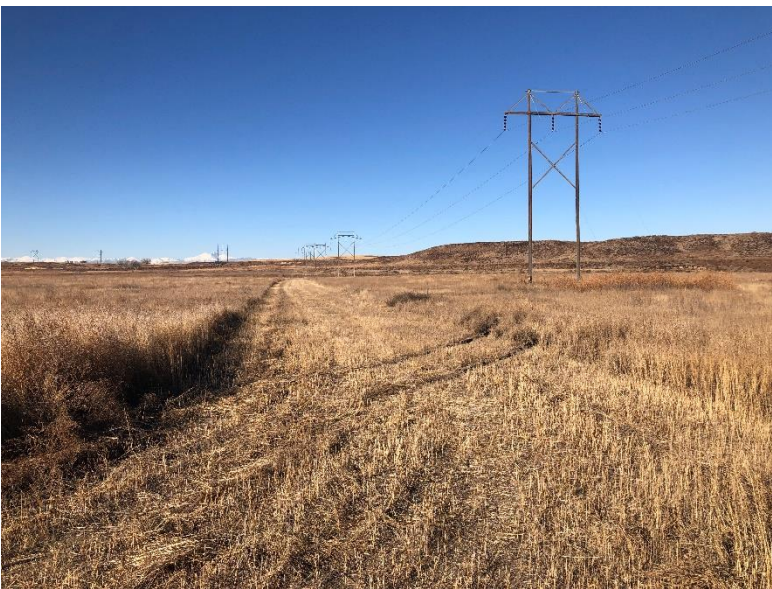
**Public Service power line on north side of site**

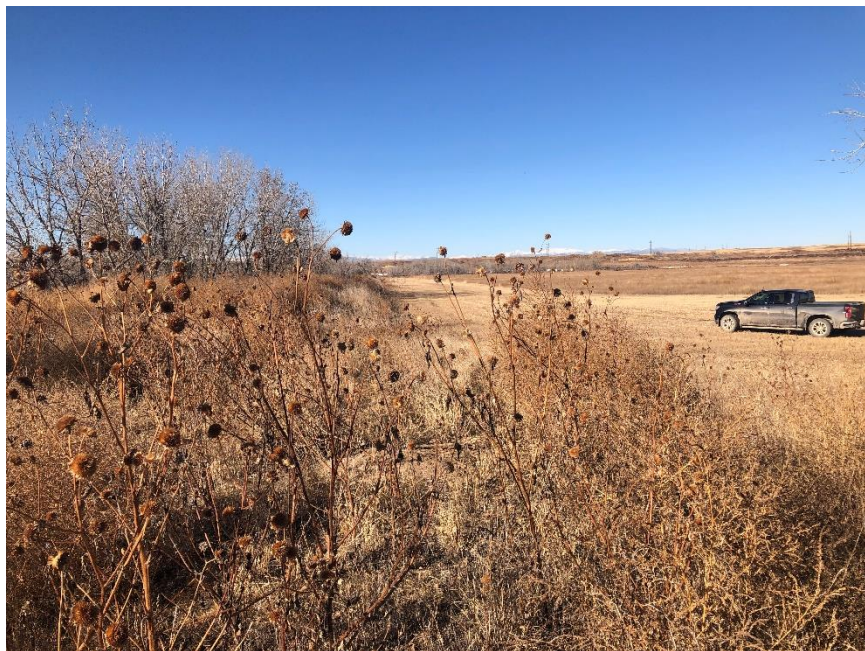
Along the south and east sides of the site, 5' – 10' levees were observed. These have been in place for decades, per Mr. Carpenter.

Levee on south side of site

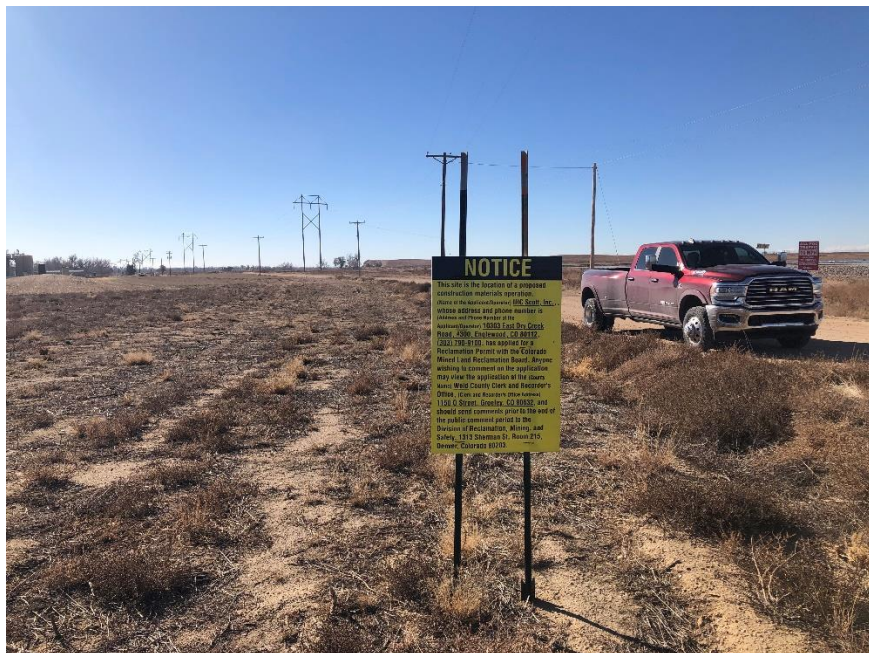
The required notice sign was posted at the entrance of the site off WCR46.

Notice at WCR46
