## Inspection Report, Peabody Sage Creek Mine, C-2009-087

**PERMIT INFORMATION**

**INSPECTION INFORMATION**

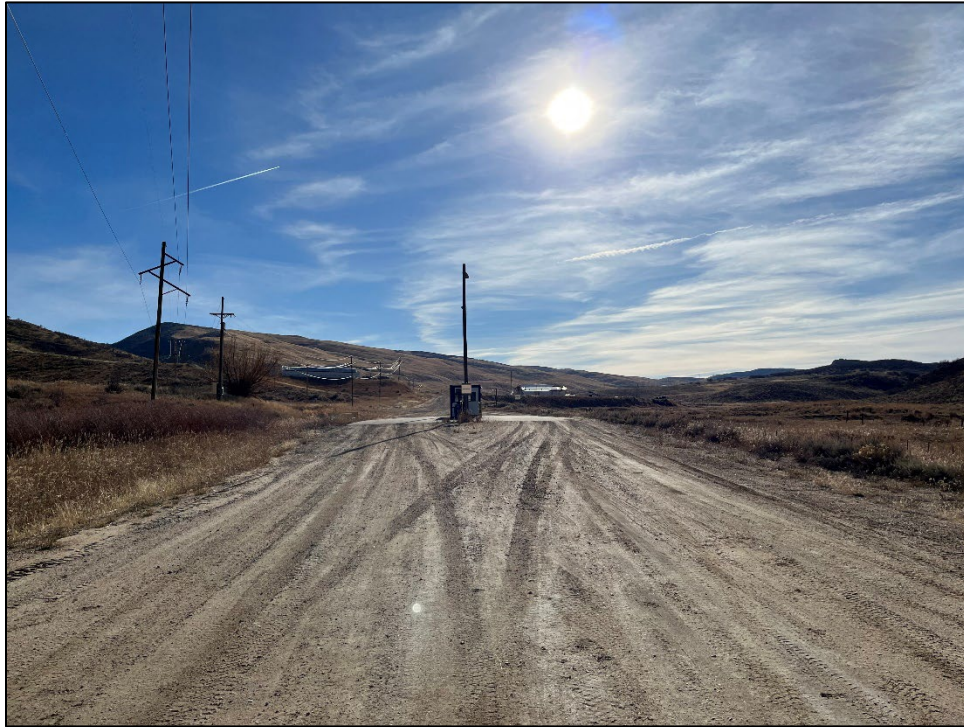
Mine identification markers were observed throughout the site. A scale, scale house, and office buildings are near the site entrance (Photo 1).

*Photo 1: View south of the scale and scale house area.*

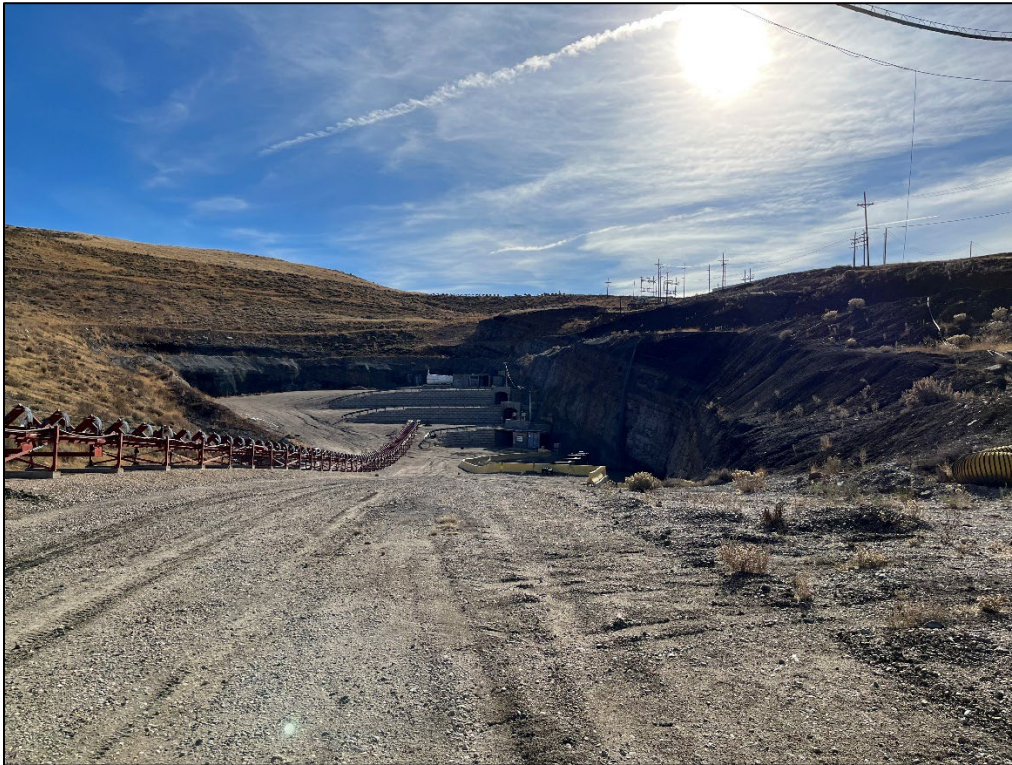
Mine water and snowmelt are no longer being continually pumped at the portal entrance (Photo 7). The float system which automatically turns on pumps when needed at the portal entry is still in place. A natural spring

*Photo 7: View east of the portal entries.*

- The ditch around the portal area needs to be cleared of cattail growth to maintain proper drainage in the area.
- Additional disturbance markers are recommended.
- Culvert at NPDES #7 needs to be repaired.
- Continue to monitor the pipe below Pond 002 for leakage or blowout.

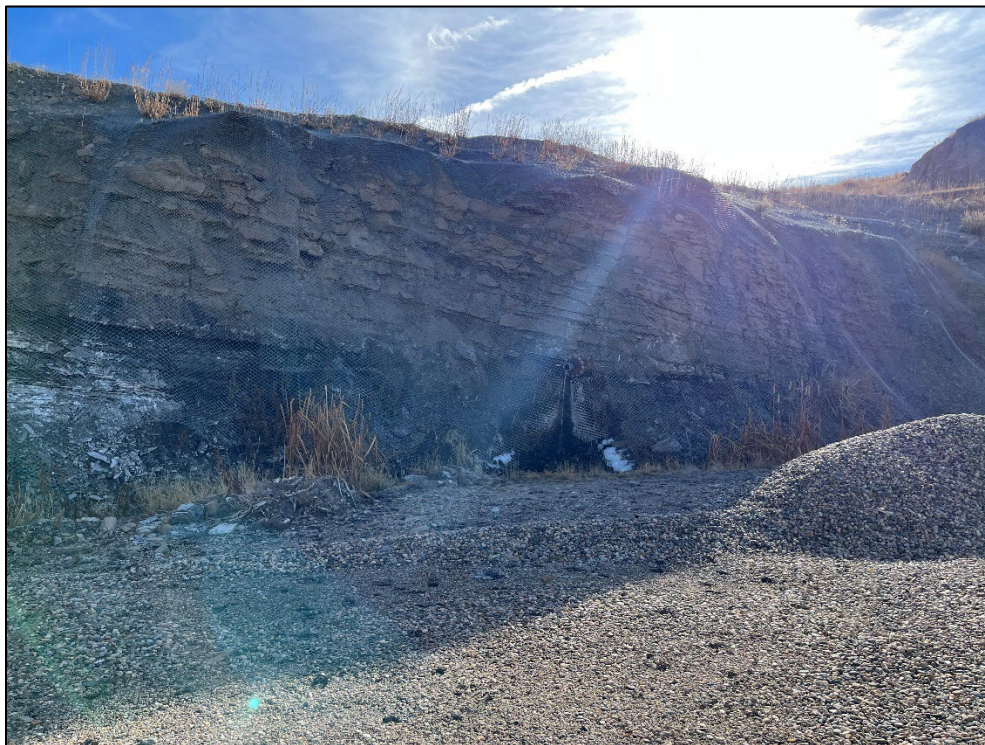
leeches from the walls at the portal entries. A series of ditches capture and carry this water to be pumped back out of the portal area (Photos 8 and 9).

*Photo 8: A natural spring leeches from a wall at the portal entries. Ditches capture and carry this water to be pumped back out of the portal area.*

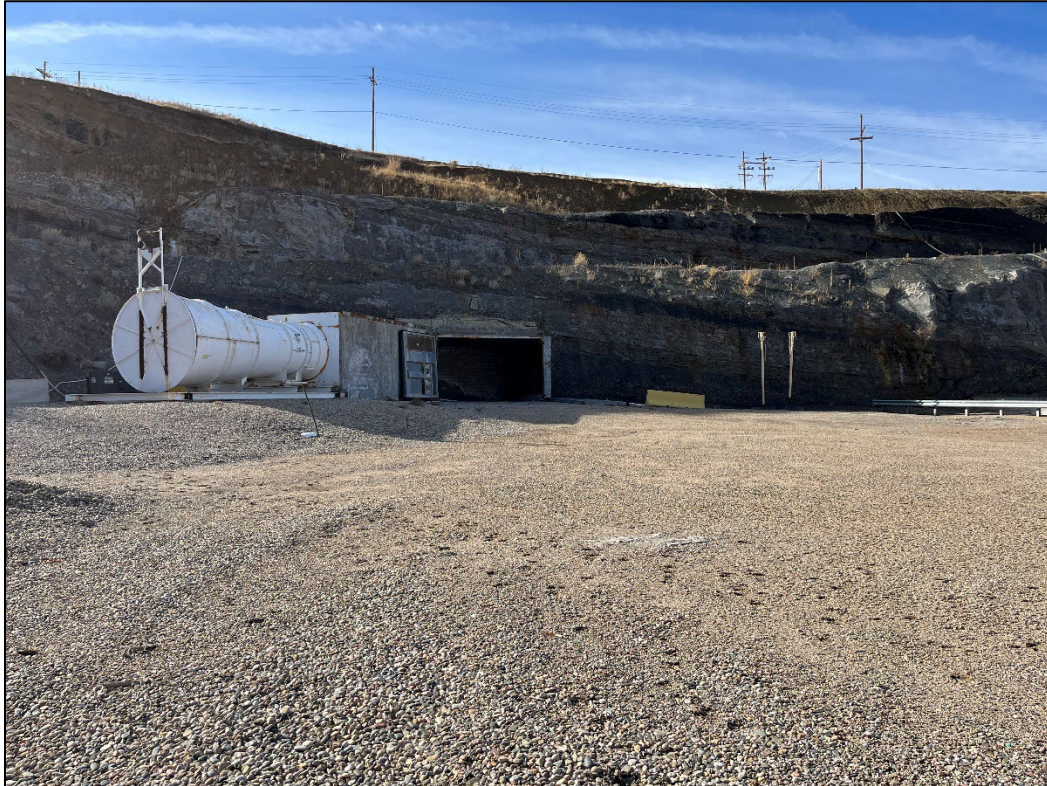
*Photo 9: View south of one of three portal entries.*

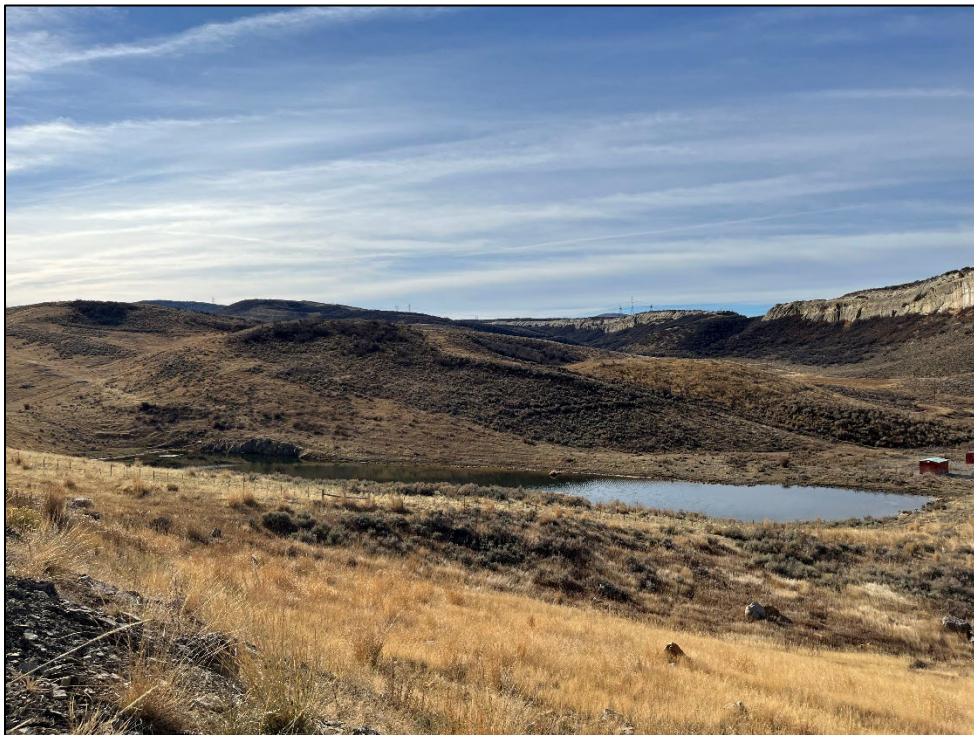
All ponds and sumps at the site were discharging at the time of inspection with no erosional features noted (Photos 2, 4, 5, 10, and 11). NPDES #7, located by the site’s main office buildings, was also discharging. However, the southeastern culvert of NPDES #7 needs repair (Photo 12). Flow was not completely blocked off from this point, but repair of the crushed culvert is required for full function. This has been added as a maintenance item. **Please inform the Division when the appropriate repairs have been completed.**

There is one large topsoil pile onsite located adjacent to the Pecoco pond (Photo 10). The pile appears stable, well vegetated and undisturbed. A small, orange flag marks this pile as topsoil.

*Photo 10: View southwest of Pecoco Pond and Topsoil Pile A.*
