MINERALS PROGRAM INSPECTION REPORT
PHONE: (303) 866-3567

MINE NAME: Slab Canyon Quarry	MINE/PROSPECTING ID#: M-1977-347	MINERAL: Limestone (general)	COUNTY: Larimer
INSPECTION TYPE: Surety Release Inspection	WEATHER: Clear	INSP. DATE: November 1, 2023	INSP. TIME: 10:00
OPERATOR: Holcim (US) Inc.	OPERATOR REPRESENTATIVE: Mike Toelle	TYPE OF OPERATION: 112c - Construction Regular Operation	
REASON FOR INSPECTION: Acreage Release Requested (AR1)	BOND CALCULATION TYPE: None	BOND AMOUNT: \$184,819.00	
DATE OF COMPLAINT: NA	POST INSP. CONTACTS: None	JOINT INSP. AGENCY: None	
INSPECTOR(S): Nikie Gagnon Amy Eschberger Jocelyn Carter	INSPECTOR'S SIGNATURE:

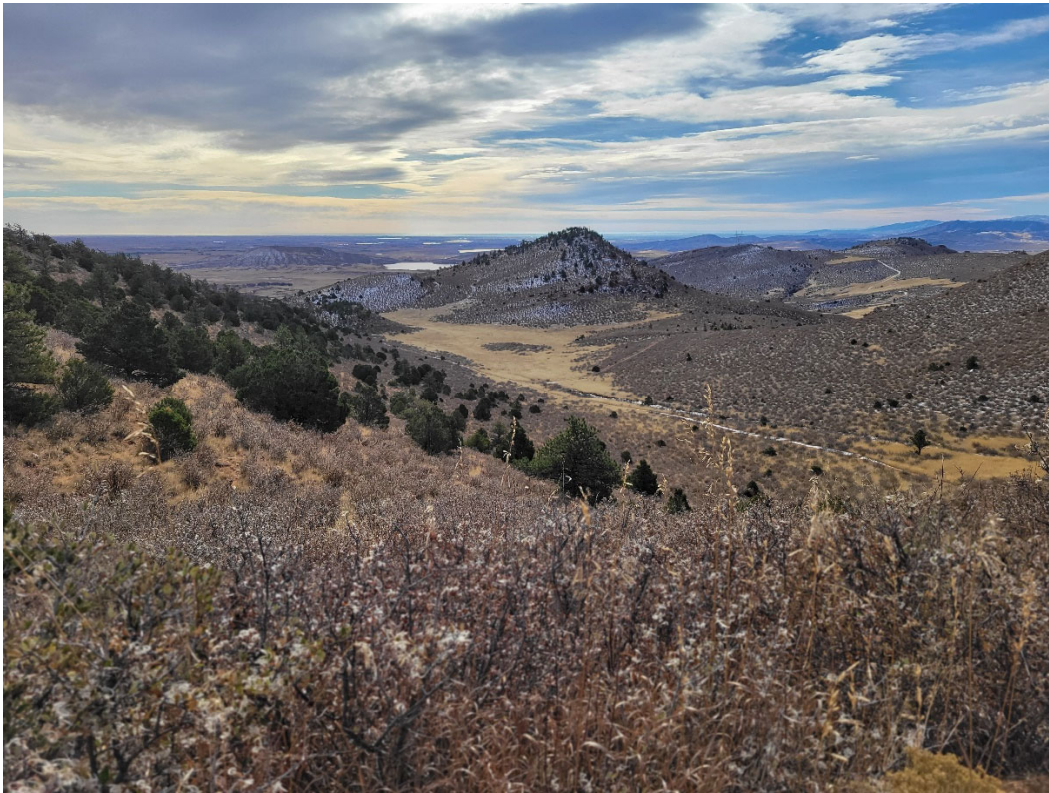
Photo 1: View looking southeast down an undisturbed valley at the southern end of the permit area.

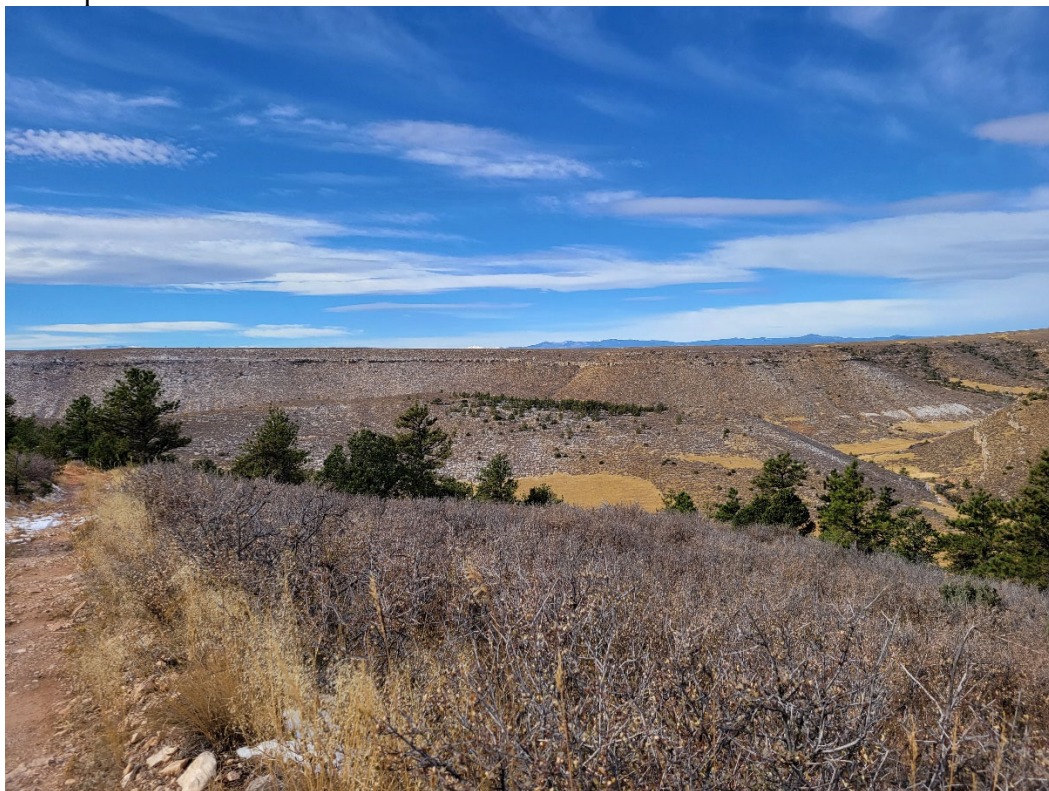
Photo 2: View looking southwest across undisturbed portion of the permit area south and west of the Phase 1 area.

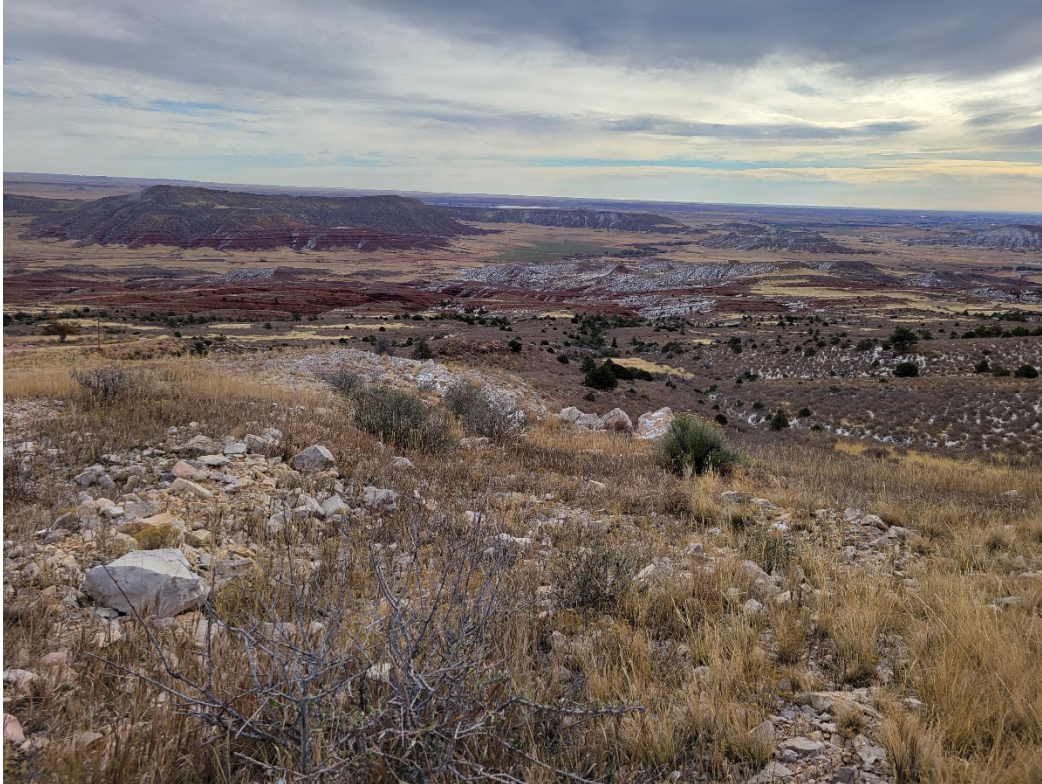
Photo 3: View looking southeast at undisturbed portion of the permit area from the southern edge of the Phase 1 mining area.

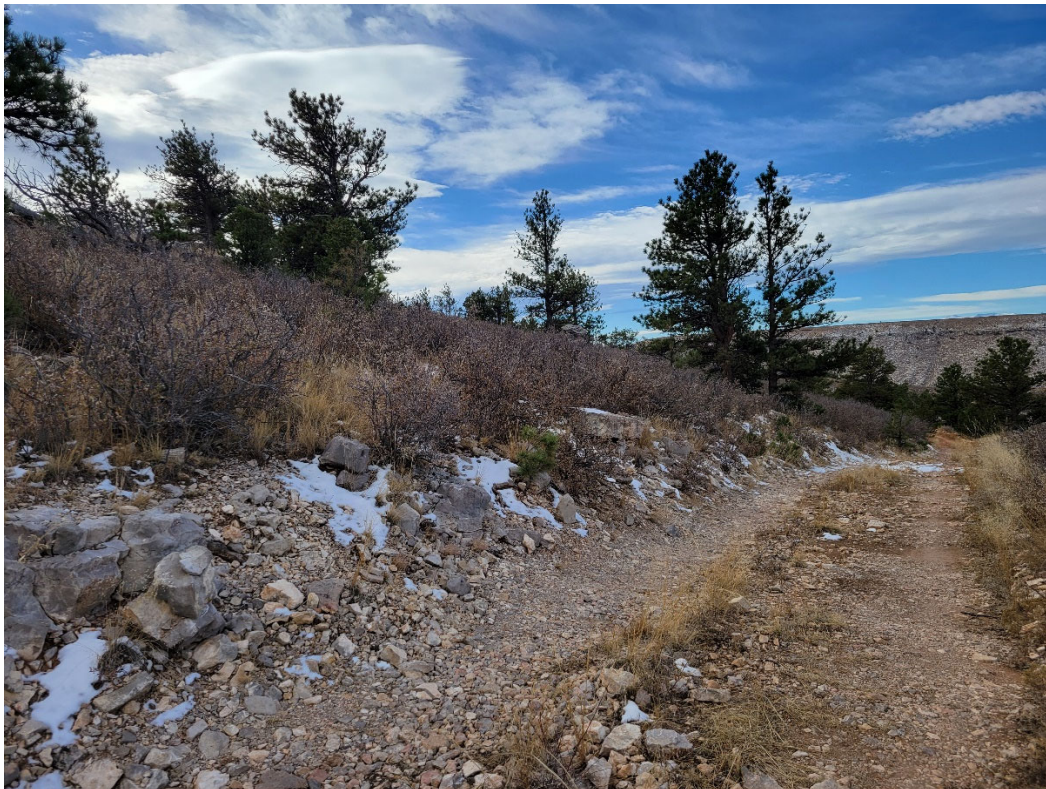
Photo 4: Two track road that runs along a ridge in the western portion of the permit area. This road will remain after release.

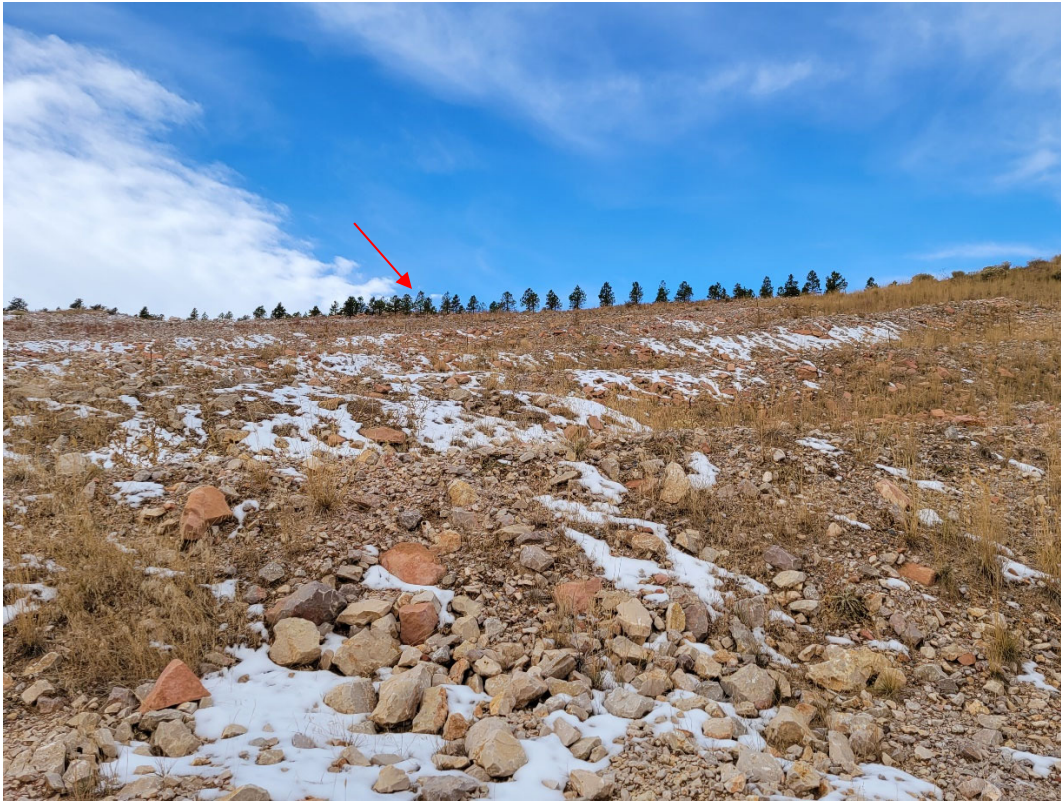
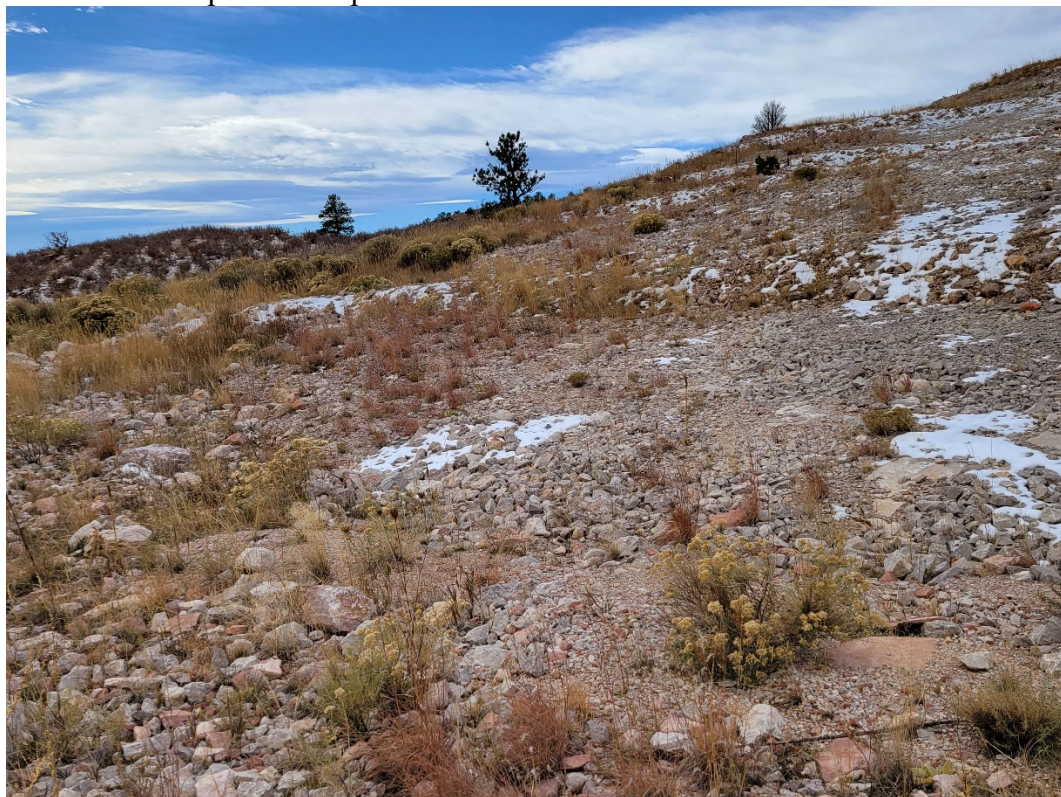
The Operator continues to monitor reclamation of the 35 acres, particularly on the east facing slopes, on the southeastern edge of the disturbance, where significant reclamation work has occurred over the years. Per the approved reclamation plan, the Operator installed tree pads across the top of the slope to capture and retain stormwater. During this inspection, the Division observed the tree pads and noted the pads are well vegetated with grasses, shrubs, and pine trees. The Division also observed the bottom half of the east-facing slope. Native grasses are growing in the trenches on the reclaimed slope and along the edges of the slope.

Photos 5 & 6: Reclaimed slope in the southeastern portion of the 35-acre disturbance area. Native grasses and shrubs noted growing in the trenches and along the edges, gradually filling in the disturbed slope. Arrow points to tree islands at the top of the slope.

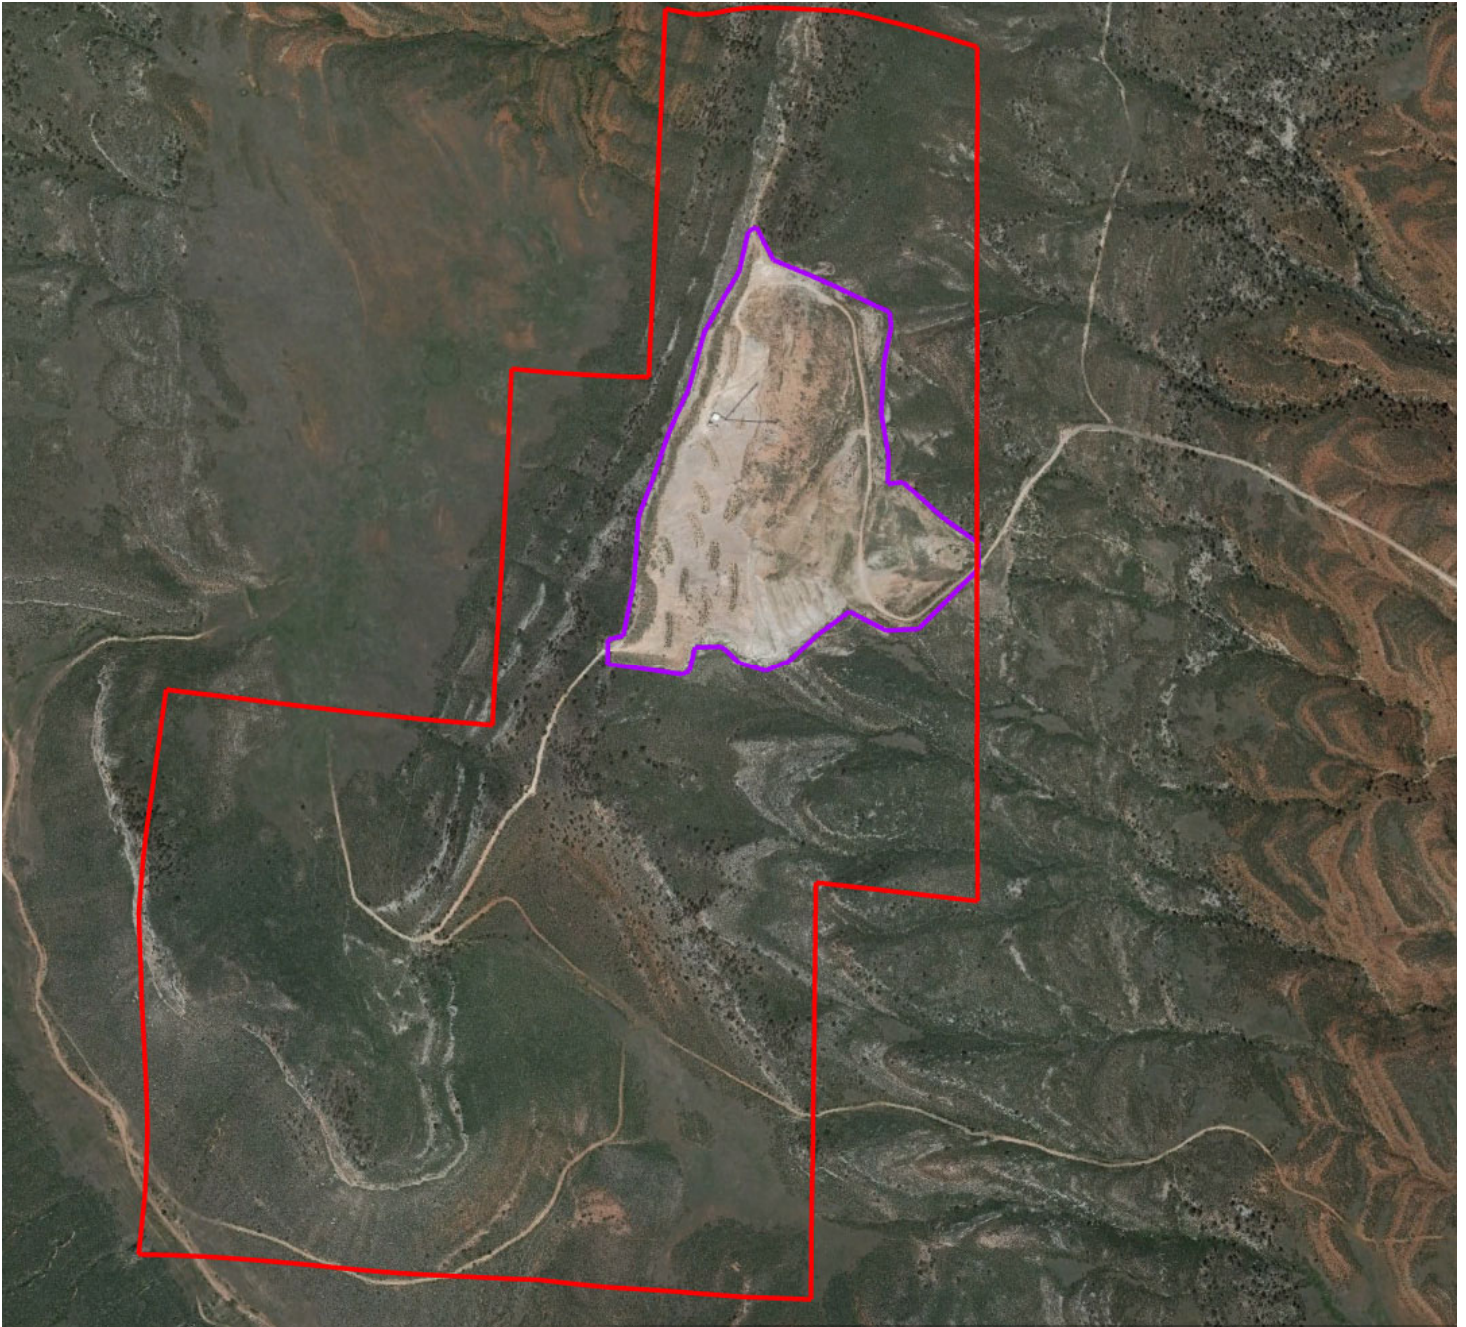
Figure 1: Google Earth image dated June 11, 2021. Red boundary line shows the 1994 Amendment 1 250-acre permit area. The purple line shows the 35-acre Phase 1 mining disturbance area that will remain in the permit after this release.
