## Inspection report for Greeley West Pit

**MINERALS PROGRAM INSPECTION REPORT**  
**PHONE: (303) 866-3567**

<b>MINE NAME:</b> Greeley West Pit	<b>MINE/PROSPECTING ID#:</b> M-1977-081	<b>MINERAL:</b> Sand and gravel	<b>COUNTY:</b> Weld
<b>INSPECTION TYPE:</b> Monitoring	<b>WEATHER:</b> Clear	<b>INSP. DATE:</b> December 19, 2023	<b>INSP. TIME:</b> 09:50
<b>OPERATOR:</b> Cottonwood Land and Farms, LLC	<b>OPERATOR REPRESENTATIVE:</b> Mike Hart and Whitey Glasser	<b>TYPE OF OPERATION:</b> 112c - Construction Regular Operation

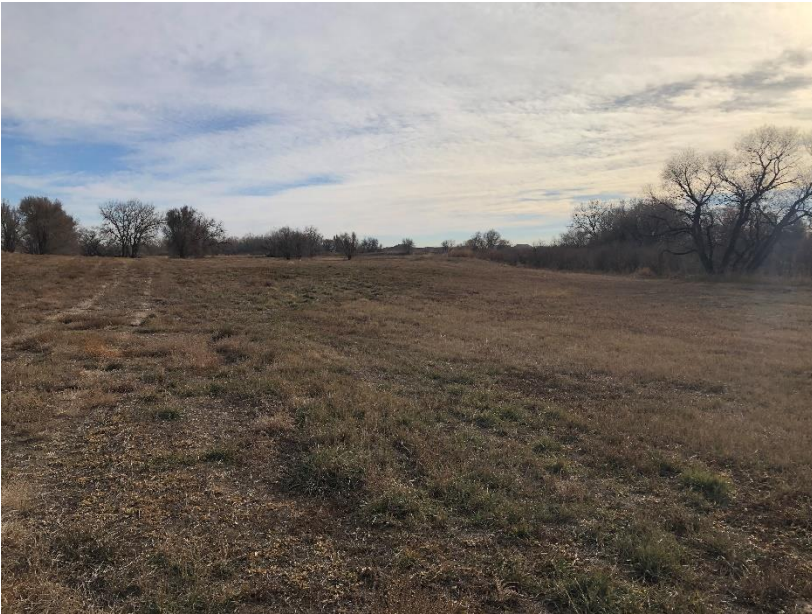
Per the Cottonwood representatives, reclamation has been performed at the site, but it was not related to mining activity; it was done by Noble Energy. Per the Annual Report Map, this reclamation was done in 2019. Currently there is no evidence of a well head or tank battery. However, there are signs on fences indicating gas pipelines. These signs indicate that the pipeline is owned by Duke Energy and another company. The operator needs to determine if the pipeline has been removed (and the signs can be removed) or if the pipeline is still in place.

**Middle of site, near reclaimed gas facility, looking east**

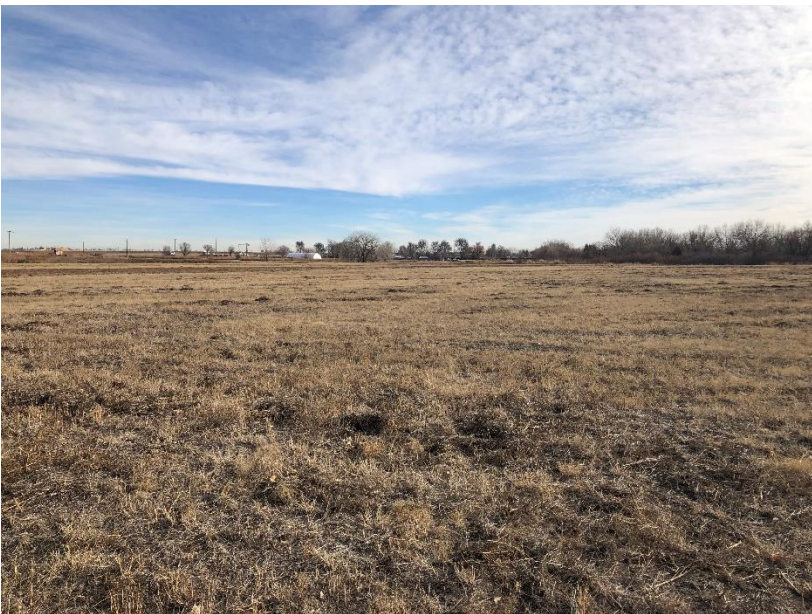
Along the northern boundary, there are no permanent man-made structures within 200 feet. There is a lot of scrap metal and other junk from the adjacent property. The boundary is well marked with t-posts. An access corridor to O Street has been mowed at the northeast corner of the permit area.

**Northern portion of site, looking northeast**

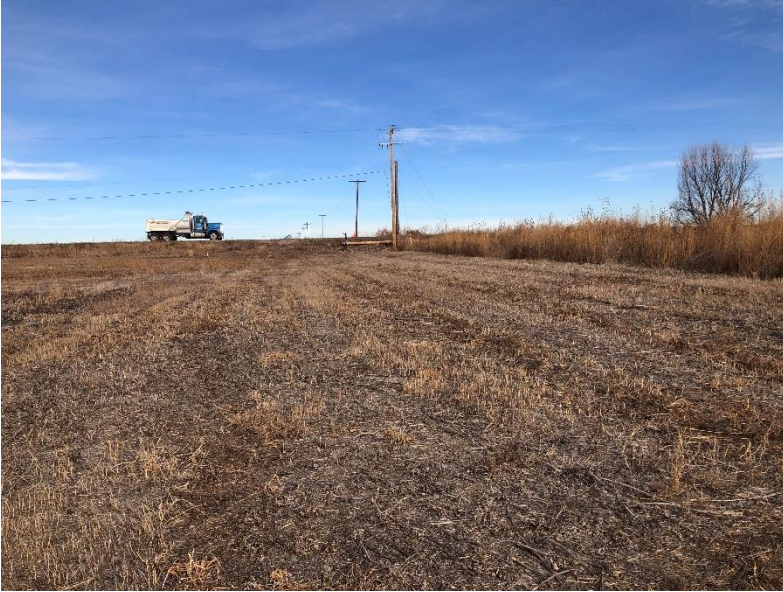
**Looking north at access to O Street, at northeast corner of site**

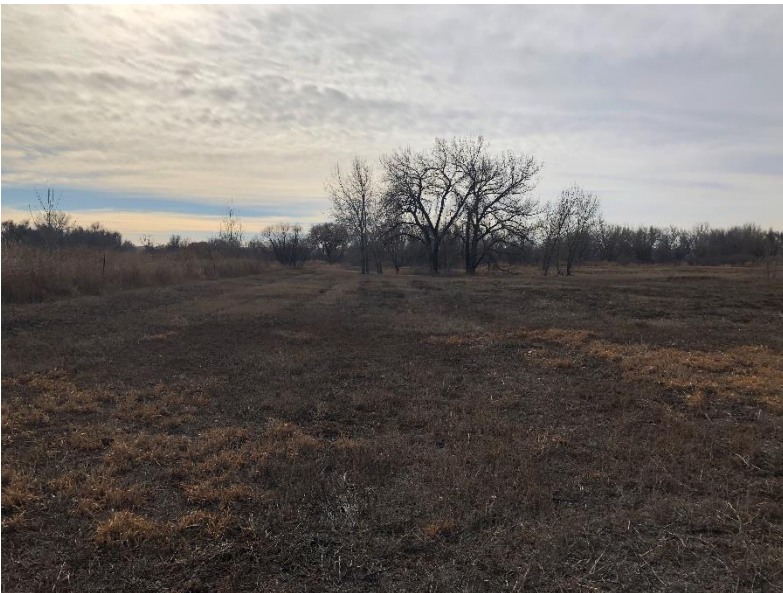
**West side, looking south**

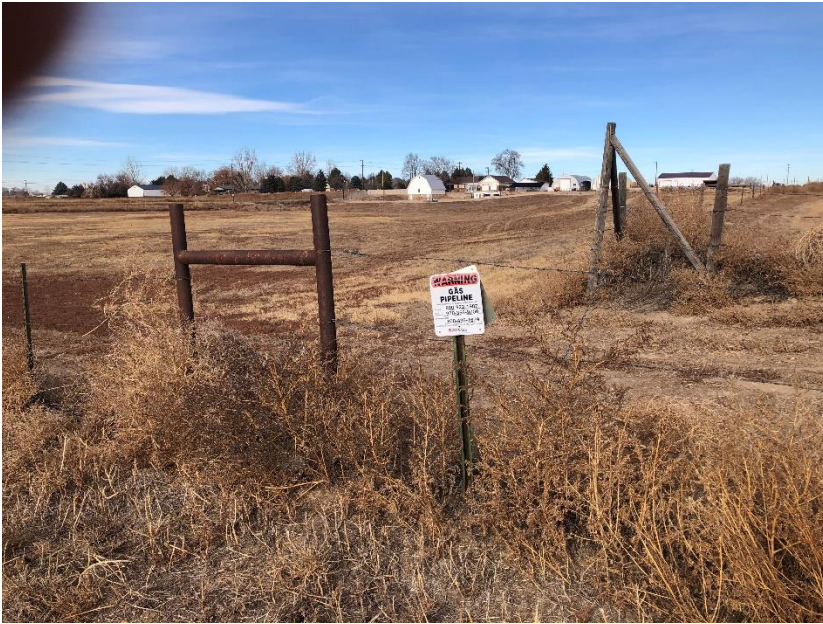
Gas pipeline sign near entrance on west side

Structure agreements are needed for the roads owned by the City of Greeley (35th Avenue and O Street) that are within 200 feet of the locations where haul or access roads are planned. This is not cited as a problem in this report but needs to be addressed. Cottonwood also needs to determine if an agreement is needed for a gas pipeline on the site (see discussion on signs for pipelines).

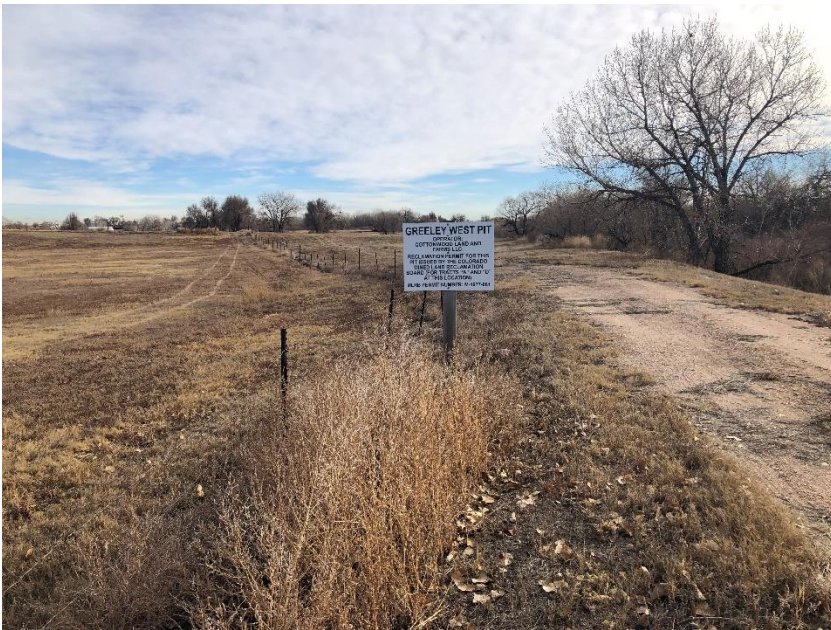
The site was previously inspected by the Division on 28 June 2019 (also a routine monitoring inspection). In the previous inspection, a problem was cited regarding the need for an entrance sign. The mine identification sign was posted at the entrance of the mine site on 19 December 2023, and it contains the necessary information.

Entrance sign on 35<sup>th</sup> Avenue (west side)
