RE: Response to Comment Request // Rolling Hills Gravel Pit // SPA-2023-00586

RE: Rolling Hills Gravel Pit Development Project - Wetland Resources Technical Memorandum

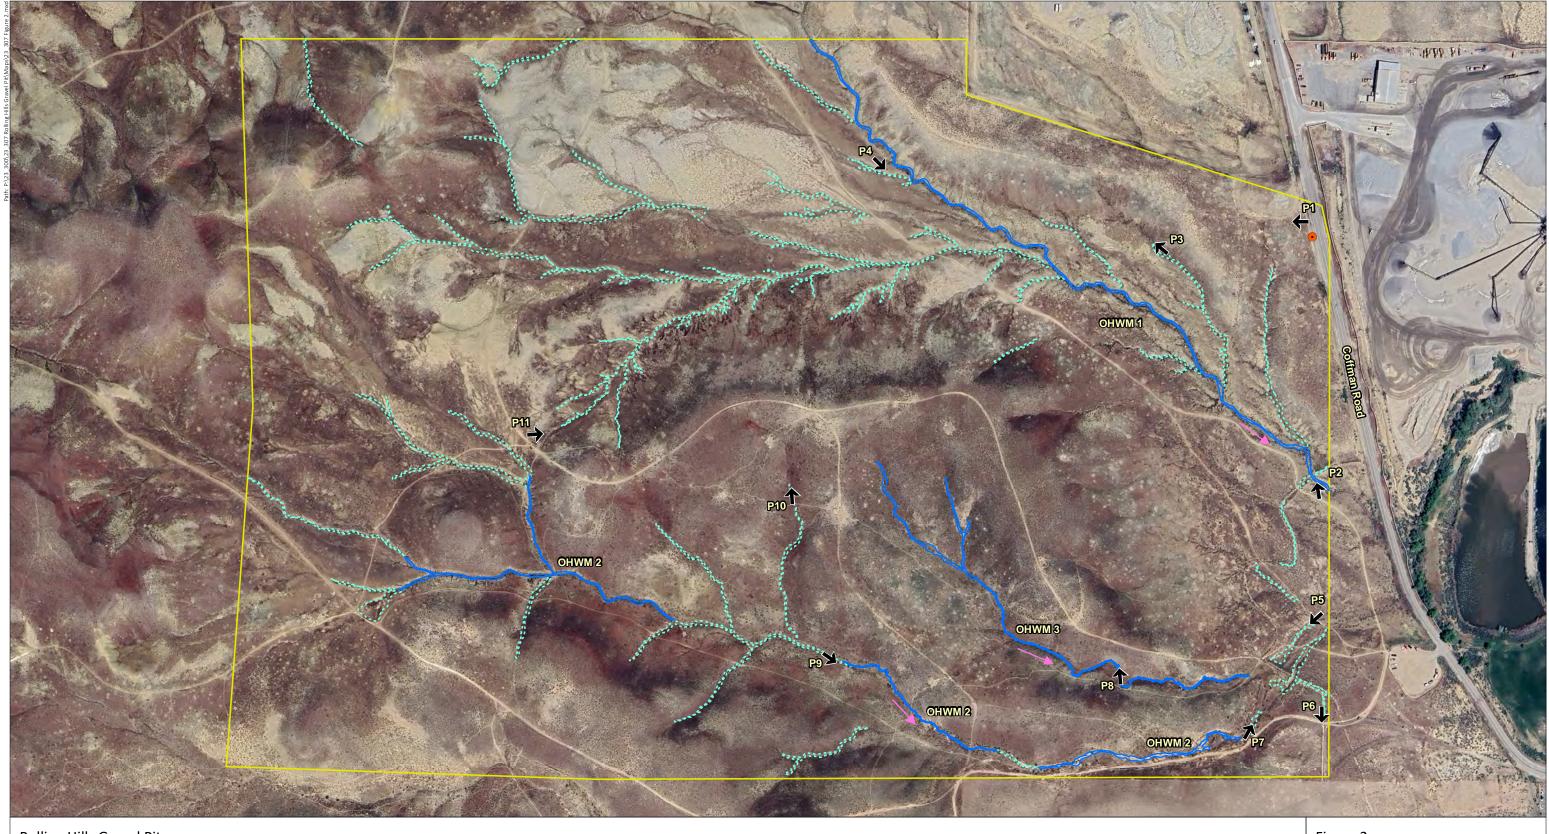
Figure 2 Existing Conditions

ERO documented three sections of OHWM (OHWM 1, OHWM 2, and OHWM 3) that extend throughout the project area and appear to be primarily fed by stormwater runoff and snowmelt from adjacent uplands (Figure 2, attached). Vegetative cover in the project area was scarce and was dominated by nonnative grasses and upland species, and no wetland species were observed during the 2024 site visit. Dominant vegetation species consisted of greasewood (Sarcobatus vermiculatus), kochia (Bassia scoparia), cheatgrass (Bromus tectorum), cactus (Opuntia spp. and Cholla spp.), crested wheatgrass (Agropyron cristatum), and threeawn (Aristida sp.) (Photo 11). ERO did not observe active water flow at the time of the 2024 site visit, no wetland indicators were present in the project area, and no wetlands were identified.

Additionally, ERO documented 3.337 acres of upland swales throughout the project area during the 2024 site visit (Figure 2). ERO mapped these swales to document the absence of wetlands and OHWM in portions of the ephemeral drainages (OHWM 1, OHWM 2, and OHWM 3) in the project area. The upland swales convey stormwater and snowmelt in the project area and do not contain defined bed and bank characteristics (Photos 3, 5, 7, and 10). Dominant vegetation was small greasewood shrubs, cheatgrass, and cactus.

OHWM 1, OHWM 2, and OHWM 3 are ephemeral in nature and, under the current guidance, would not likely be considered a WOTUS by the U.S. Army Corps of Engineers (Corps) because of their lack of RPW and absence of a continuous downstream connection to a known WOTUS. If the Corps needs further documentation, ERO recommends submitting a request for an approved jurisdictional determination to the Corps to confirm no further action regarding Section 404 permitting is necessary.

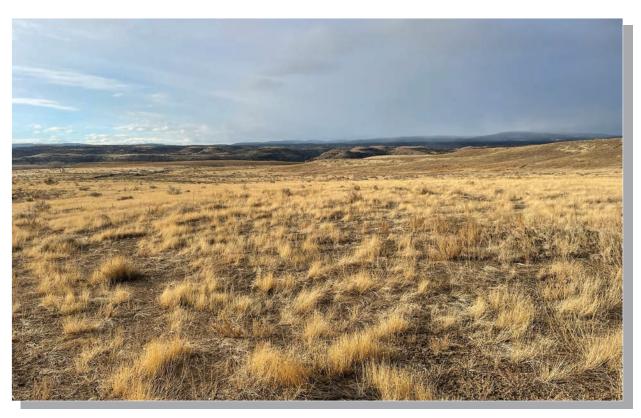
Photo 1 - Project area overview with typical vegetation species and coverage found across the site. View is to the west.

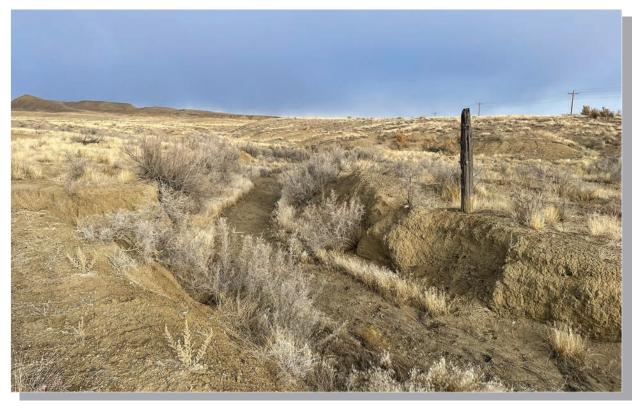
OHWM 1 is the northernmost drainage flowing generally from northwest to southeast in the project area (Photos 2 and 4; Figure 2). OHWM 1 is not shown on the Whitewater, CO U.S. Geological Survey (USGS) quadrangle but is shown on the National Wetland Inventory (NWI) as an intermittently flooded stream (Service 2023; USGS 2024). ERO mapped 0.446 acre of OHWM associated with OHWM 1 during the 2024 site visit. No flowing water or wetlands were observed in OHWM 1 during the 2024 site visit. Vegetation was dominated by upland species such as cheatgrass, threeawn, crested wheatgrass, greasewood, and cactus. OHWM 1 is an ephemeral drainage that does not contain relatively permanent water (RPW). OHWM 1 appears to have a downstream connection to two detention ponds outside of the project area; the detention ponds do not appear to have a continuous surface connection to a known WOTUS or other RPW feature.

Photo 2 - OHWM 1, an ephemeral drainage in the northeast portion of the project area. View is to the north.

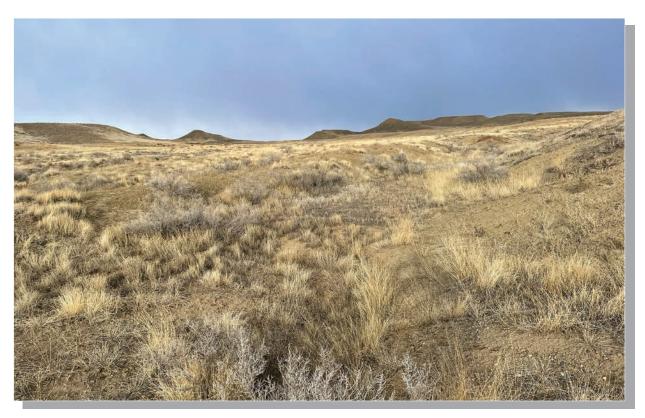
Photo 3 - Upland swale in the northeast portion of the in project area with typical vegetation coverage and species. View is to the northwest.

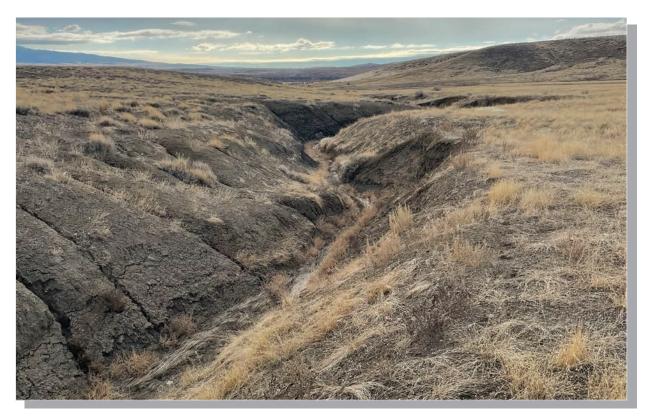
Photo 4 - OHWM 1 without water and unconsolidated channel bottom. View is to the southeast.

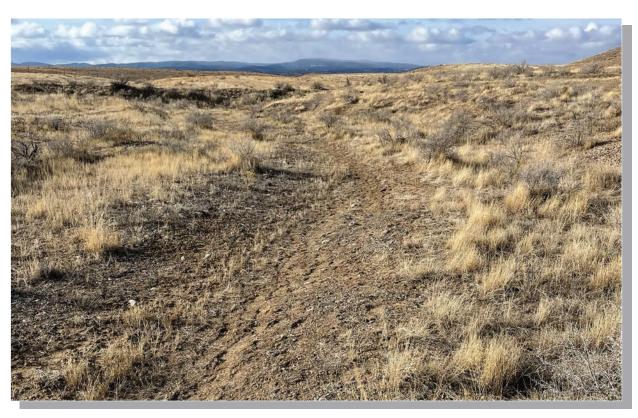
Photo 5 - Upland swale with walking path at the lower extent of OHWM 3. View is to the southwest.

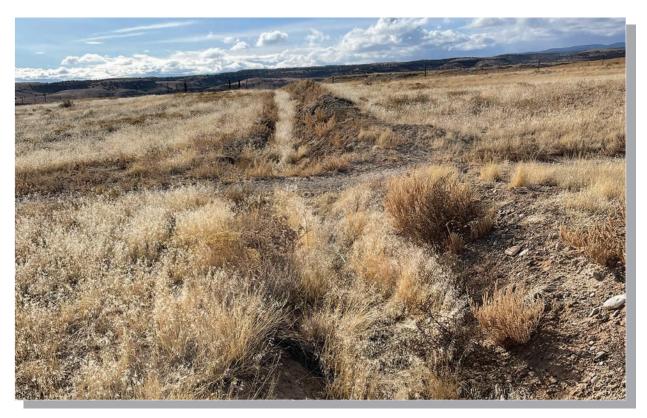
OHWM 2 is along the southern border of the project area, running generally west to east toward Coffman Road (Photo 9; Figure 2). OHWM 2 is not shown on the Whitewater, CO USGS quadrangle or NWI. ERO mapped 0.455 acre of OHWM associated with OHWM 2 during the 2024 site visit. No flowing water or wetlands were observed in OHWM 2 during the 2024 site visit. Vegetation was dominated by upland species such as cheatgrass, threeawn, crested wheatgrass, greasewood, and cactus. OHWM 2 is an ephemeral drainage that does not contain RPW. OHWM 2 does not appear to have a continuous surface connection downstream to a known WOTUS or other RPW feature. Portions of OHWM 2 consist of an upland vegetated swale lacking a defined OHWM that separates it from the two detention ponds east of Coffman Road. A historic irrigation canal truncates the lower end of OHWM 2 and is filled with sediment and upland vegetation (Photo 6).

Photo 6 - Historic irrigation canal filled in with sediment and upland vegetation. View is to the south.

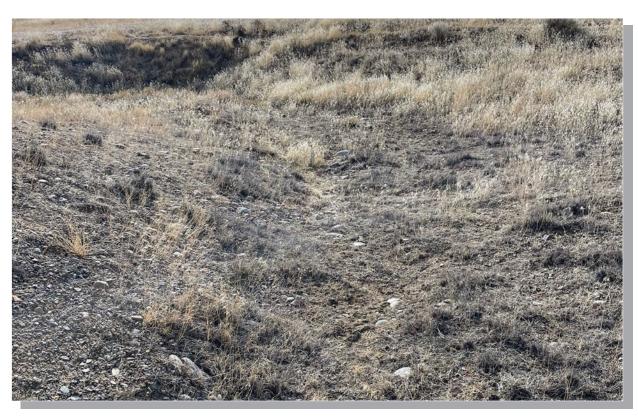
Photo 7 - Sediment wash into an upland swale at the lower extent of OHWM 2. View is to the northeast.

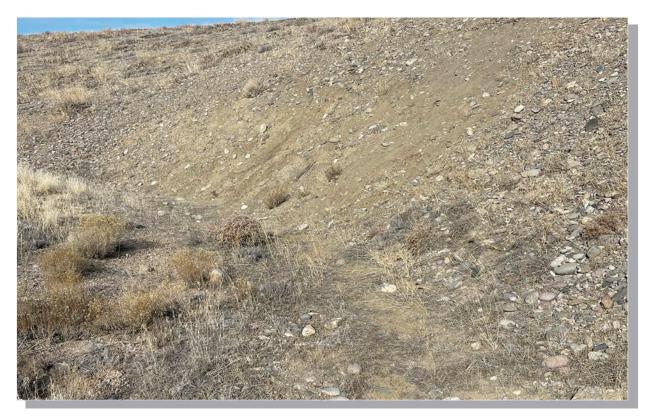
OHWM 3 initiates from a high point near the center of the project area and flows northwest to southeast in the project area (Photo 8; Figure 2). OHWM 3 is not shown on the Whitewater, CO USGS quadrangle or NWI. ERO mapped 0.304 acre of OHWM associated with OHWM 3 during the 2024 site visit. No flowing water or wetlands were observed in OHWM 3 during the 2024 site visit. Vegetation was dominated by upland species such as cheatgrass, threeawn, crested wheatgrass, greasewood, and cactus. OHWM 3 is an ephemeral drainage that does not contain RPW. OHWM 3 does not appear to have a continuous surface connection downstream to a known WOTUS or other RPW feature. Portions of OHWM 3 consist of an upland vegetated swale lacking a defined OHWM that separates it from the two detention ponds east of Coffman Road.

Photo 8 - Channel characteristics of OHWM 3. View is to the north.

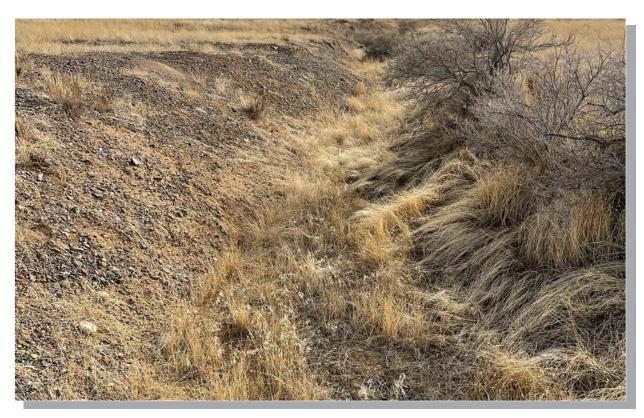
Photo 9 - Channel characteristics of OHWM 2. View is to the southeast.

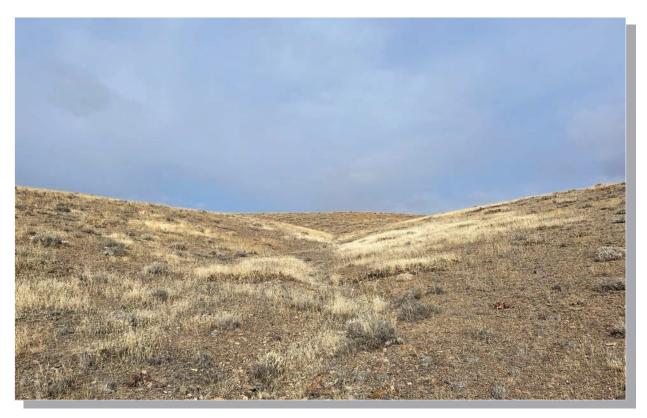
Photo 10 - Erosional feature initiating at the base of a hill near OHWM 2. View is to the north.

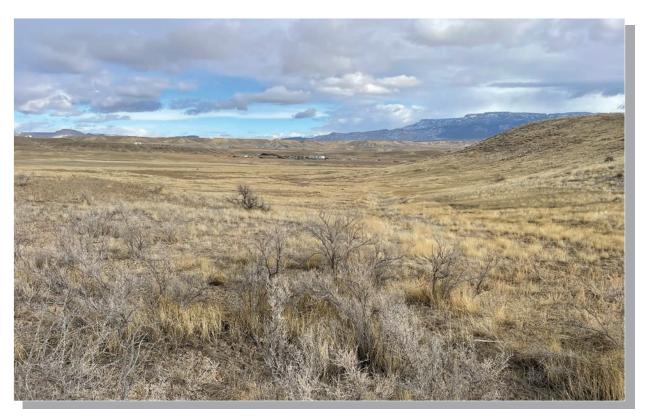
Photo 11 - Hillslope features from walking path in the center of the project area. View is to the east.
