MINERALS PROGRAM INSPECTION REPORT
PHONE: (303) 866-3567

MINE NAME: Camenish Borrow	MINE/PROSPECTING ID#: M-2006-078	MINERAL: Sand and gravel	COUNTY: Weld
INSPECTION TYPE: Surety Release Inspection	WEATHER: Clear	INSP. DATE: January 10, 2024	INSP. TIME: 09:00
OPERATOR: Flatiron Constructors, Inc.	OPERATOR REPRESENTATIVE: John Lamb	TYPE OF OPERATION: 111 - Construction by Government Agency	
REASON FOR INSPECTION: Surety Release Requested	BOND CALCULATION TYPE: None	BOND AMOUNT: \$127,000.00	
DATE OF COMPLAINT: NA	POST INSP. CONTACTS: None	JOINT INSP. AGENCY: None	
INSPECTOR(S): Brock Bowles	INSPECTOR'S SIGNATURE:

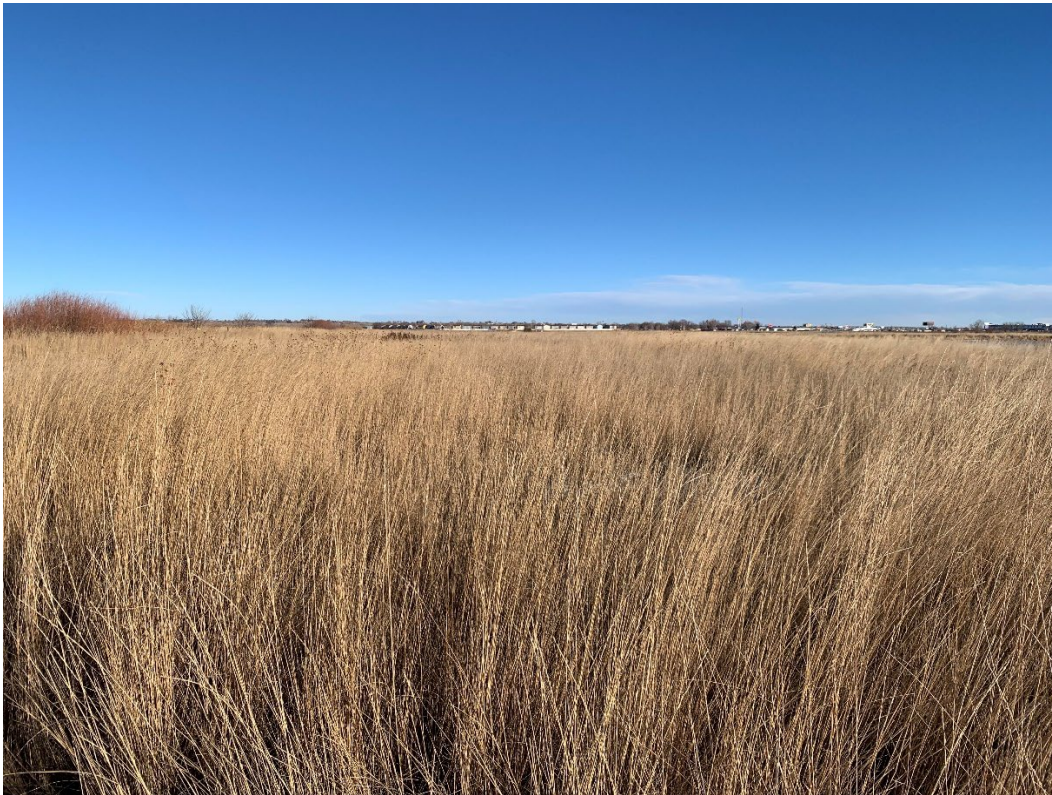
Photo 1 – From the southwest corner of the permit area facing north.

The vegetation was dormant and very well established. The grasses were dense and about waist high over most of the site (photo 1). They consisted of bromes and wheatgrasses. Patches of sunflowers were seen, and rushes and sedges were in the lower wet areas on the eastern side of the pond (photo 2). No noxious weeds were noted during this inspection. The Aug 2023 inspection noted some kochia and curly dock were seen. These species were not seen during this inspection, but the vegetation was dormant making plant identification more challenging. Neither kochia nor curly dock are listed as noxious species.

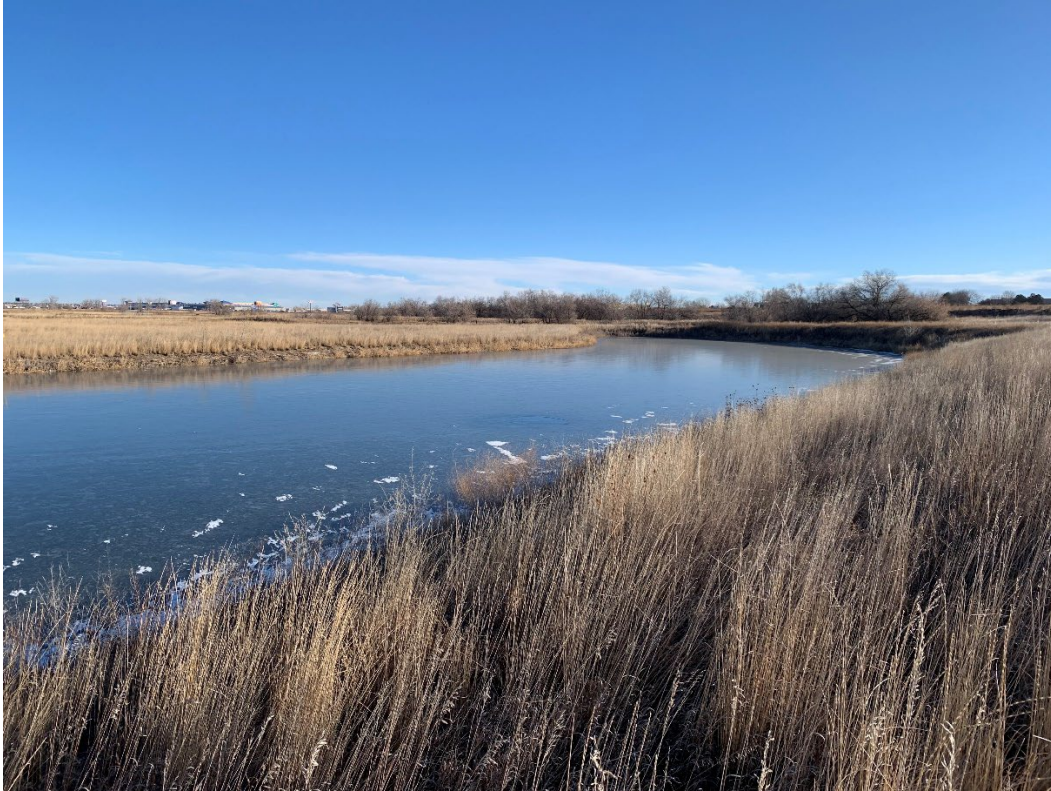
Photo 3 – The southern section of the lake facing east

The pond contained water and appeared to be almost at capacity based on the water line created by the grasses (photo 3). The banks of the pond were also well vegetated and appeared stable (photo 4). No rills or gullies were noted.
