2024 January DRMS Inspection Report Complete

23 January 2024

Permit Number: C1981010 Mine Name: Trapper Mine Operator: Trapper Mining, Inc. Operator Address: Mr. Graham Roberts P.O. Box 187 Craig, CO 81626	County: Moffat Operation Type: Surface Permit Status: Active Ownership: Federal
	Operator Representative Present: Graham Roberts
This report was issued electronically from the Divisions' Denver Office.

Inspection Start Date: 23 January 2024 Inspection Start Time: 13:00 p.m. Inspection End Date: 24 January 2024 Inspection End Time: 13:30 p.m.	Inspection Type: Coal Complete Inspection Inspection Reason: Normal I & E Weather: Cloudy
Joint Inspection Agency:	Joint Inspection Contacts:
Post Inspection Agency: None	Post Inspection Contacts:
Inspector(s): Robin A. Reilley, M.S. GISP	Inspector's Signature: Signature Date:

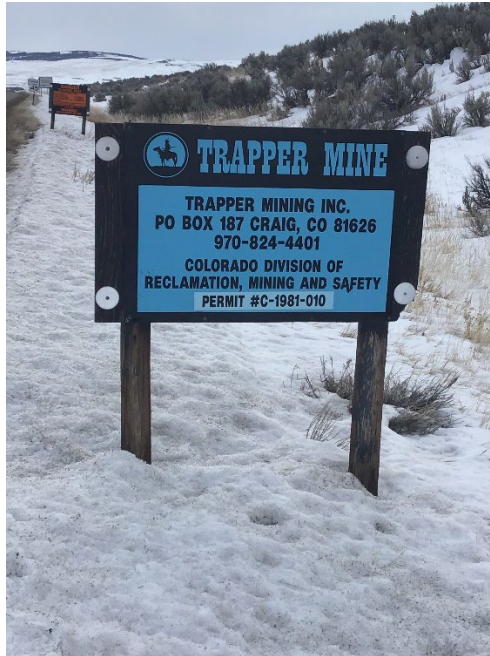
- Mine identification sign and blasting notice is posted at the main entrance off of State Highway 13.
- Topsoil stockpiles observed were clearly marked with identifying signs.

Photo 1: Mine identification sign at main entrance.

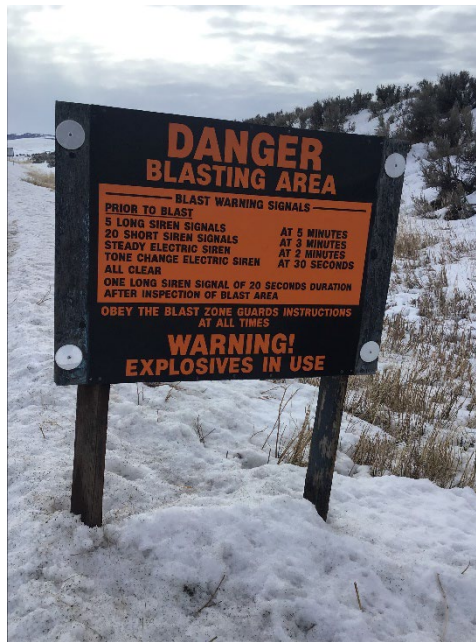
Photo 2: Blasting notice sign at main entrance

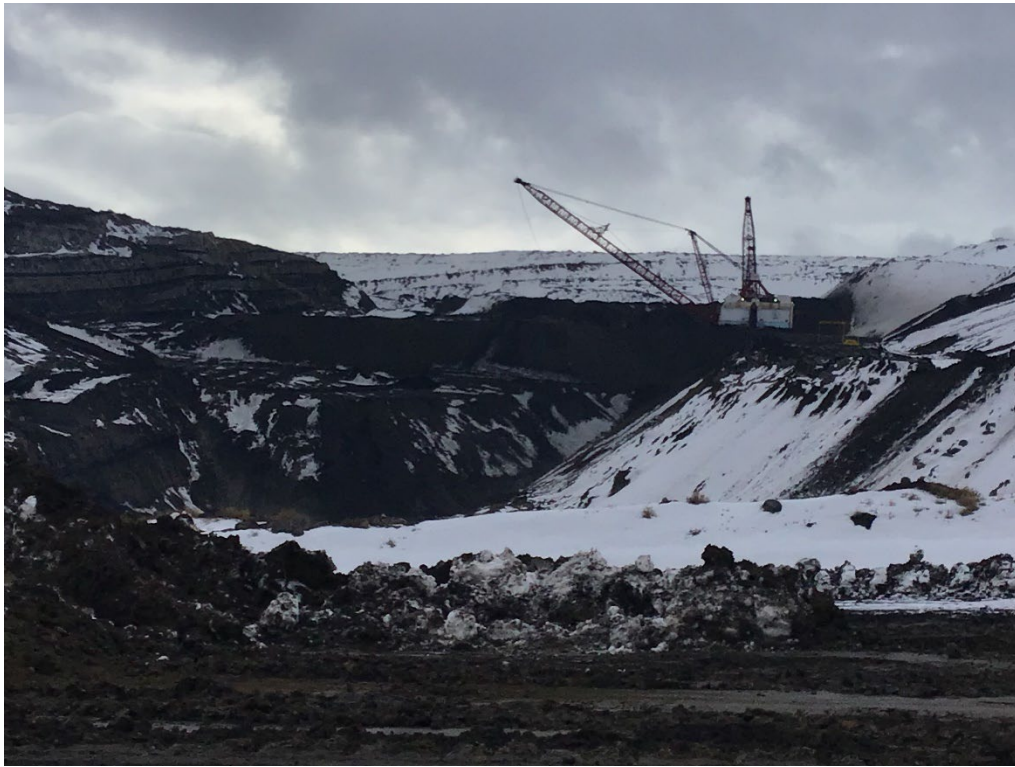
The inspection began in L Pit. The Molly Braun drag line was stationed at the south end of the pit. The drag line was idle as it was being worked on. The Baby Doe drag line positioned mid pit and was casting spoil. Two blasts were being prepared and drilled. Mining is complete at a lower section of L Pit and is ready for back filling.

Photo 3: L Pit, looking south.

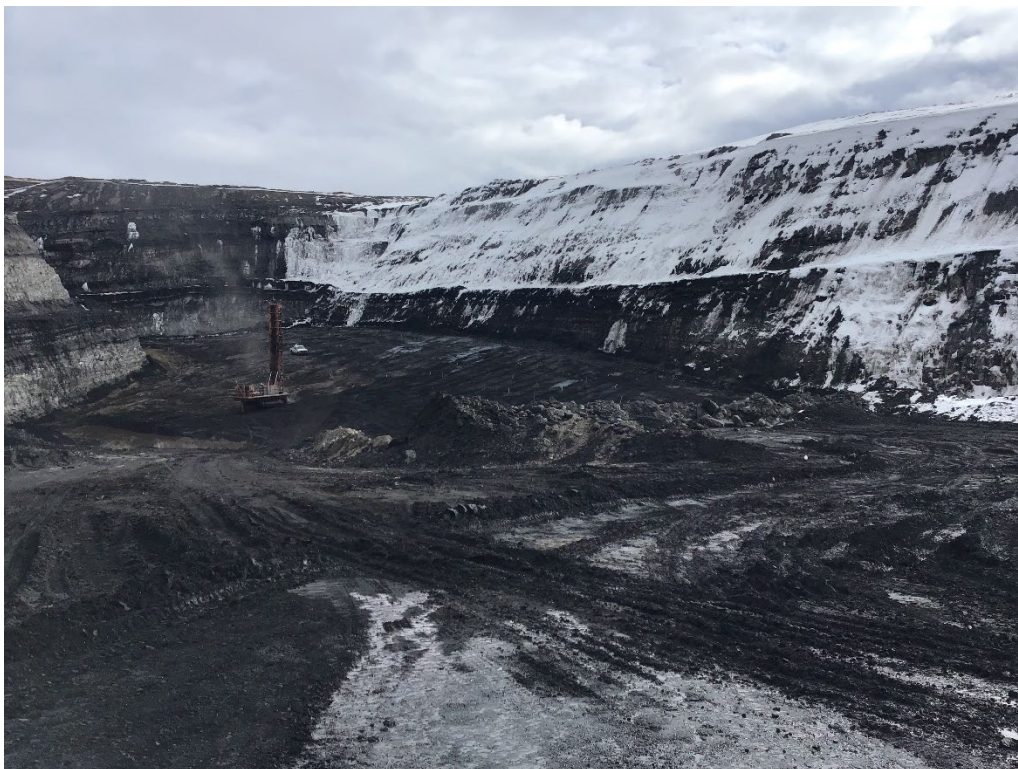
Mining in N Pit was not occurring at the time of inspection. However, a blast was being set up at the west end to remove overburden for Q seam mining.

Photo 4: N Pit mining activities, looking east.

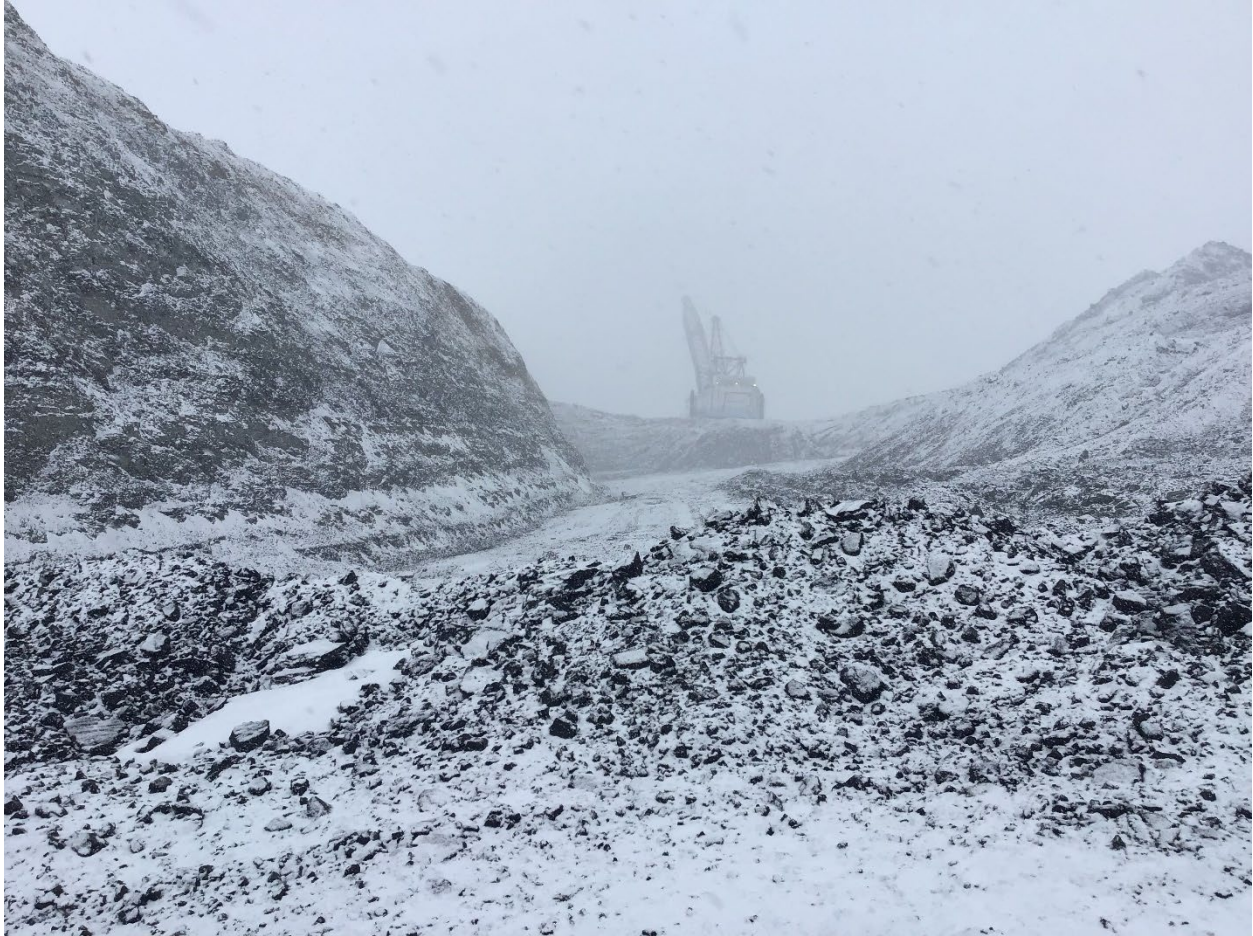
J Pit has been opened and no activity was occurring at the time of inspection. The Queen Ann dragline had excavated a large overburden pile.

Photo 5: J Pit dragline.
