Division of Reclamation,  
Mining and Safety

<b>Permit Number:</b> C1981033 <b>Mine Name:</b> Bear Mine <b>Operator:</b> N/A <b>Operator Address:</b> N/A	<b>County:</b> Gunnison <b>Operation Type:</b> Underground <b>Permit Status:</b> Revoked <b>Ownership:</b> Private
	<b>Operator Representative Present:</b>  N/A
<b>Operator Representative Signature: (Field Issuance Only)</b>

<b>Inspection Start Date:</b> February 13, 2024 <b>Inspection Start Time:</b> 12:00 <b>Inspection End Date:</b> <b>Inspection End Time:</b>	<b>Inspection Type:</b> Aerial Inspection <b>Inspection Reason:</b> Normal I&E Program <b>Weather:</b> Clear
<b>Joint Inspection Agency:</b>  None	<b>Joint Inspection Contacts:</b>  
<b>Post Inspection Agency:</b>  None	<b>Post Inspection Contacts:</b>  
<b>Inspector(s):</b>  Leigh Simmons  Brock Bowles	<b>Inspector's Signature:</b>

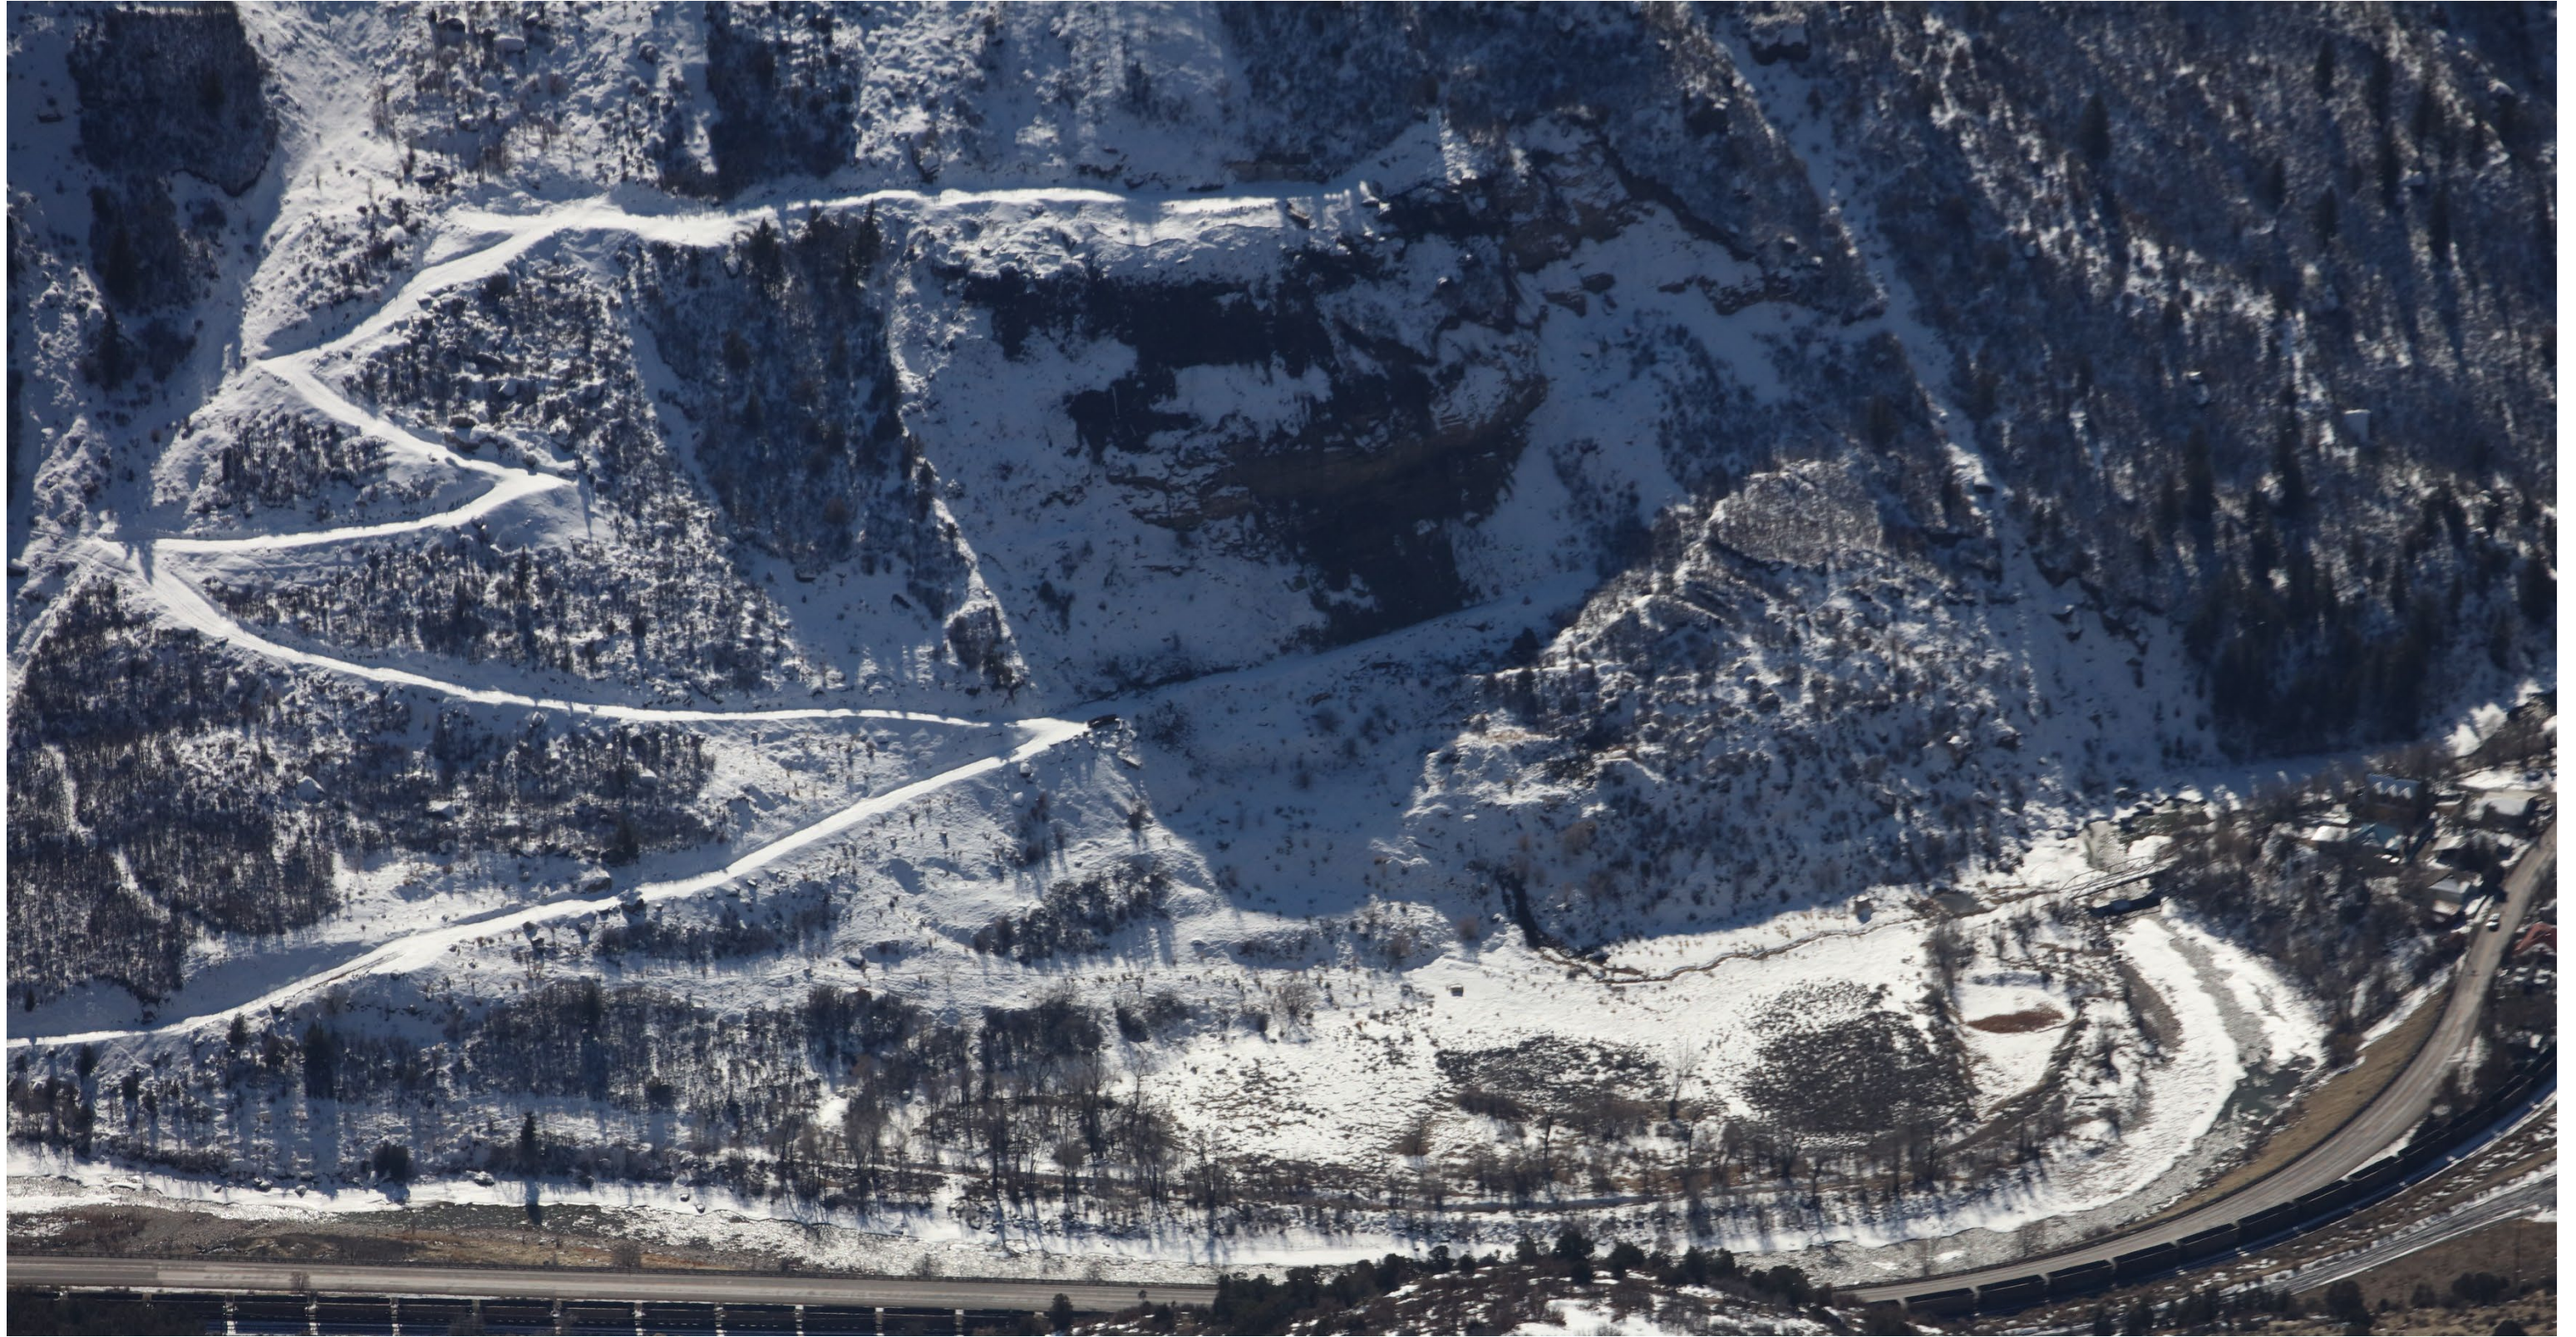
*Figure 1: Bear Mine*

Figure 1 shows the north-facing site almost completely covered with snow. The elevated ground temperatures around the slide area, caused by the underground fire, can be inferred from the areas where snow has melted. The groundwater seep, directly below the slide area, is also easy to see. There does not appear to have been any recent changes at the site.
