January 8, 2024

Job Number: 99-3983

Subject: Quarterly Observation Report,
Refuse Pile, Foidel Creek Mine, Routt
County, Colorado.

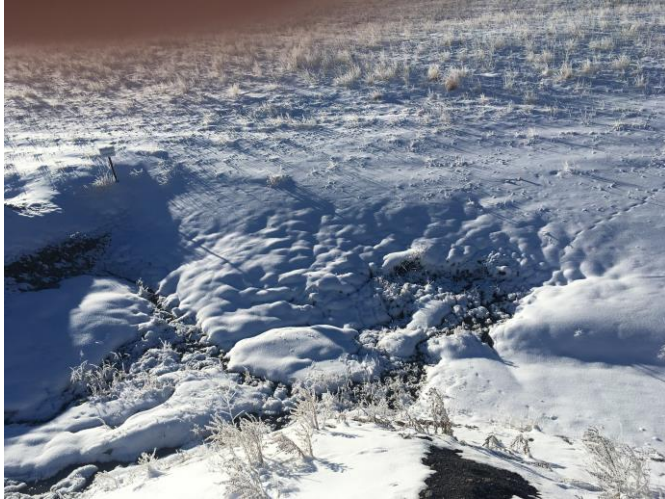
A seepage area at the toe of the northeast end of the refuse pile expansion area, approximately 30 feet northwest of the outlet of the underdrain, developed in fall 2014. At the time of our observations, the seepage was surfacing at the toe of the slope and flowing into the drainage from the undrain outlet then into the existing pond east of the Refuse Pile Expansion Area. The discharge was clear, with no evidence of sediment. No signs of washout, slumps or slope instability were observed at this time. The seepage area will be monitored during future inspections and noted in our inspection reports. Photographs of the seepage area taken at the time of our inspection on December 29, 2023 are attached.

December 29, 2023-Drain Outlet and Seepage Area

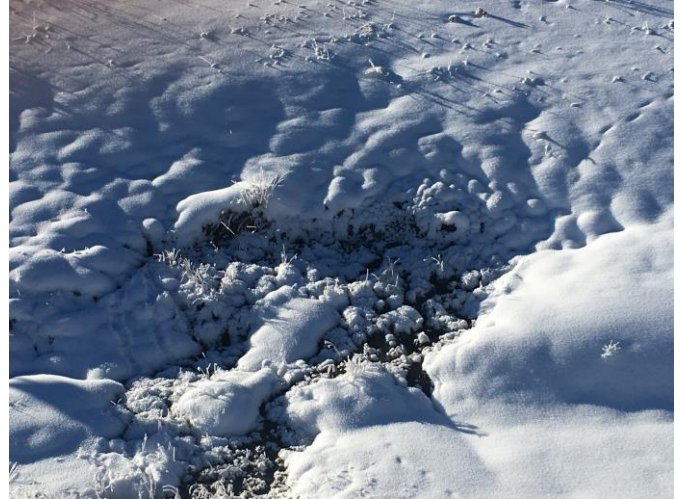
December 29, 2023-Seepage Area

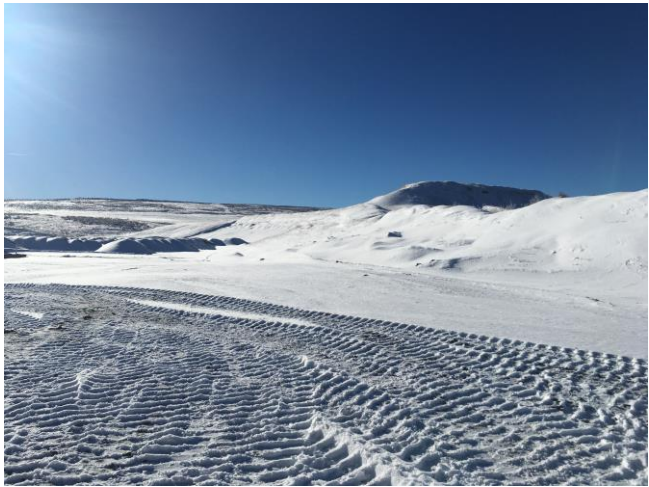
December 29, 2023- Areas 2, 3 and 4 from Expansion Area

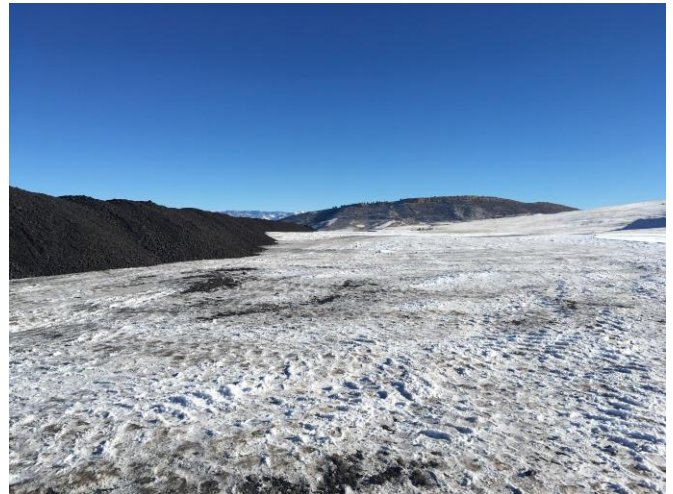
At the time of our site visit on December 29, 2023, NWCC completed a site inspection of the existing refuse pile. Based on our observations made during this visit, it appeared that the contractor was presently stockpiling, grading and compacting refuse coal in the new Expansion Area. At the time of our site visit, the refuse coal had been placed and compacted to an elevation above the third bench situated along the east side of the stockpile.

December 29, 2023- Expansion Area

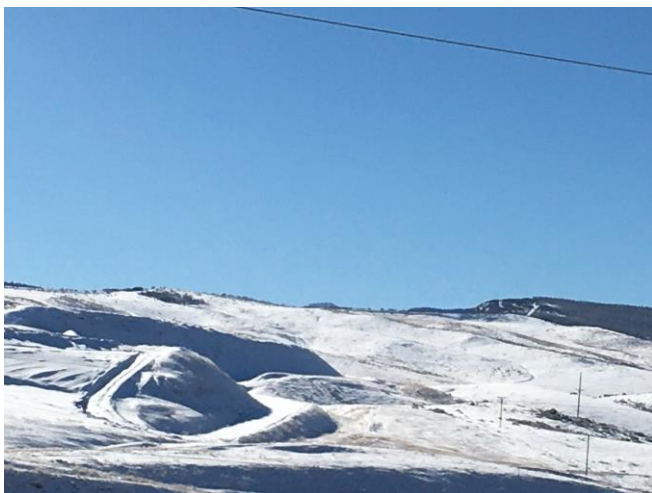
The internal roadways in the new expansion area of the pile are in good condition. The upper haul road to Areas 2, 3 and 4 of the refuse pile was not accessible at the time of our site visit due to snow.

December 29, 2023- Road to Areas 2, 3 and 4

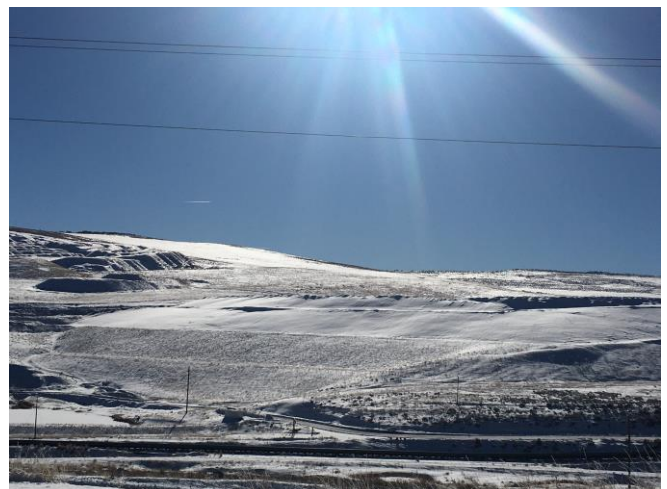
December 29, 2023- Benches on East Side of Refuse Pile
