MINERALS PROGRAM INSPECTION REPORT
PHONE: (303) 866-3567

MINE NAME: Cooley Reservoir & Fulton Wildlife Area	MINE/PROSPECTING ID#: M-1999-034	MINERAL: Sand and gravel	COUNTY: Adams
INSPECTION TYPE: Surety Release Inspection	WEATHER: Clear	INSP. DATE: January 24, 2024	INSP. TIME: 10:00
OPERATOR: Holcim - WCR, Inc.	OPERATOR REPRESENTATIVE: Wyatt Webster	TYPE OF OPERATION: 112c - Construction Regular Operation	
REASON FOR INSPECTION: Surety Release Requested (SR2)	BOND CALCULATION TYPE: None	BOND AMOUNT: \$1,510,800.00	
DATE OF COMPLAINT: NA	POST INSP. CONTACTS: None	JOINT INSP. AGENCY: None	
INSPECTOR(S): Nikie Gagnon	INSPECTOR'S SIGNATURE:

This inspection was completed as part of acreage release request (AR2), submitted in accordance with Rule 4.17, received by the Division on January 4, 2024. Nikie Gagnon with the Division of Reclamation, Mining and Safety (Division/DRMS) conducted the inspection. Wyatt Webster, representing Holcim-WCR Inc. (Operator) accompanied the Division during the inspection.

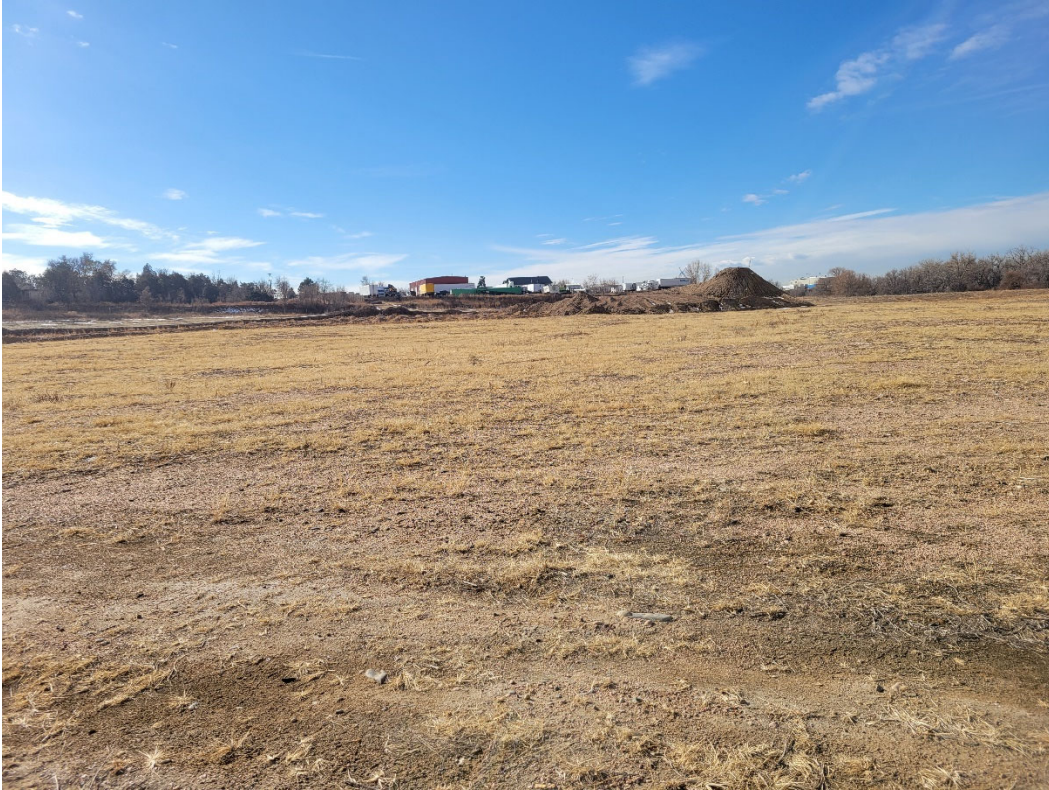
Photo 1: Looking south across the former processing area.

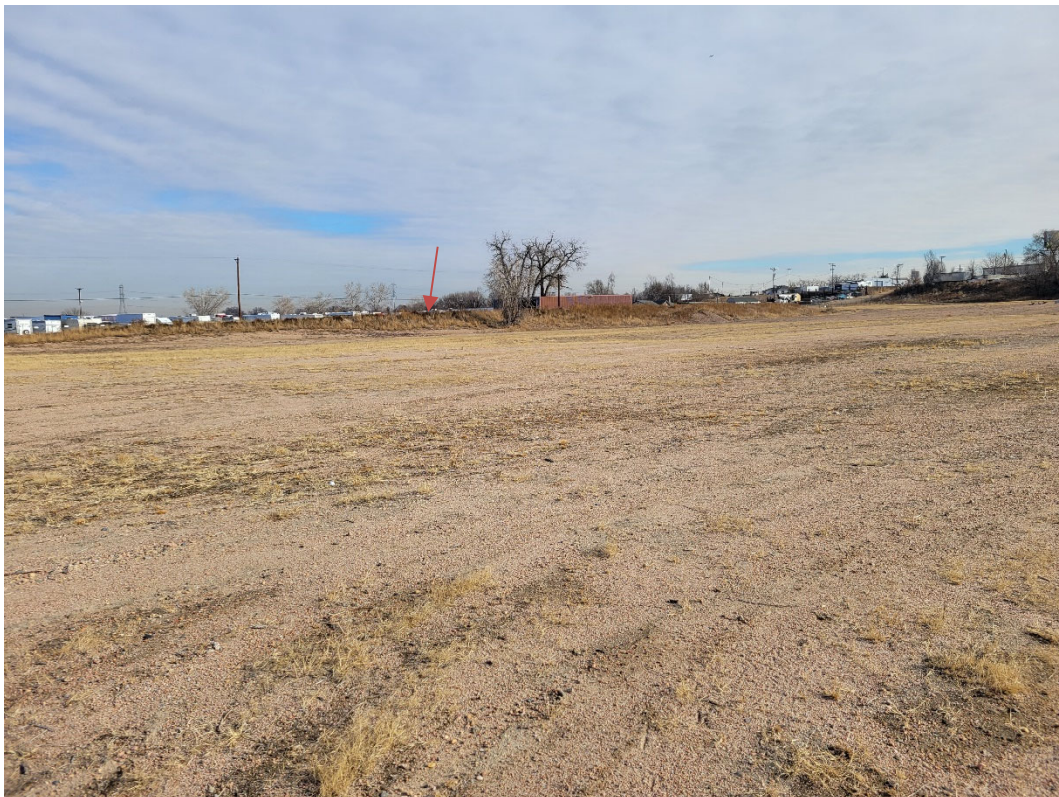
Photo 2: Looking north across the former processing area. Vegetated berm runs along 100th Avenue noted by red arrow.

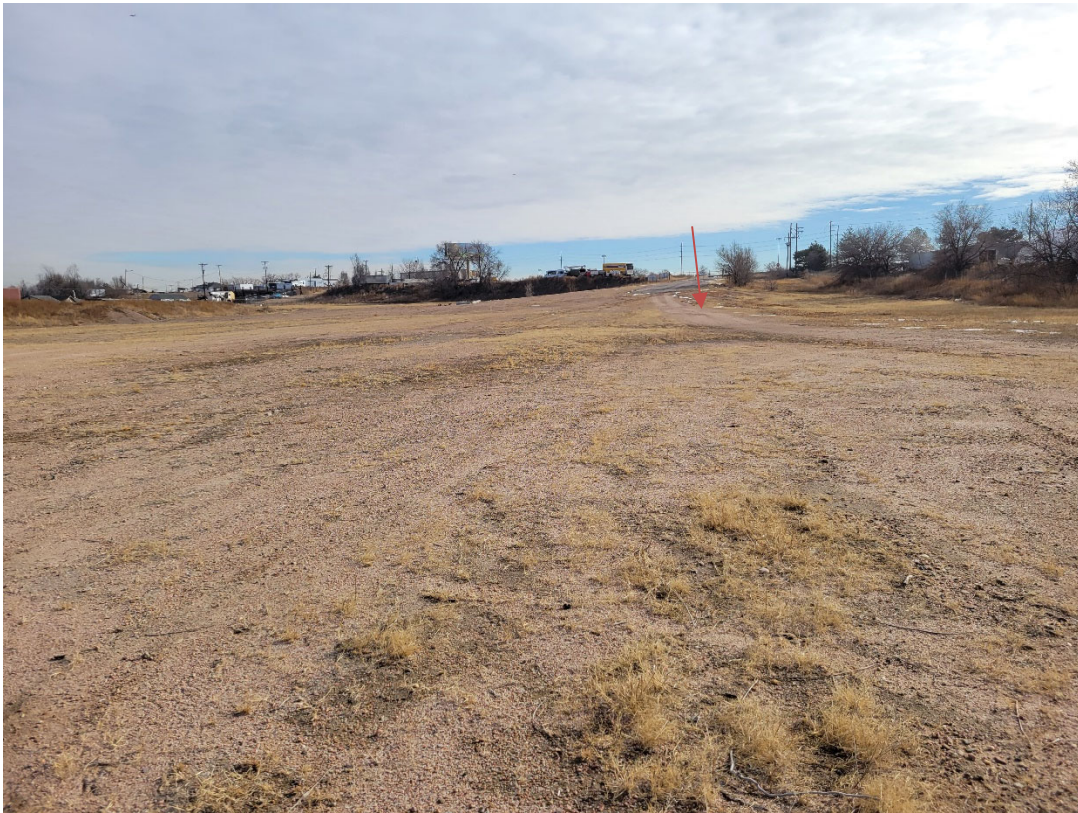
Photo 3: Looking east towards the entrance to the site. Access road to the entrance to remain for future industrial use of the property (red arrow)

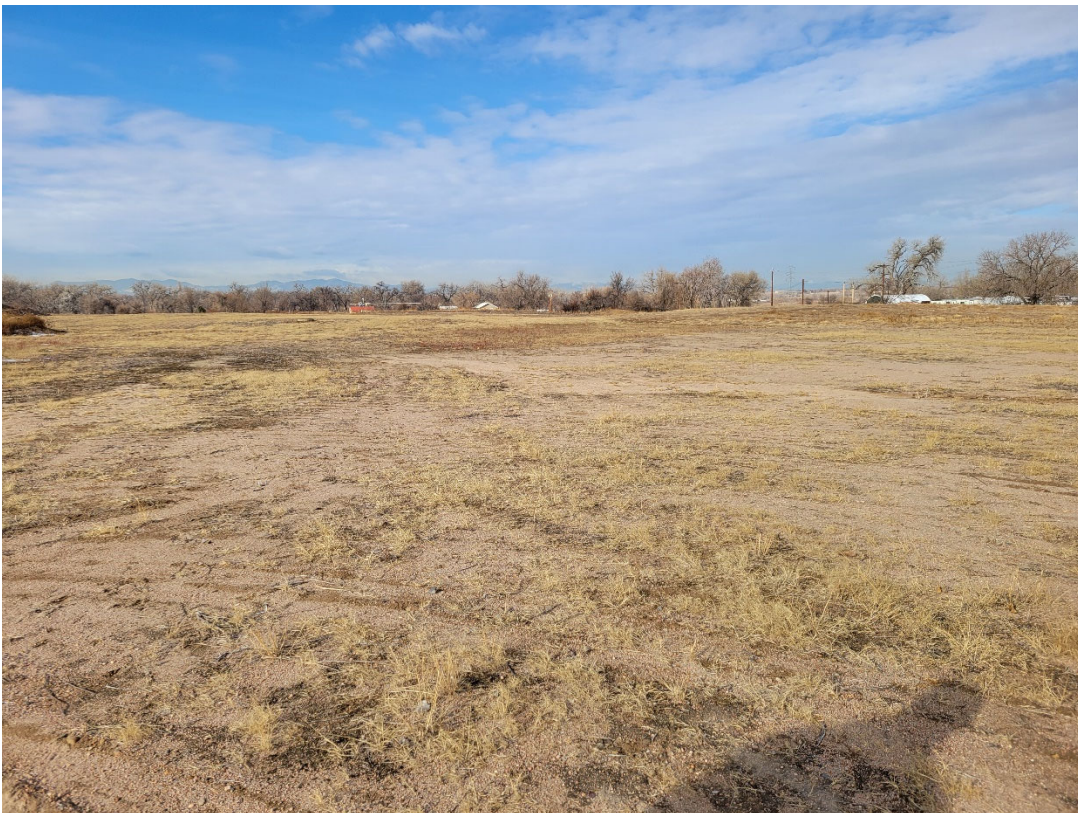
The former processing area has been graded flat for future industrial use by the landowner. The site is gravel with sparse vegetation. The side slopes have been graded to 3:1 or shallower around the perimeter. Slopes on the north and southeast ends are vegetated with grasses. The Division observed recent hydroseeding on the recently graded slope along the southern boundary where the stockpiled material was previously stored. The powerlines have been relocated to the original location along 100th Avenue. Stockpiled material (gravel and imported soil) was observed stored in the center of the property, consistent with the approved reclamation plan in TR6. The Division also observed the approved shallow rip rap berm constructed to control erosion and siltation into the adjacent Bull Seep. According to Division records, extensive weed control was conducted in July 2023 to control thistles. The Operator recently mowed and hydro seeded the strip of land adjacent to the Bull Seep.

Photo 4: Looking west across the graded former processing area.

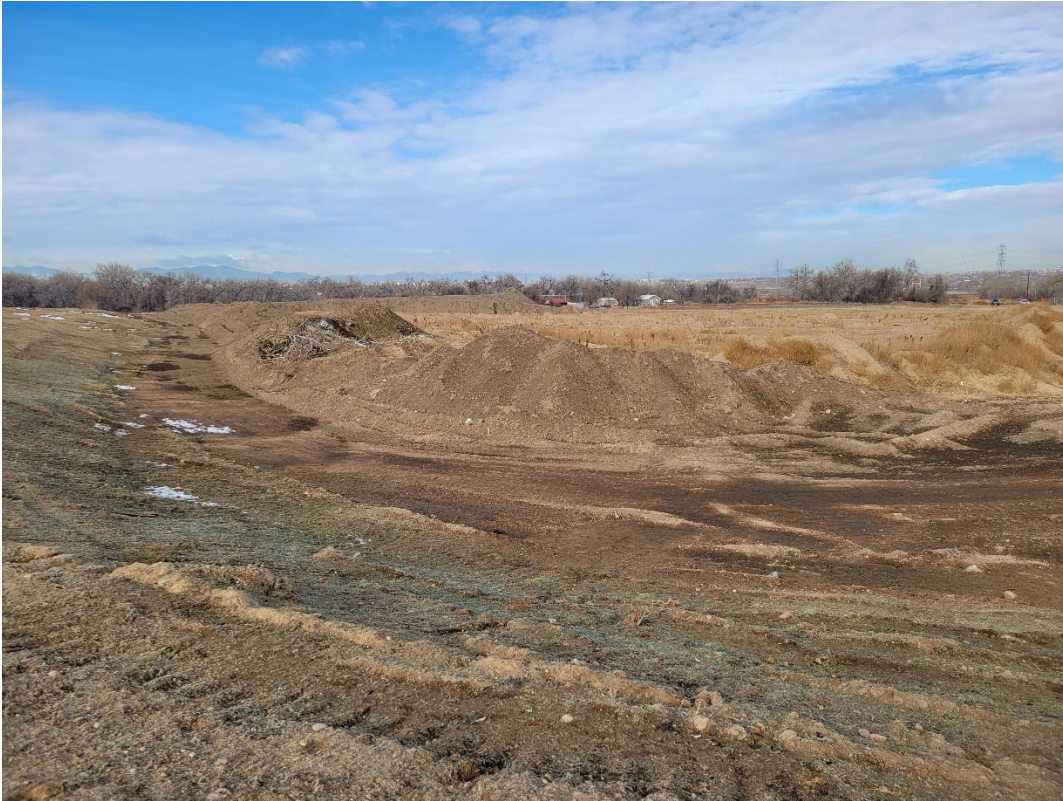
On February 1, 2024, the Division received an email from Joel Bolduc, representing the landowner, confirming that the stockpiles of gravel and imported soil should remain on site for future industrial use and there are no remaining concerns with the reclamation.

Photo 5: Looking west from the southeast corner of the former processing area. Stockpiled material in the center will remain for future industrial use by the landowner.

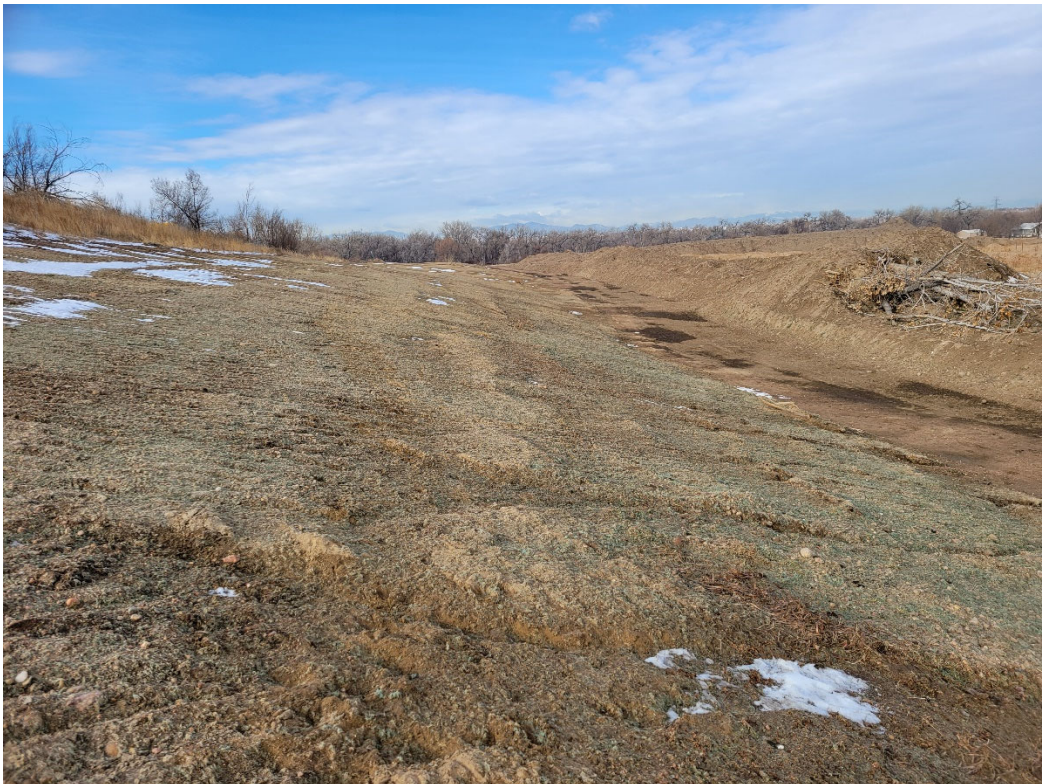
Photo 6: Looking west along the southern boundary recently graded and hydroseeded.

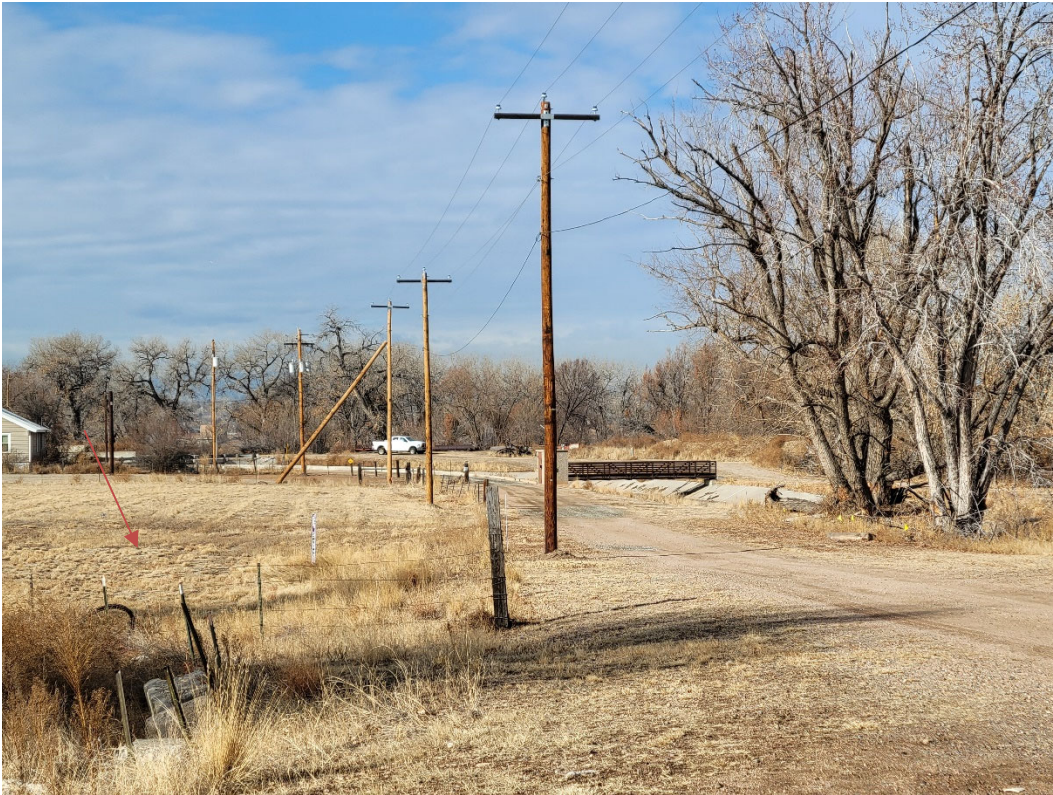
The southwestern corner of the permit area and the strip of land west of the Bull Seep within the release area were undisturbed by mining. These areas are vegetated with grasses. The vegetation cover is consistent with adjacent natural areas.

Photo 7: Looking west along 100th Ave. at relocated power poles. Arrow points to area undisturbed by mining on the west side of the Bull Seep within the release area.

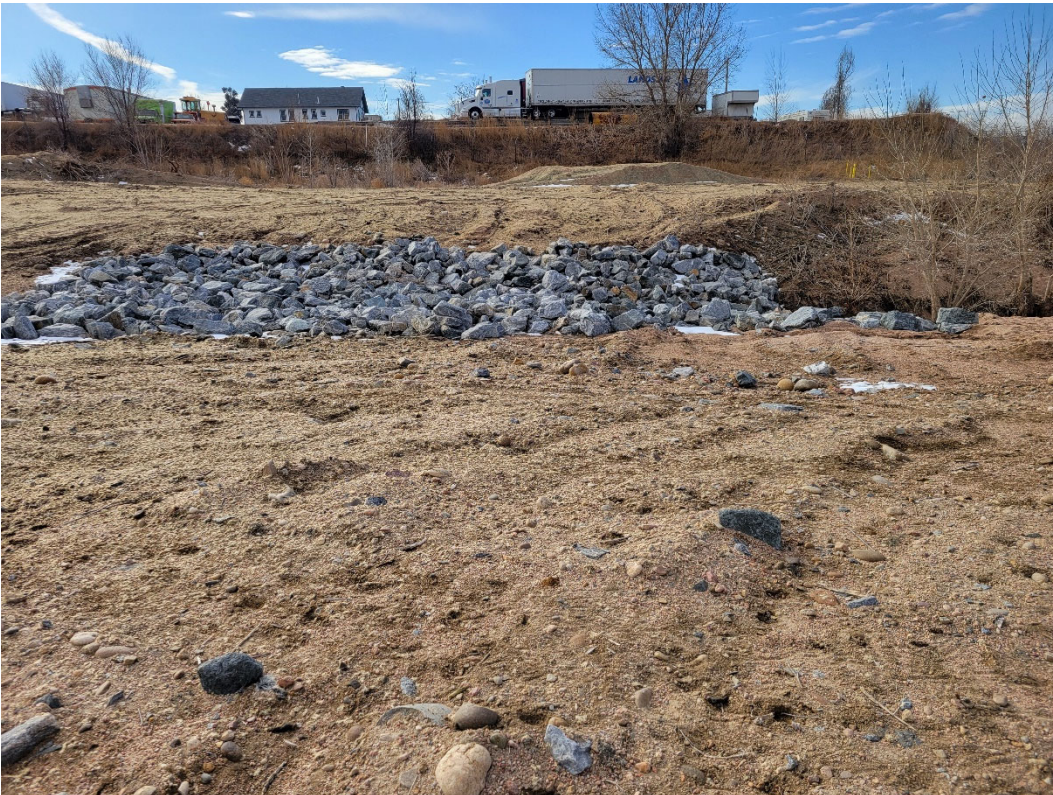
Photo 8: View of rip rap sediment control structure installed on the southwest end of the site.

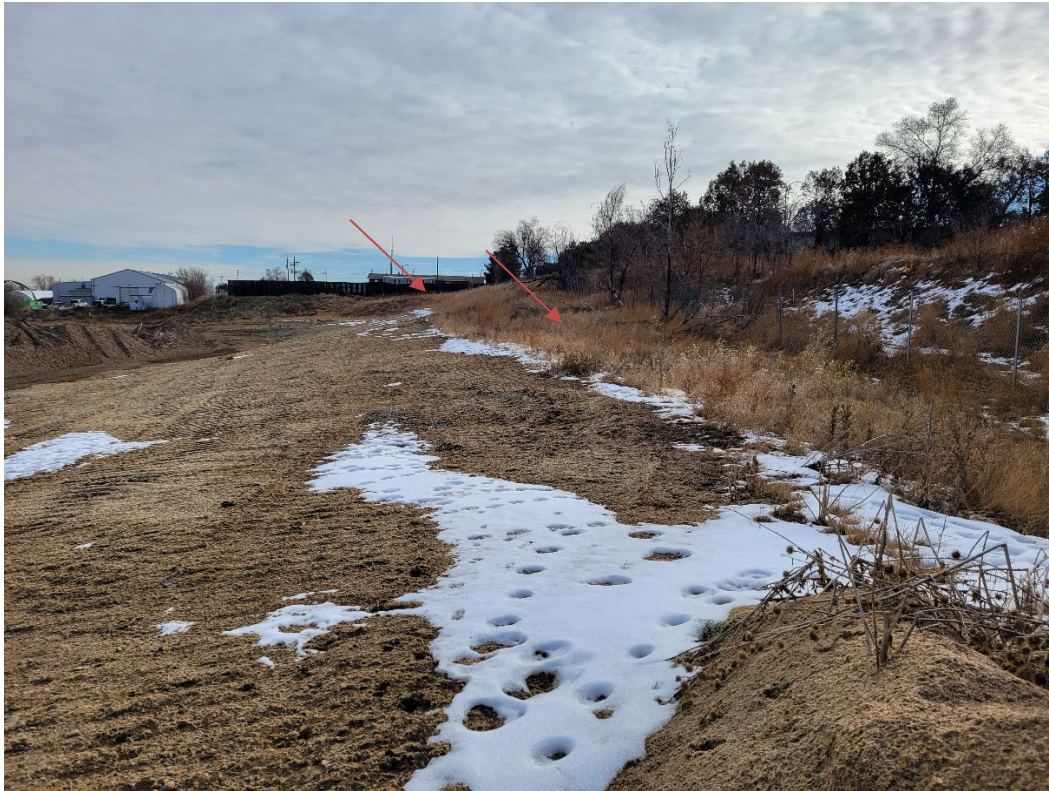
Photo 8: Looking at slopes graded 3:1 or shallower. Grassy vegetation controlling erosion on perimeter slopes noted by red arrows.

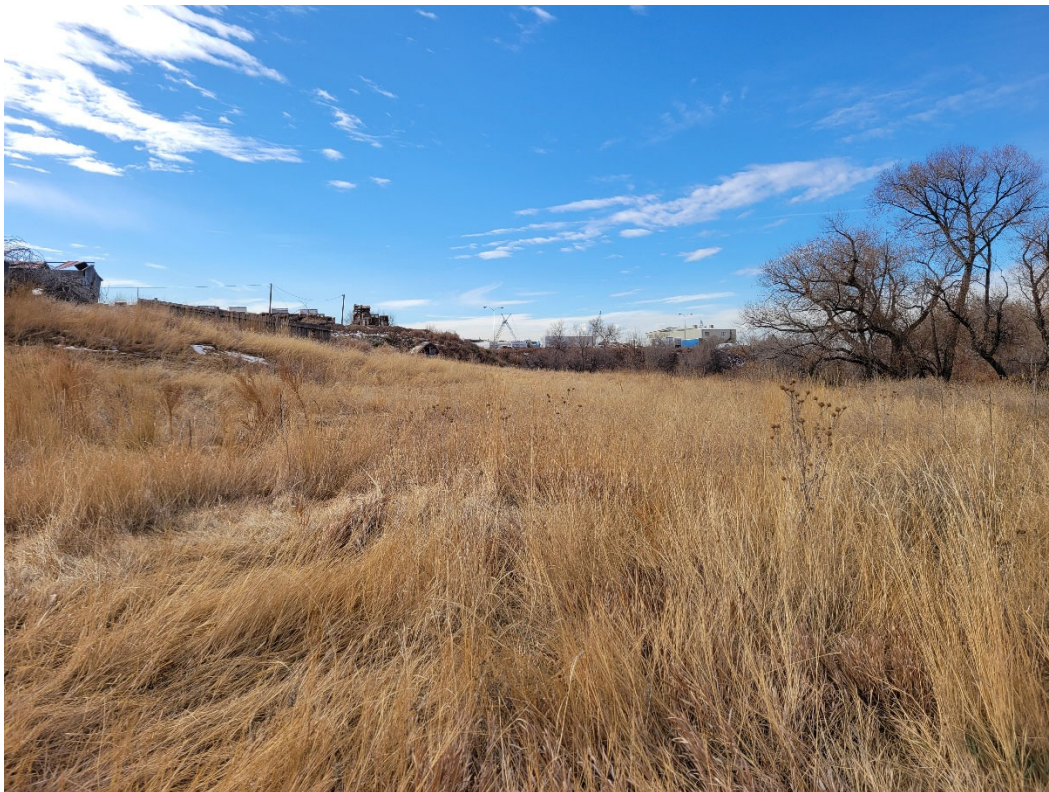
Photo 8: Southwest corner of the release area. This area was undisturbed by mining.
