**MINERALS PROGRAM INSPECTION REPORT**  
**PHONE: (303) 866-3567**

| <b>MINE NAME:</b><br>Menzer Quarry | <b>MINE/PROSPECTING ID#:</b><br>M-1976-009-HR | <b>MINERAL:</b><br>Granite, granite gneiss | <b>COUNTY:</b><br>El Paso |
| <b>INSPECTION TYPE:</b><br>Monitoring | <b>WEATHER:</b> Clear | <b>INSP. DATE:</b><br>February 21, 2024 | <b>INSP. TIME:</b><br>13:00 |

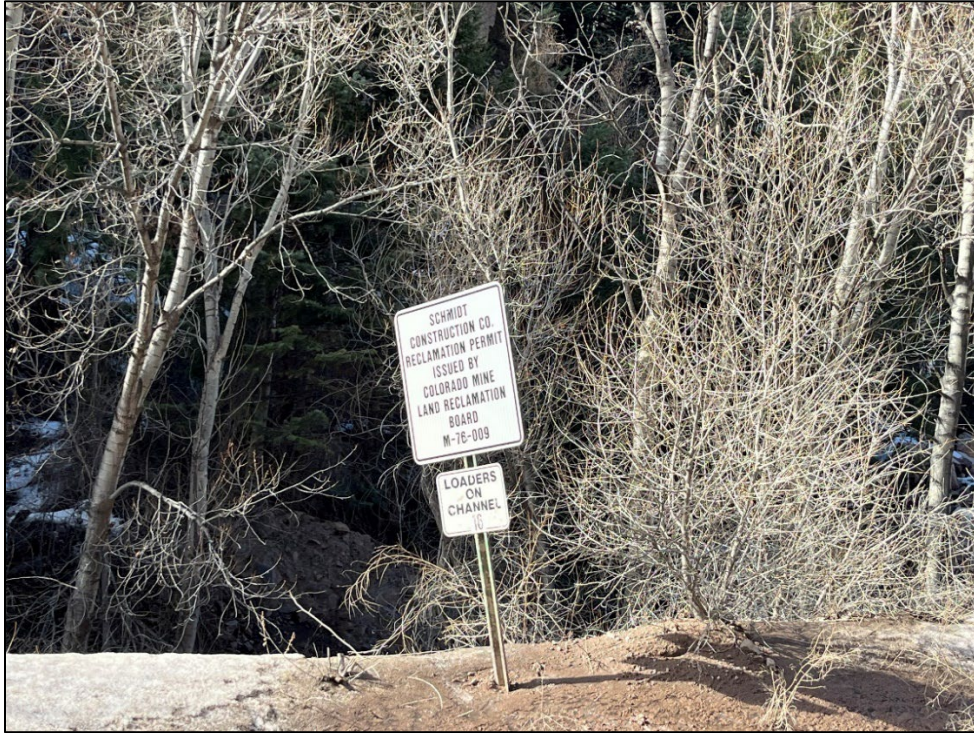
**Photo 1: A mine sign was posted 1 mile up-road from the scale house.**

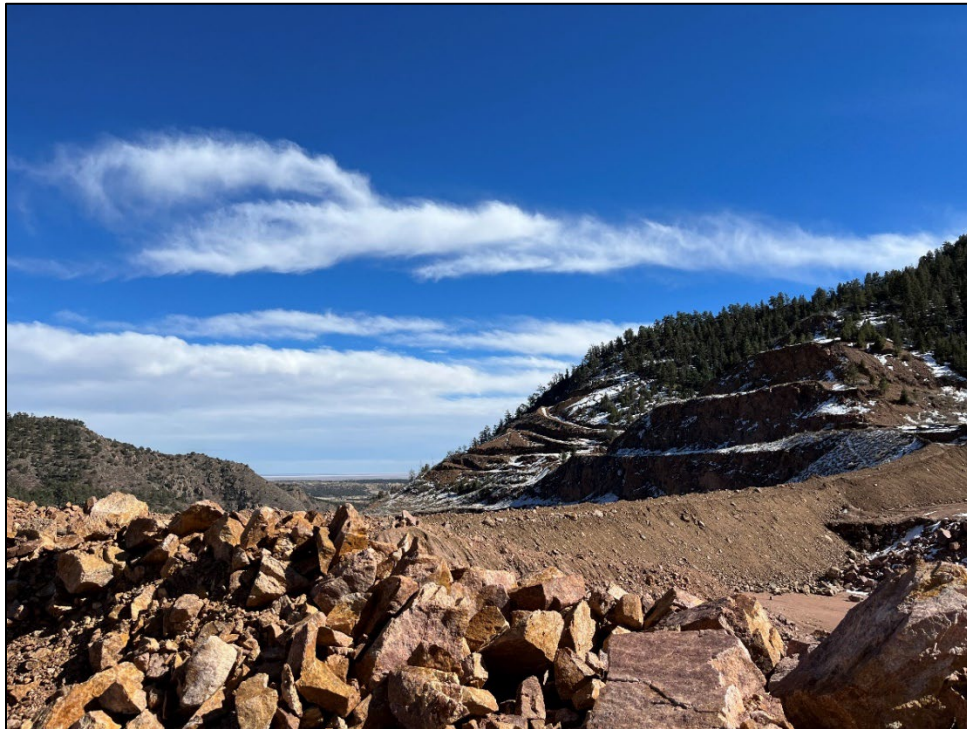
**Photo 2: View southeast of the southern corner to be eventually mined.**

For the purposes of tracking this item, the Division will cite this as a problem with the corrective action of submitting a Technical Revision to the Division to update the Mining Plan to include additional detail on the mining and reclamation plan for the southeast corner in question. Schmidt Construction representatives and DRMS also discussed submitting a blasting plan for the site which includes updated information about the site's new process of pre-splitting their shots. Attached below is DRMS's guide for formulating this kind of report.
