**MINERALS PROGRAM INSPECTION REPORT**  
**PHONE: (303) 866-3567**

<b>MINE NAME:</b> Uncompahgre Pit	<b>MINE/PROSPECTING ID#:</b> M-2013-007	<b>MINERAL:</b> Gravel and sand	<b>COUNTY:</b> Montrose
<b>INSPECTION TYPE:</b> Monitoring	<b>WEATHER:</b> Clear	<b>INSP. DATE:</b> February 28, 2024	<b>INSP. TIME:</b> 10:30
<b>OPERATOR:</b> Lazy K-Bar Land & Cattle Company, LLLP	<b>OPERATOR REPRESENTATIVE:</b> Zane Luttrell	<b>TYPE OF OPERATION:</b> 112c - Construction Regular Operation

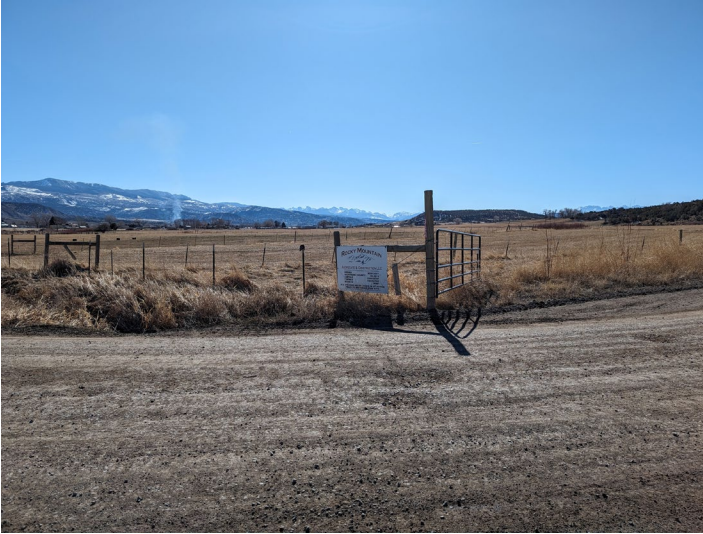
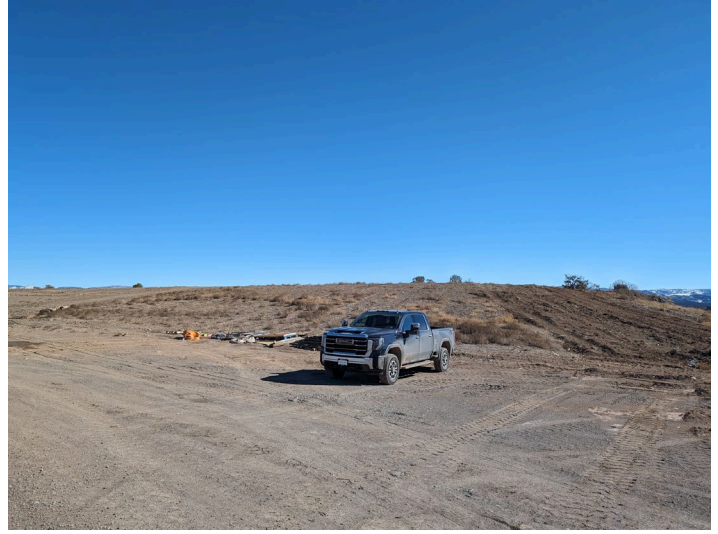
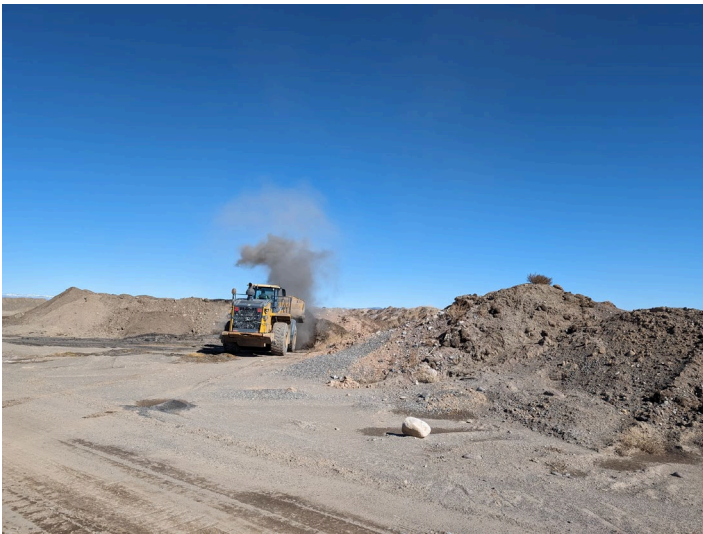
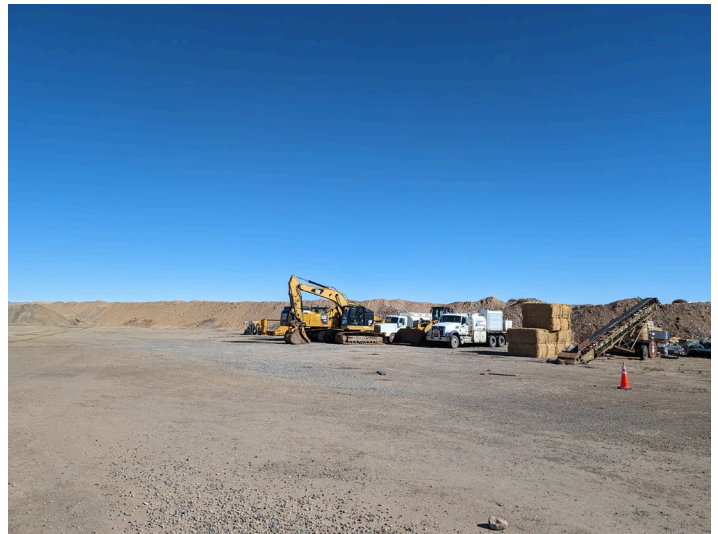
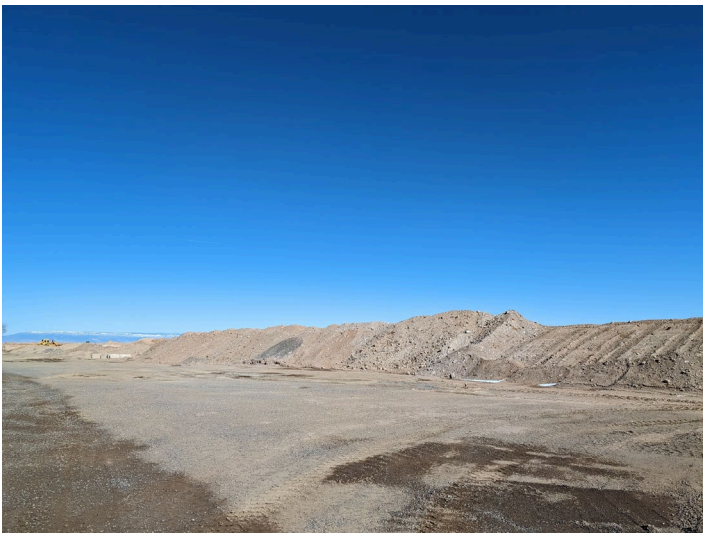
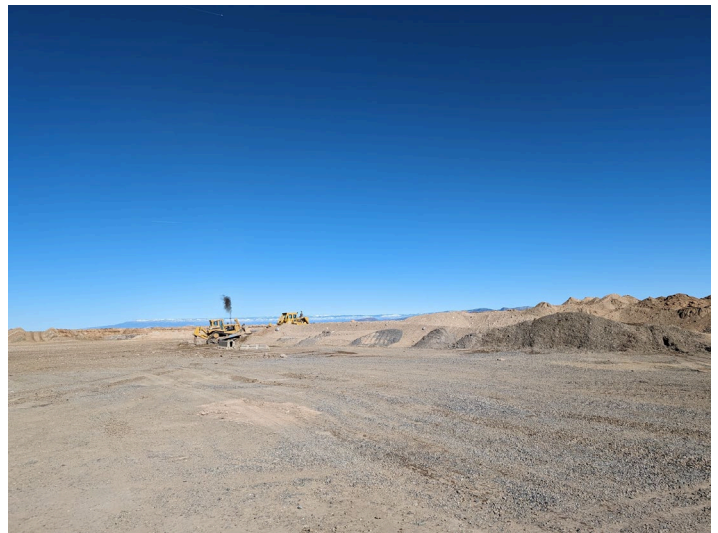
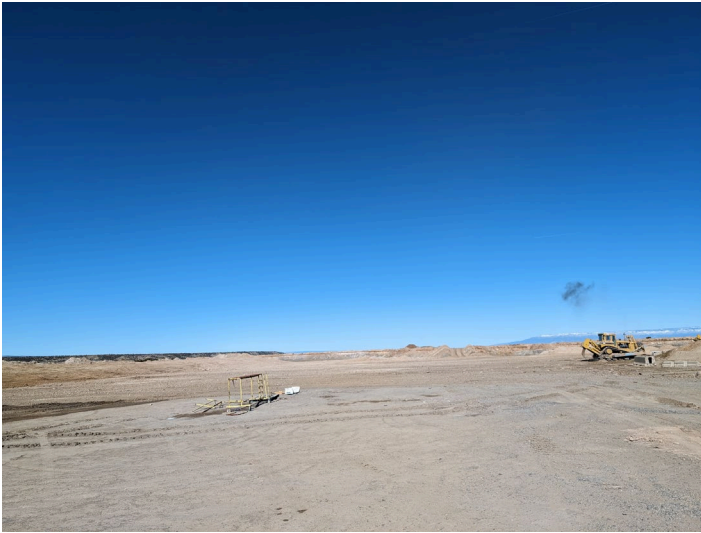
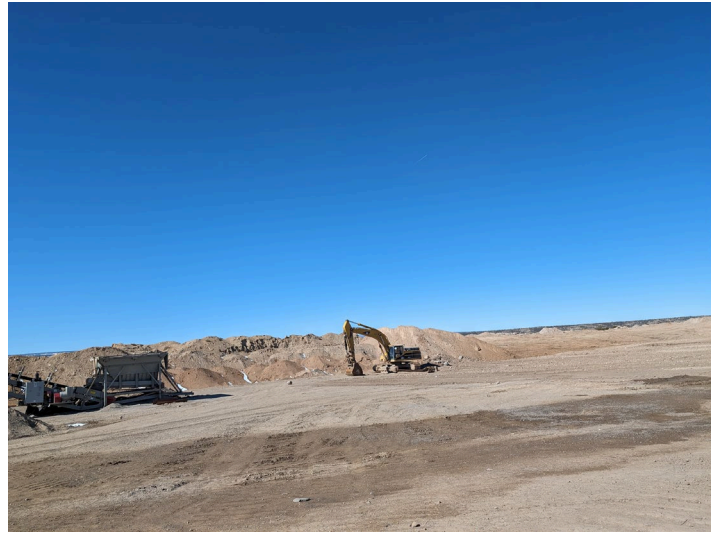
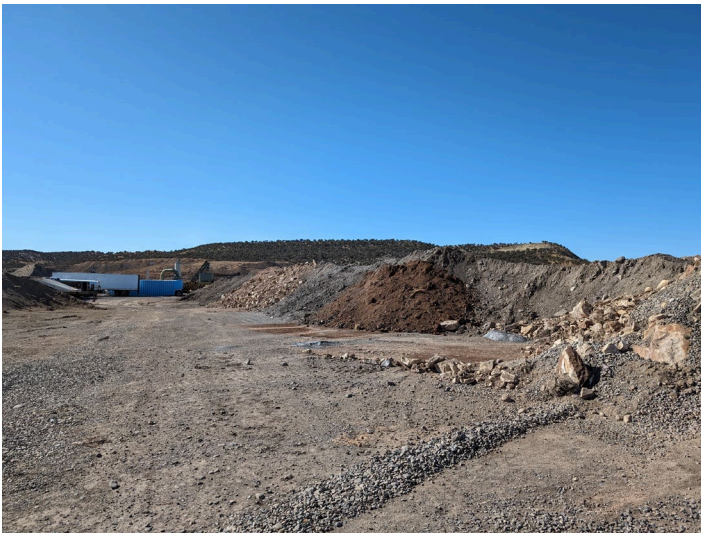
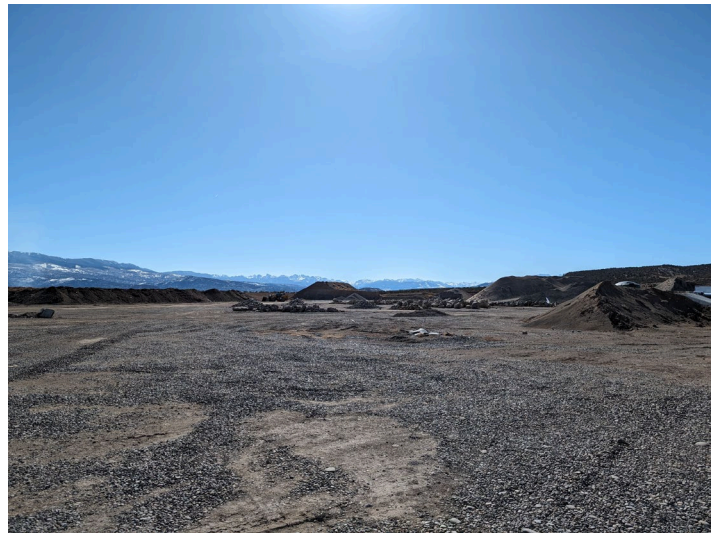
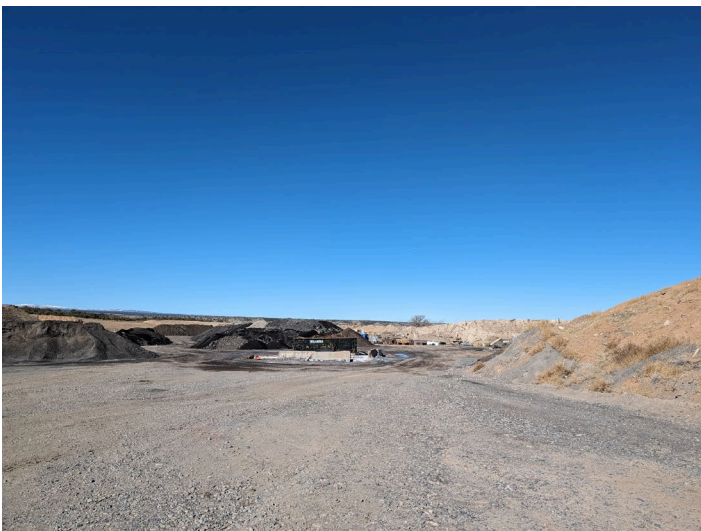
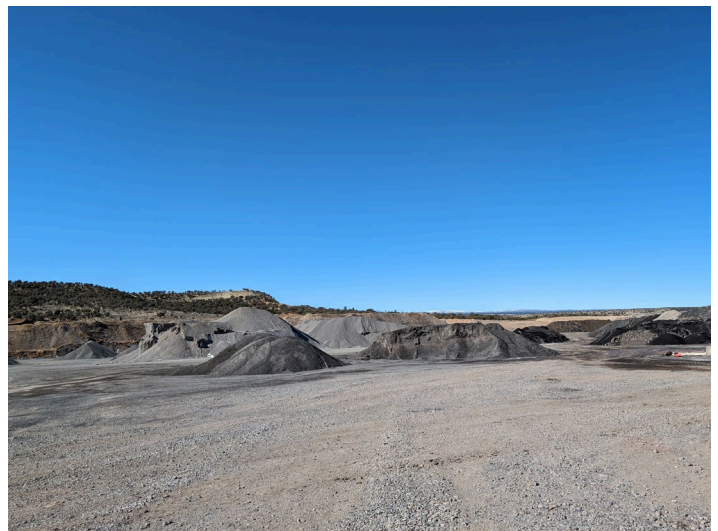
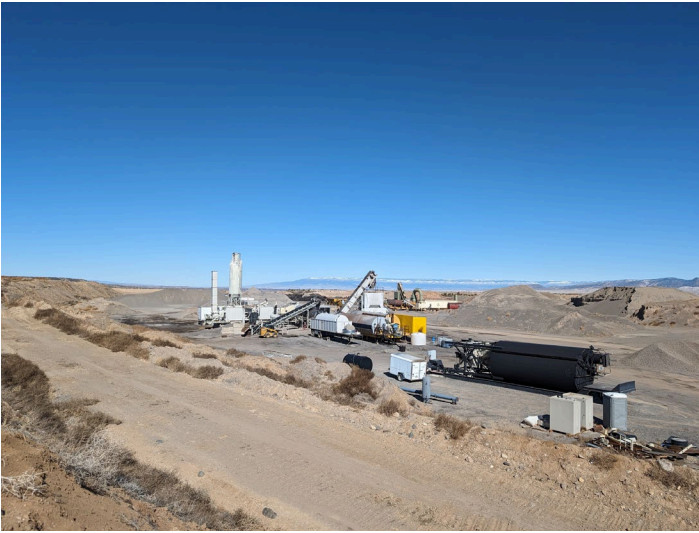
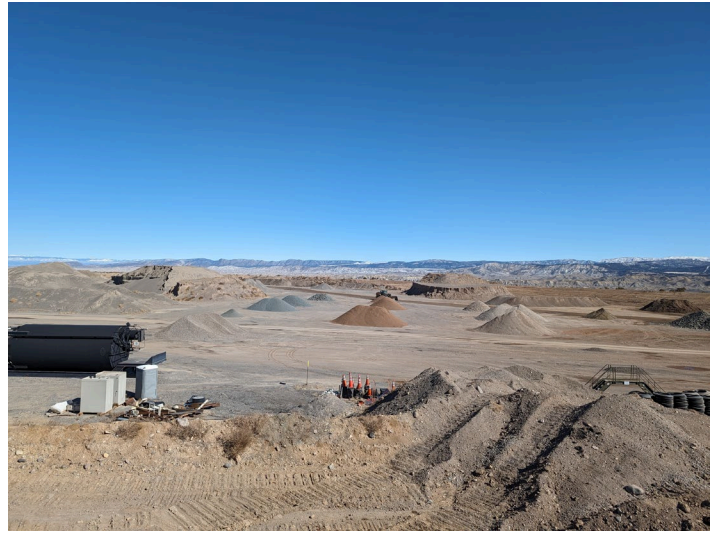
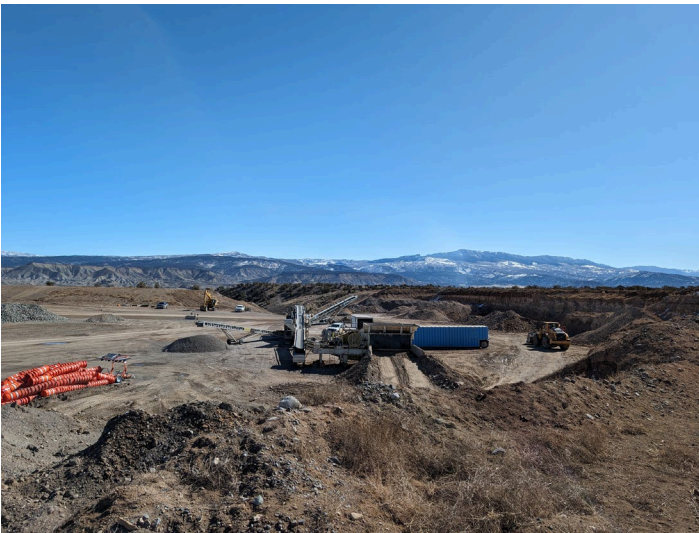
Mining at the site is progressing to the north. Materials stockpiles are located throughout the pit. Topsoil is stockpiled in different areas around the pit perimeter. The plant area is set up at the top of the access road, in the southwest part of the pit. Import fill and recycled asphalt are stockpiled north of the plant area.

Noxious weed infestations were not noted. Drainage problems were not noted. Fuel stored onsite is in adequate secondary containment.

Overall, the site appears well maintained and orderly.
