**COLORADO**  
Division of Reclamation,  
Mining and Safety  
Department of Natural Resources

Re: Colorado Environmental Spills or Release Reporting Form  
Incident Report Number 2023-0838

DRMS visited the site on December 20, 2023. The mine, identified as the Ethel Rose in the DRMS database, lies on Untied States Forest Service (USFS) land in the Arapaho National Forest approximately  $\frac{3}{4}$  miles south of the intersection of Soda Creek Rd. and Little Bear Rd. (just below the switchbacks). The mine was closed with an adit door by DRMS in 1994 as part of the Little Bear project (212-2). The DRMS lock has been removed and replaced with a combination lock. Otherwise the closure is in good condition.

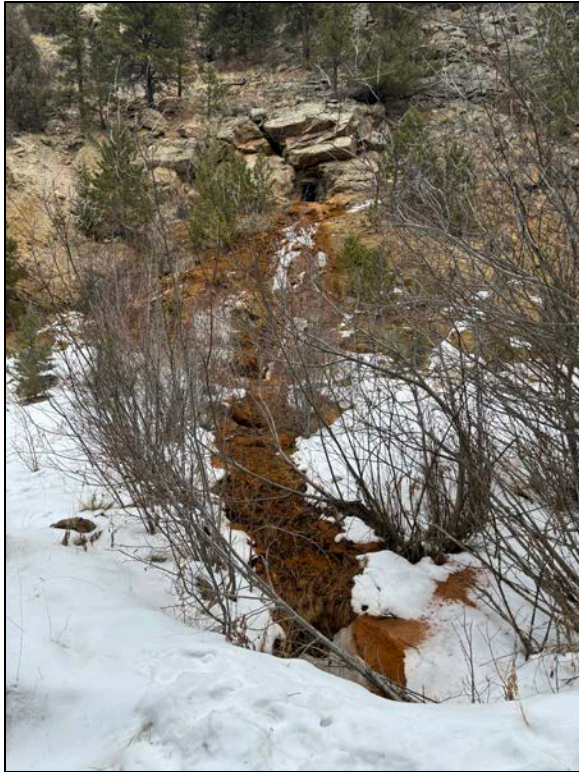
*Figure 1 - View of Sediment and staining from the Ethel Rose mine water release 2023-12-20.*

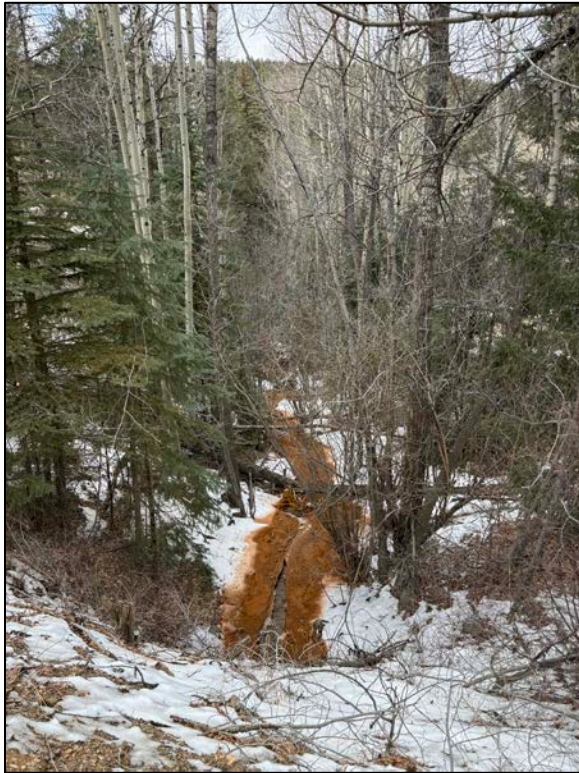
*Figure 3 – Heavy sedimentation and staining in the stream channel. View looking downstream on Little Bear Creek approximately 250ft below the mine portal.*
