MINERALS PROGRAM INSPECTION REPORT
PHONE: (303) 866-3567

MINE NAME: Greeley 35th Ave Pit	MINE/PROSPECTING ID#: M-1977-036	MINERAL: Sand and gravel	COUNTY: Weld
INSPECTION TYPE: Surety-Related Inspection	WEATHER: Cloudy	INSP. DATE: March 7, 2024	INSP. TIME: 08:00
OPERATOR: Martin Marietta Materials, Inc.	OPERATOR REPRESENTATIVE: Julie Mikulas	TYPE OF OPERATION: 112c - Construction Regular Operation	
REASON FOR INSPECTION: Surety Related	BOND CALCULATION TYPE: Partial Bond	BOND AMOUNT: \$7,764,000.00	
DATE OF COMPLAINT: NA	POST INSP. CONTACTS: None	JOINT INSP. AGENCY: None	
INSPECTOR(S): Brock Bowles	INSPECTOR'S SIGNATURE:

MMM submitted a Surety Reduction application (SR1) on February 12, 2024 to reduce the bond amount for the completion and certification of the West Pit slurry wall. The Division received one comment from Weld County Dept of Planning Services. These comments were forwarded to MMM.

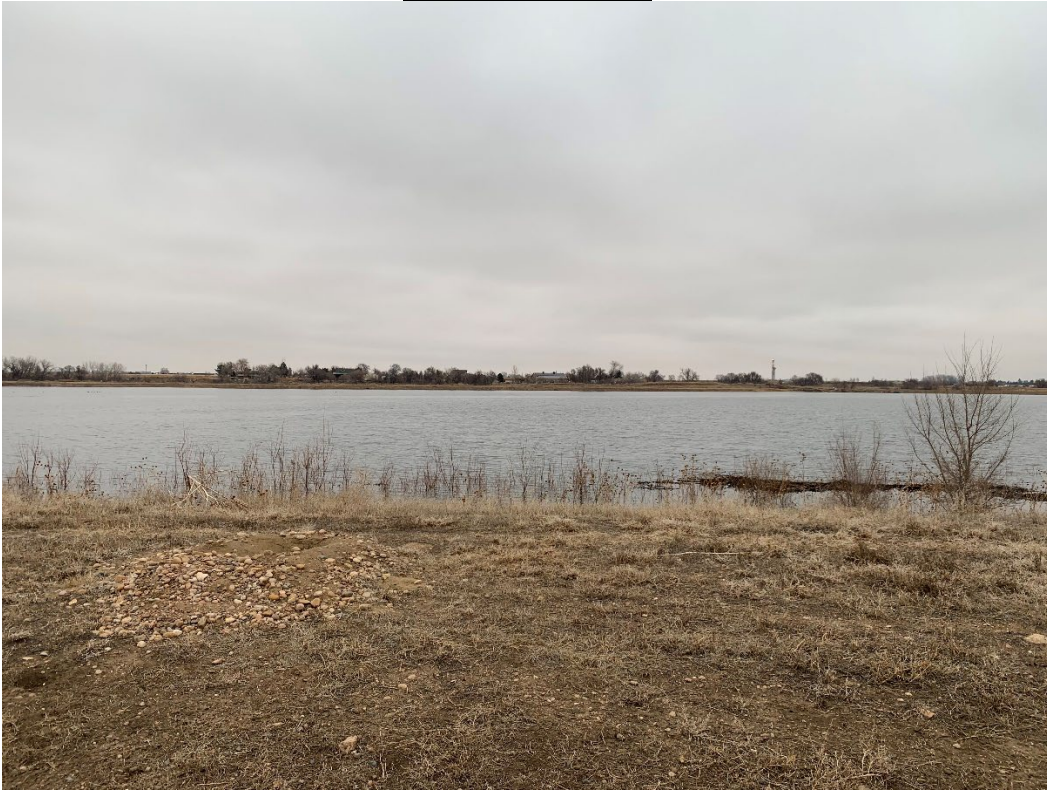
The West Cell Reservoir is the western most reservoir in the 35th Ave permit area (photo 1). It is bordered on the north and west sides by the Cache la Poudre River, and railroad tracks on the south side. A public pedestrian pathway is located between the river and the reservoir but is not within the permit boundary. The east side borders two other ponds currently being mined.

Photo 1 – West Cell Reservoir, facing north.

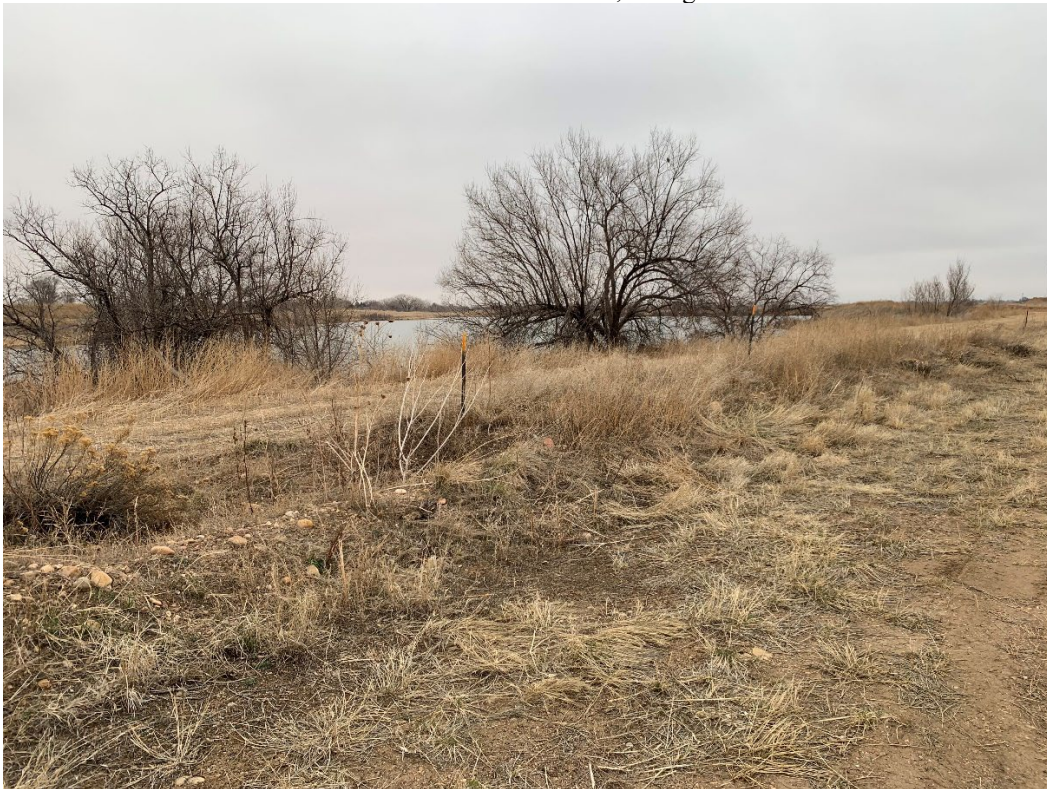
The reservoir was lined with a soil bentonite slurry wall. The leak test was conducted between August and November 2015. The West Cell Reservoir liner was approved by the Division of Water Resources on December 1, 2015. The approval letter is included with the SR1 application package.

The liner is marked on the surface with t-posts spaced every 100-200 feet (photo 2). No surface disturbance or damage was noted in the area of the liner. The pond contained water and a couple black pvc water pipes were in place on the southwest corner of the reservoir to manage the water quantity.

Photo 2 – Liner marked with t-posts.

The Division will recommend approval of the surely reduction (SR1) based on the observations from this inspection. The notice of DRMS's decision will be sent under separate cover.

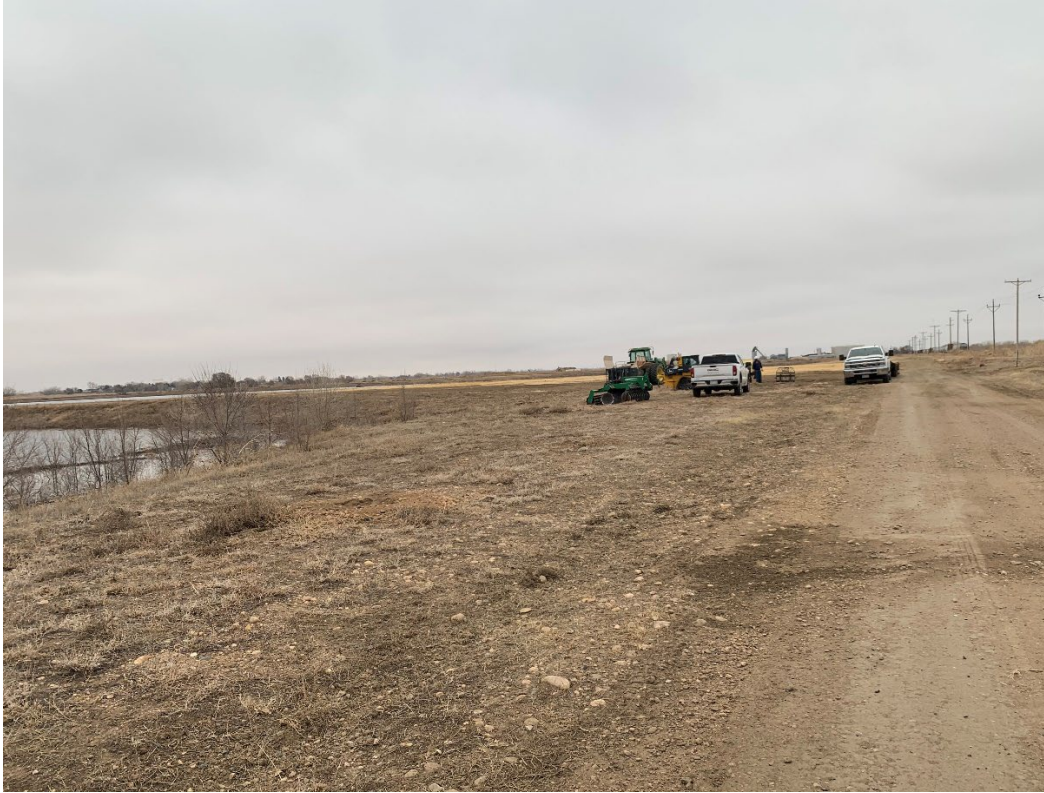
The oil and gas well on the south side of the reservoir was in the process of being reclaimed (photo 3). It looked like the pad had been seeded, mulched, and crimped. A crew was onsite doing the final work. This reclamation work for the oil and gas permit is not regulated by the Division and is only being reported here as an observation that the work was not compromising the integrity of the slurry wall.

Photo 3 – Reclamation of oil and gas pad on south side of the reservoir.
