MINERALS PROGRAM INSPECTION REPORT
PHONE: (303) 866-3567

MINE NAME: Hawkeye Mine	MINE/PROSPECTING ID#: M-1978-311	MINERAL: Uranium and vanadium	COUNTY: San Miguel
INSPECTION TYPE: Surety Release Inspection	WEATHER: Clear	INSP. DATE: March 6, 2024	INSP. TIME: 09:30
OPERATOR: Gold Eagle Mining, Inc.	OPERATOR REPRESENTATIVE: Don Coram, Gold Eagle Mining	TYPE OF OPERATION: 110d - Designated Limited Impact	
REASON FOR INSPECTION: Surety Release Requested	BOND CALCULATION TYPE:	BOND AMOUNT: \$100.00	
DATE OF COMPLAINT: NA	POST INSP. CONTACTS: None	JOINT INSP. AGENCY: Other Agency	
INSPECTOR(S): Lucas West	INSPECTOR'S SIGNATURE:

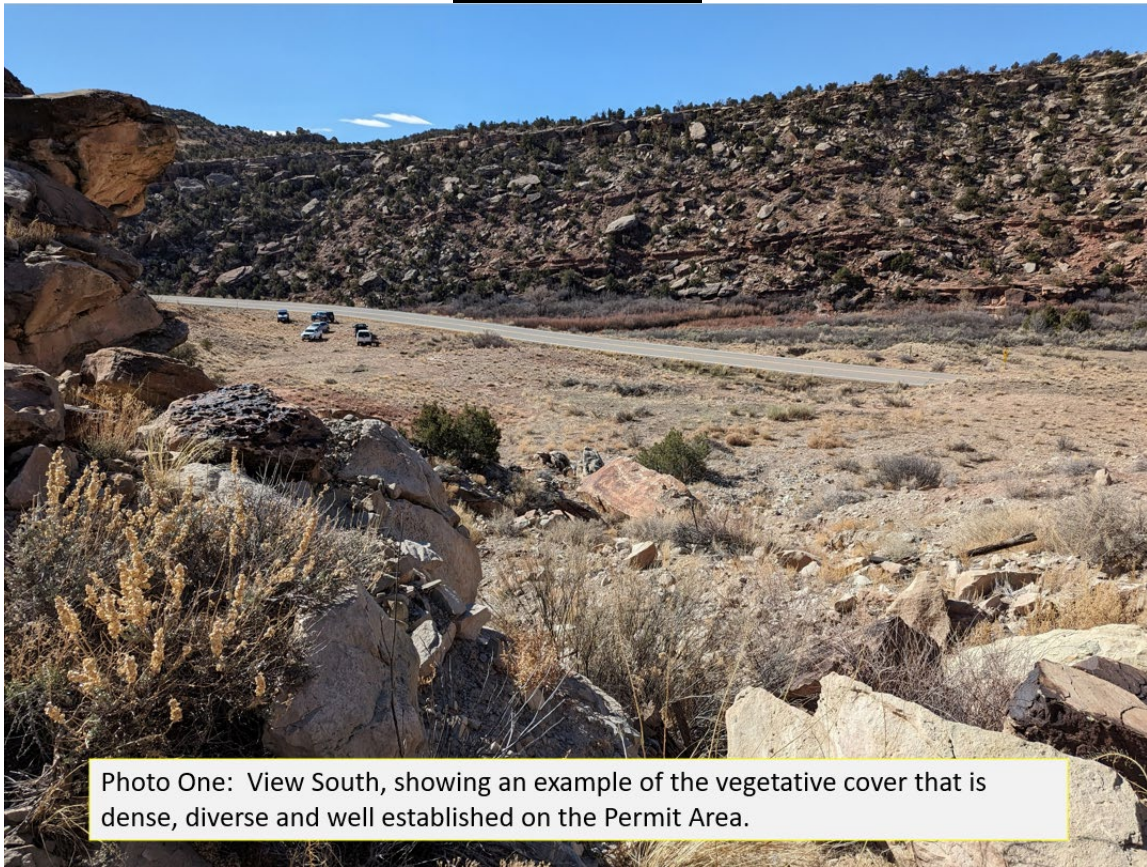
Photo One: View South, showing an example of the vegetative cover that is dense, diverse and well established on the Permit Area.

Final reclamation of the site has been completed, and the site remains in the same condition as the previous inspection. During this inspection it was observed that the vegetation is well established and appears to be healthy. The vegetative cover across the site is well established and in good condition. Multiple year's growth was noted indicating the vegetation is self-sufficient and capable of self-regeneration. The vegetation is currently as good as or better than adjacent undisturbed lands. Examples of the vegetative establishment can be seen in Photos One and Two.

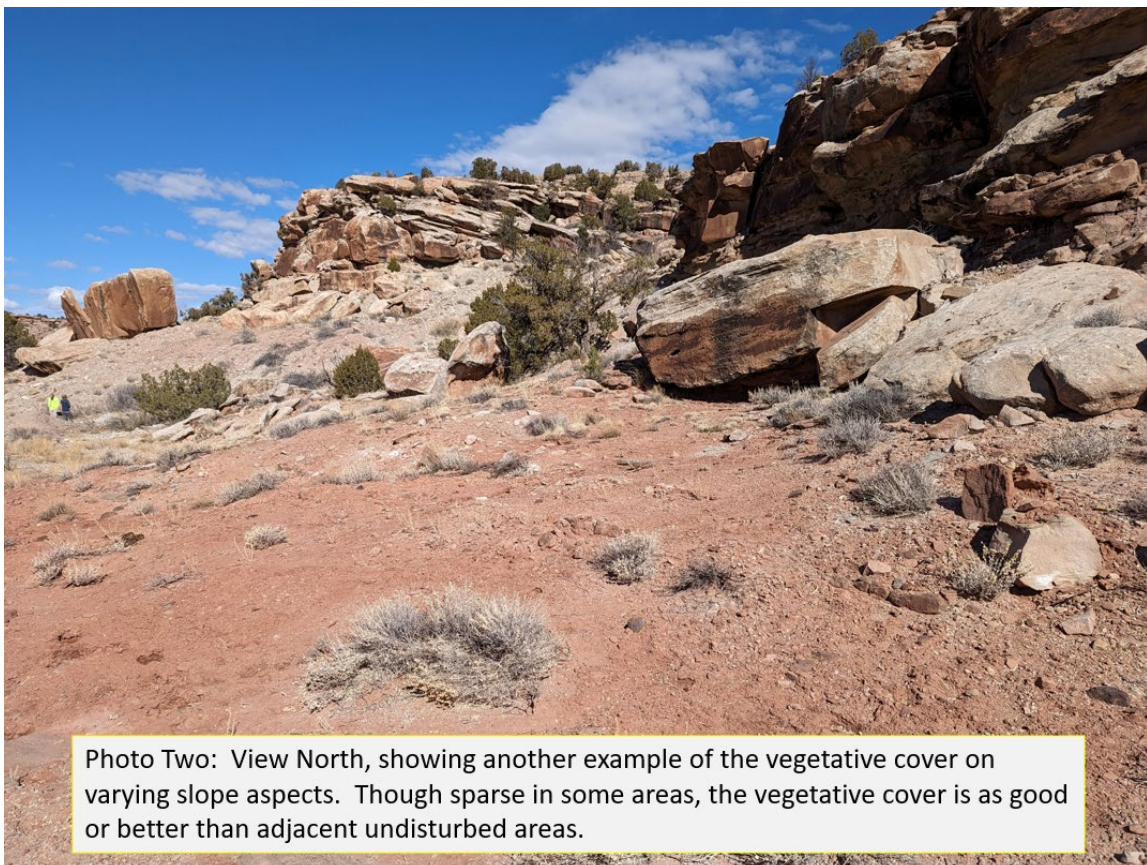
Photo Two: View North, showing another example of the vegetative cover on varying slope aspects. Though sparse in some areas, the vegetative cover is as good or better than adjacent undisturbed areas.

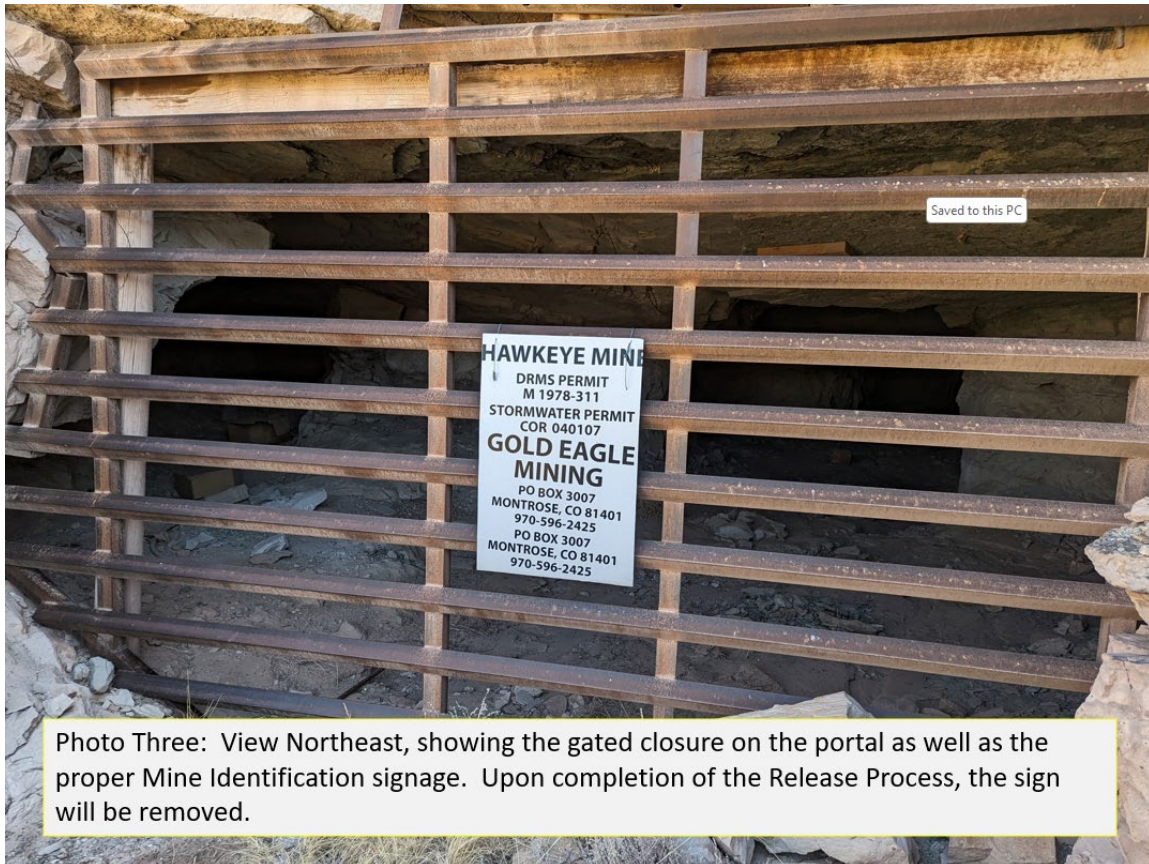
The site contains a secured portal onsite leading to the underground workings that is closed with a welded steel closure. The portal closure, seen in Photo Three, is stable and in good condition. The proper Mine Identification signage is secured to the portal closure. It shows no signs of vandalism or attempted unauthorized entry. The access road leading to the portal is equipped with various storm water control structures and appears to be stable. The access road can be seen in Photo Four. Adjacent to the portal is a natural drainage leading down toward the county road. The storm water controls lead through the site, down the natural drainage to a small "sediment pond" near the County Road. The sediment pond is well vegetated to dissipate flows and was in good condition. The waste rock pile was observed and appeared to be stable at the time of the inspection.
