**MINERALS PROGRAM INSPECTION REPORT**  
**PHONE: (303) 866-3567**

<b>MINE NAME:</b> Henderson Mine	<b>MINE/PROSPECTING ID#:</b> M-1977-342	<b>MINERAL:</b> Molybdenum	<b>COUNTY:</b> Clear Creek, Grand
<b>INSPECTION TYPE:</b> Monitoring	<b>WEATHER:</b> Clear	<b>INSP. DATE:</b> March 20, 2024	<b>INSP. TIME:</b> 09:00
<b>OPERATOR:</b> Climax Molybdenum Company	<b>OPERATOR REPRESENTATIVE:</b> Shelby Epperson	<b>TYPE OF OPERATION:</b> 112d-3 - Designated Mining Operation	
<b>REASON FOR INSPECTION:</b> Normal I&E Program	<b>BOND CALCULATION TYPE:</b> None	<b>BOND AMOUNT:</b> \$170,904,202.00	
<b>DATE OF COMPLAINT:</b> NA	<b>POST INSP. CONTACTS:</b> None	<b>JOINT INSP. AGENCY:</b> None	
<b>INSPECTOR(S):</b> Brock Bowles Amber Gibson Joel Renfro	<b>INSPECTOR'S SIGNATURE:</b>

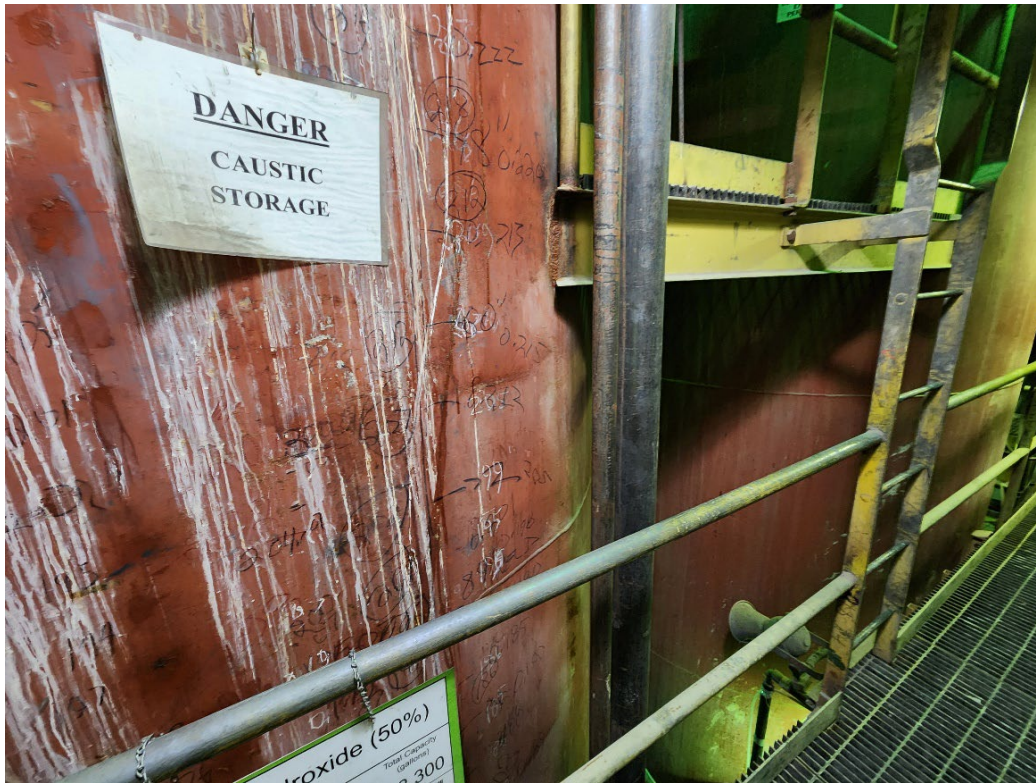
**Mill EPF 2.1** - Sodium Hydroxide Storage- Two 12,300 gallon tanks are located in the Nokes building on the north side of the mill building (photo 1). They are located in a containment area which appeared to be free of obstructions.

Photo 1 – Sodium Hydroxide storage in the Nokes building.

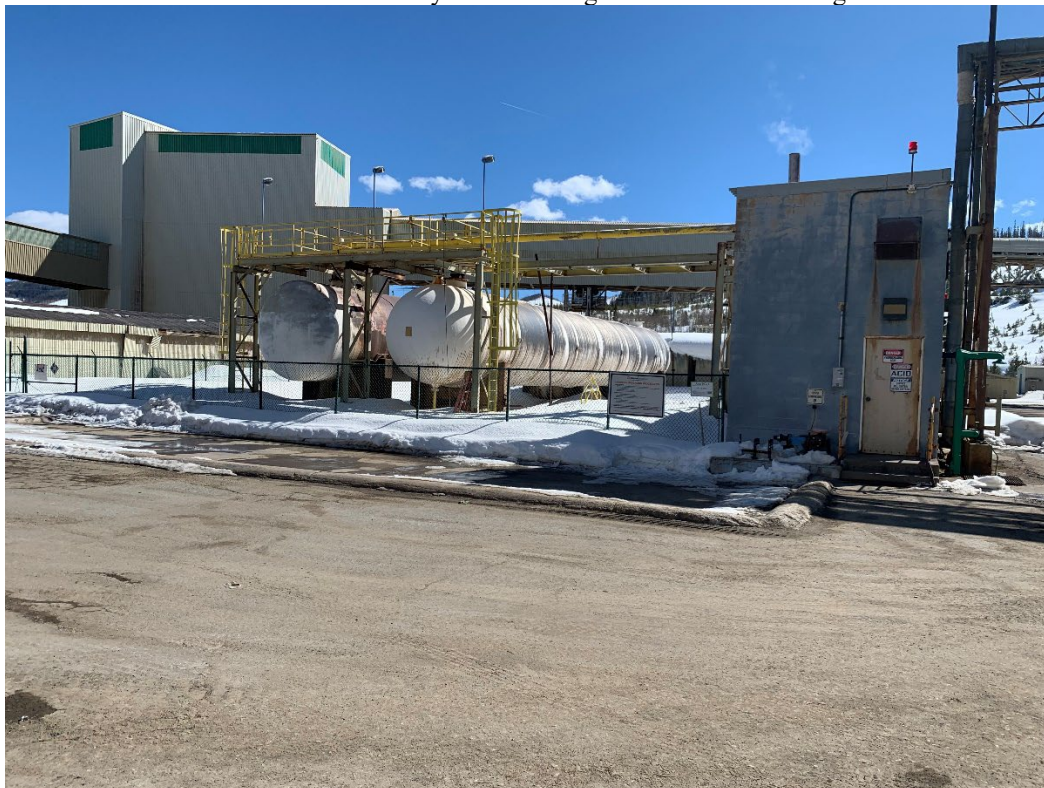
**Mill EPF 2.2** - Hydrochloric Acid Storage- Two 50,000-gallon HCL tanks are located outside the mill building on the north side (photo 2). The Operator stated that the north tank is not presently being used, and that the south tank is only at about 40% capacity. The tanks are sectioned off from the rest of the area by a perimeter fence.

Photo 2 – HCL storage tanks. The left tank (north) is not being utilized

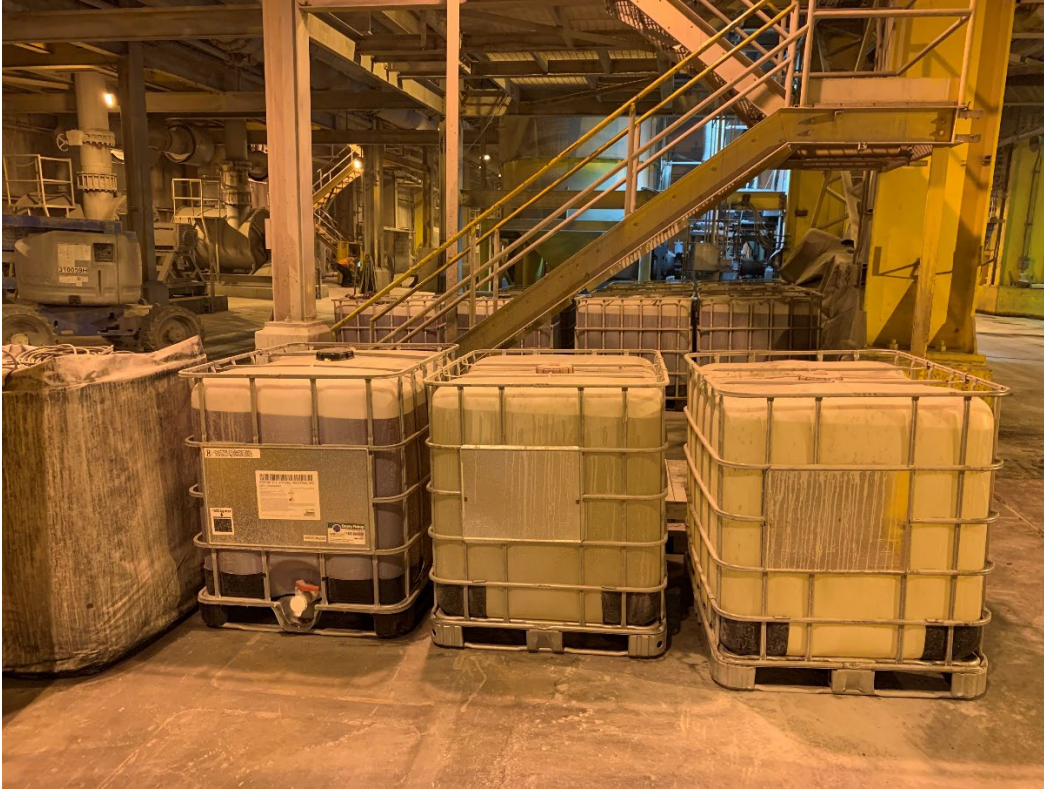
**Mill EPF 2.3b** - Depressant Chemical Storage (Orform D8 Depressant)- The Orform D8 Depressant is currently stored in 275-gallon totes in the Mill building with a maximum storage capacity of 5,400 gallons. 14- 275-gallon totes were currently being stored on the main floor of the mill building for a total of 3,850 gallons (photo 3). In the Division's March 14, 2023 inspection, the Division noted that the Operator was in the process of relocating the Orform D8 Depressant from tote to tank storage and that the empty tank was observed during the inspection. During the March 20, 2024 inspection, the Division inquired if this was still the plan, to which the Operator stated that to their knowledge this is no longer the case. The Division reminds the Operator that if the Orform D8 Depressant is changed to tank storage, the Operator will be required to update the EPP to accurately describe its storage.

Photo 3 – 275-gallon totes of Orfom D8 Depressant

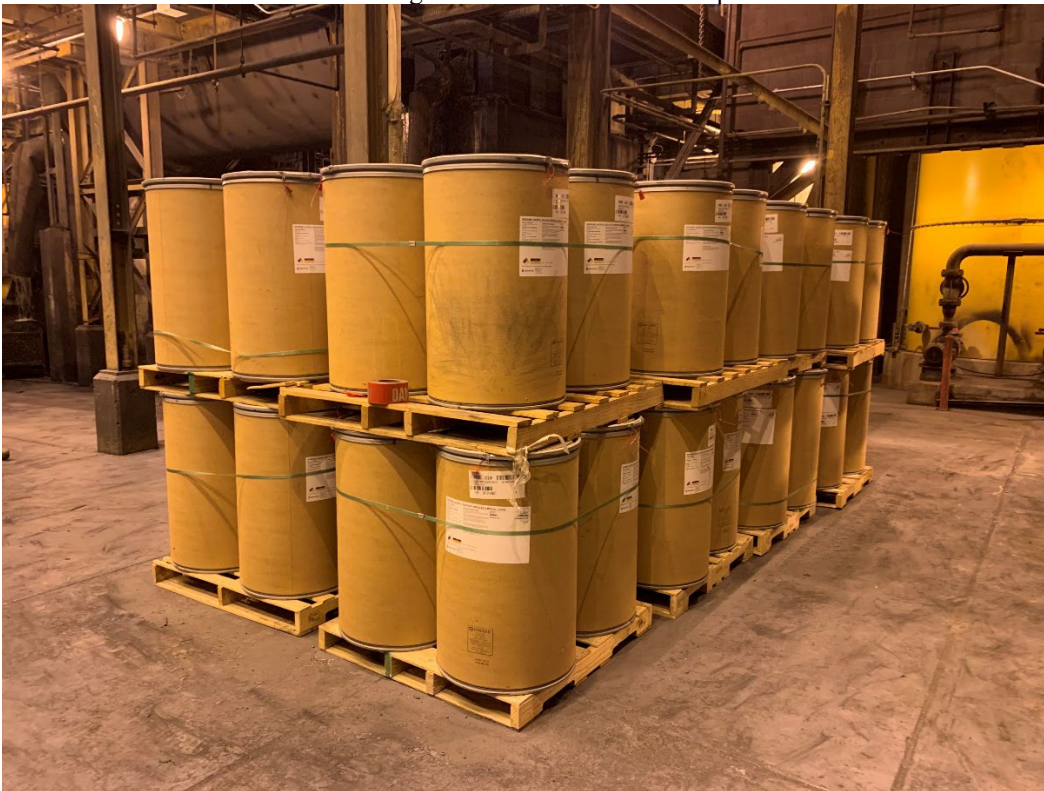
**Mill EPF 2.7** - Sodium Lauryl Sulfate Storage- 79- 220 lbs. storage containers were onsite for a total quantity of 17,380 lbs. (photo 4). The maximum approved quantity is 26,400 lbs. The storage location was clean, and no spills were noted.

Photo 4 – 64 of the 79 Sodium Lauryl Sulfate containers.

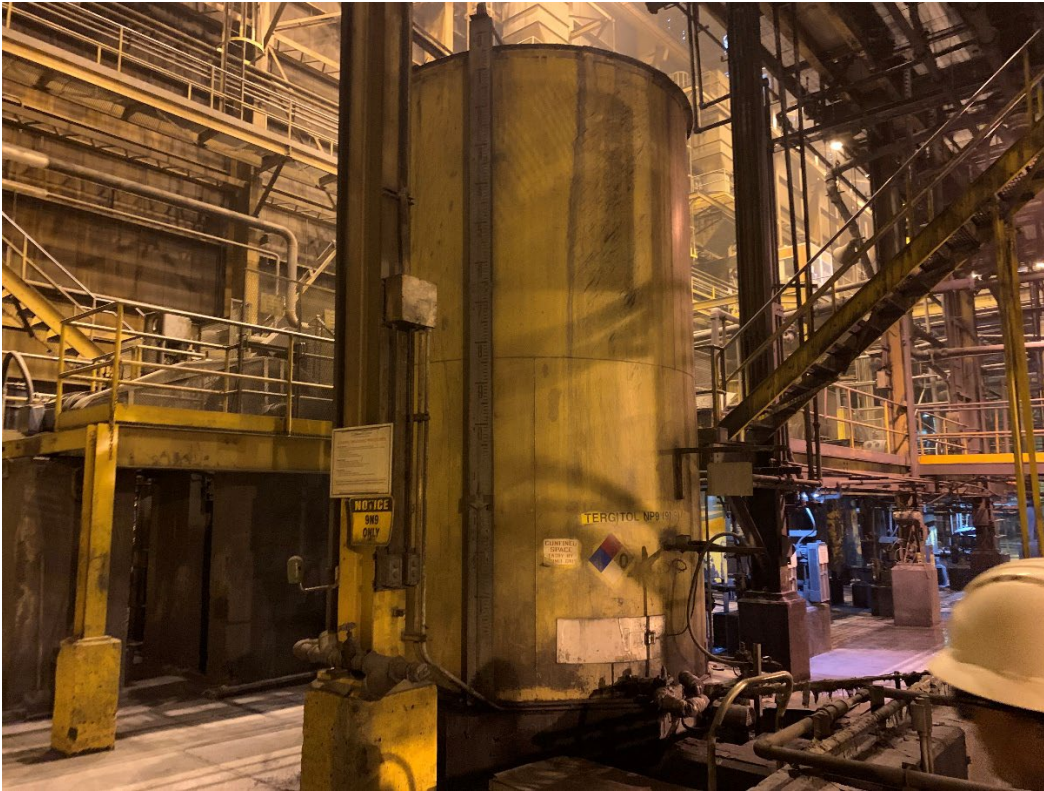
**Mill EPF 2.8** - Tergitol NP-9/9N9 Surfactant Storage- The main 9,400-gallon, double walled storage tank is located in the mill building on the ground floor (photo 5). A second 500-gallon plastic storage tank is located on the upper floor, east side (photo 6). Both tanks were in operating condition and no leaks were noted.

Photo 5 – Main Tergitol NP-9/N9N storage tank.

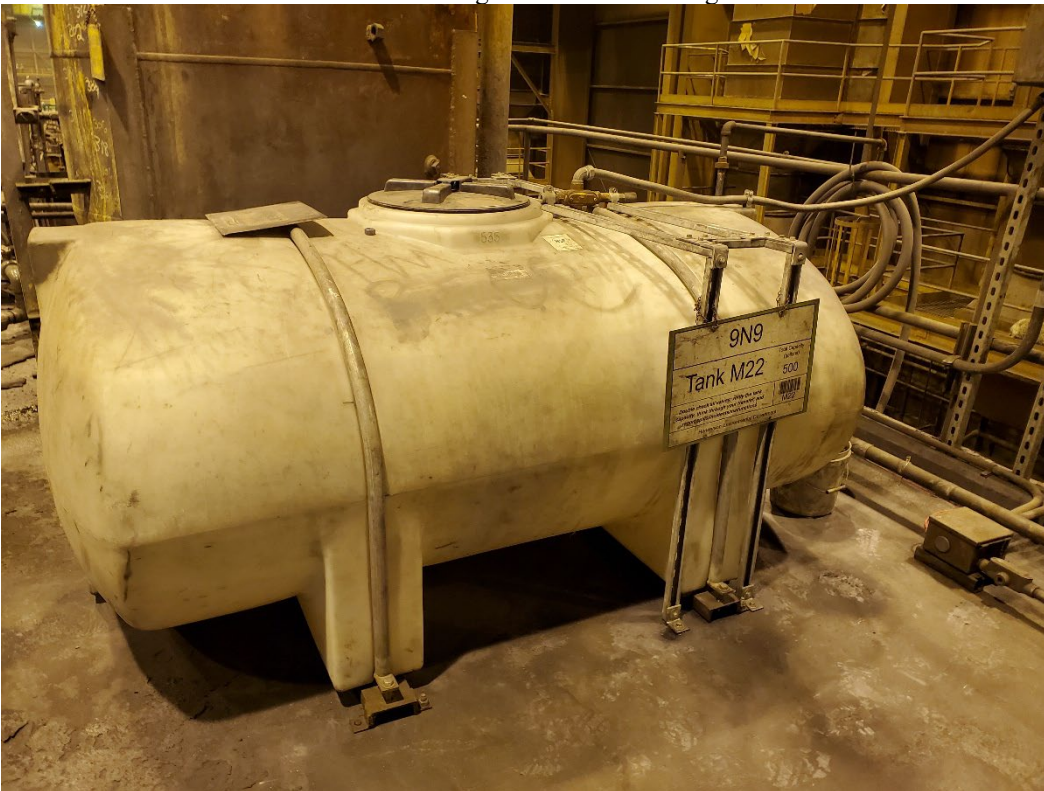
Photo 6 – 500-gallon head tank-Tergitol NP-9/N9N.

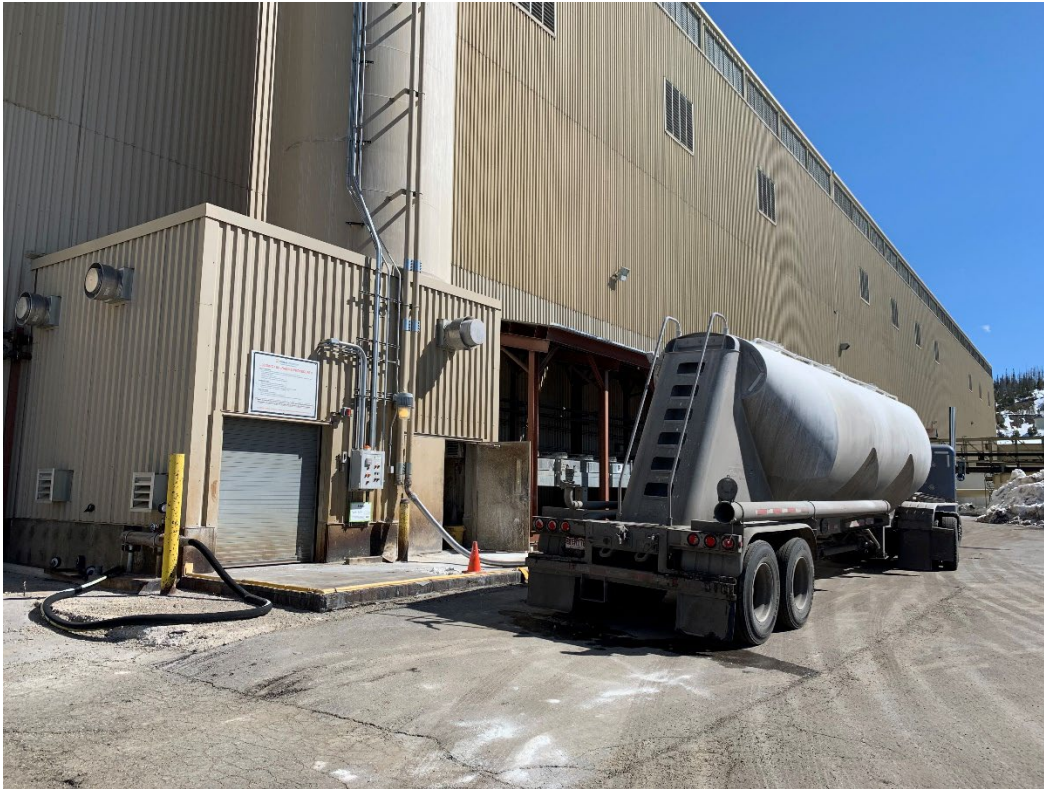
**Mill EPF 2.9** - Quicklime Storage- This area was not inspected because lime was being delivered and offloaded from a truck (photo 7).

Photo 7 – Quicklime delivery truck.

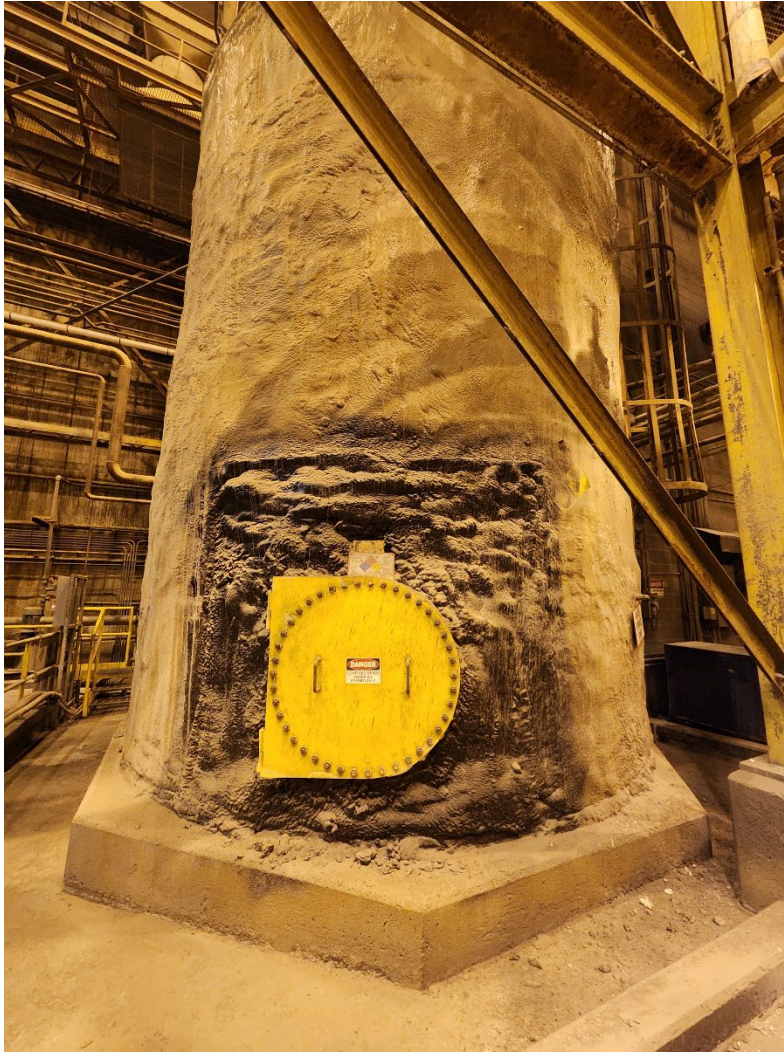
**Mill EPF 2.10** - Nokes Storage- The 21,800-gallon storage tank is in the main mill building on the north side, ground level (photo 8). No spills were noted in the storage location.

Photo 8 – Nokes storage tank.
